Wetland Biological Conditions EA Report

Project Name	H-600 Pipeline Spread A	AFE	124300129	Spread	H-600 Pipeline Spread A
Contractor	Precision	Report #	4		
Environmental Auditor	Samantha Felix			Date/Time	7/20/2023 2:29 PM
Wetland ID	W-A27 PFO	Crossing Start Date	7/7/2023	Crossing Completion Date	7/13/2023
Milepost	5.53	Pre-Con Assessment Date	7/6/2023	Post-Con Assessment Date	7/14/2023
Station	291+98	Cowardin Classification	PFO	Wetland Impact Area(acres)	0.0547
State	WV				
County	Wetzel

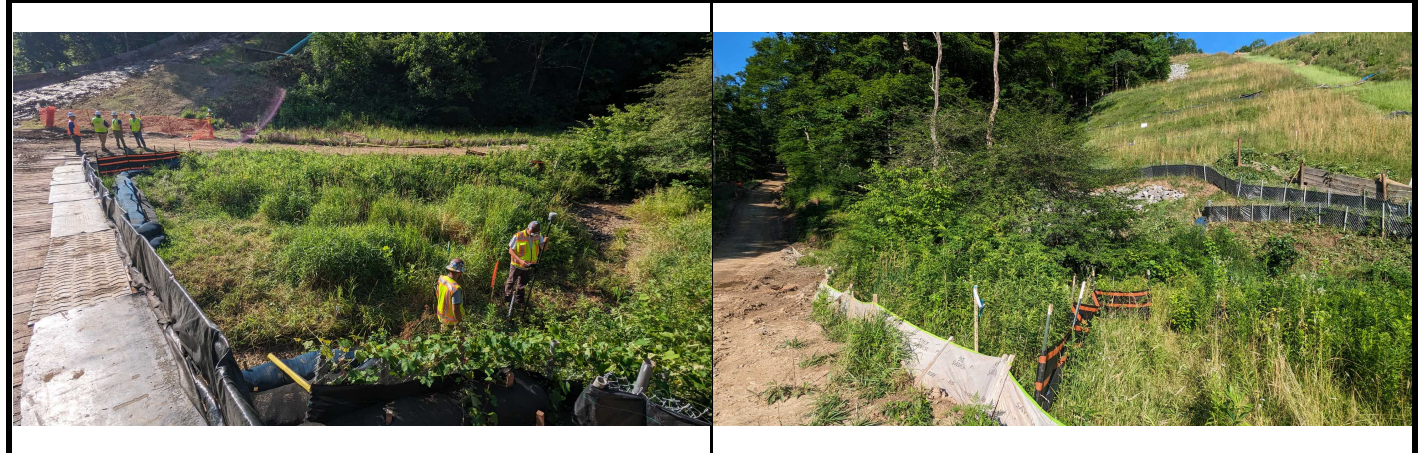
Heavily vegetated emergent wetland bordering the south side of stream S-A118. A timber matted access road unaffiliated with Mountain Valley Pipeline runs through W-A27 PFO going north to south. Wetland W-A27 PFO did not appear to have any large rocks or woody debris present. No standing water was observed. The timber mat temporary equipment crossing installed for the project runs along the north side of the wetland W-A27 PFO going east to west.

GPS Location	39.502414, -80.523324	GPS Location	39.502333, -80.523209
Description	View of permitted resource impact area during pre-construction assessment.	Description	At edge of LOD, view of unimpacted resource area conditions during pre-construction assessment.

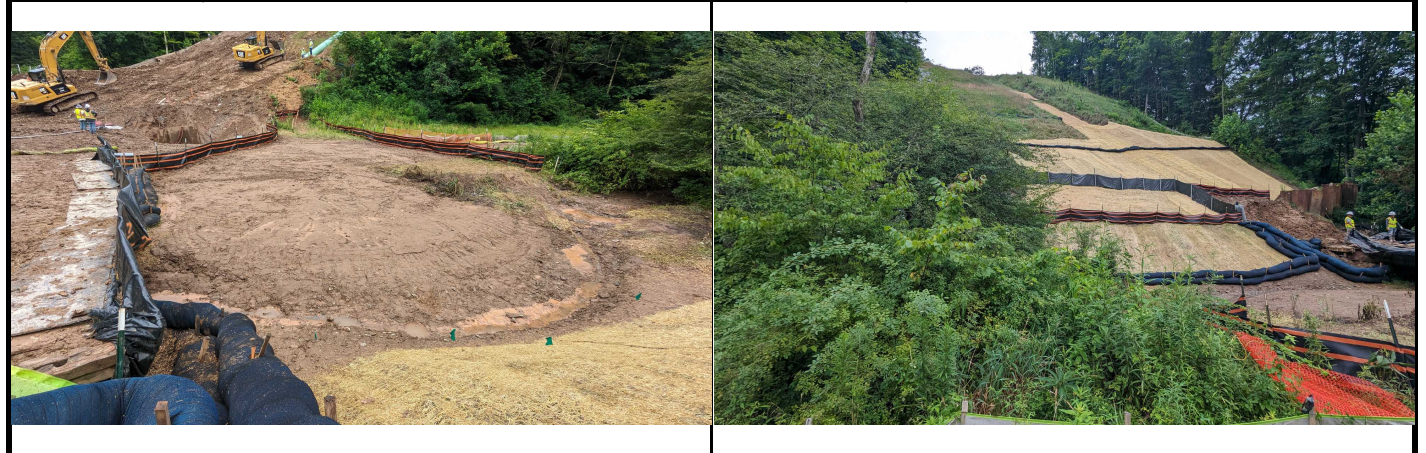
Conditions 18 and 19 were given a rating of 4 due to the lack of vegetation in the disturbed permitted impact area following completion of the crossing and restoration efforts. The W-A27 PFO topsoils have been properly stabilized and the disturbed area has been seeded with the appropriate permanent seed mix in accordance with Appendix B: Restoration Work Plan of the Mountain Valley Pipeline Comprehensive Stream and Wetland Monitoring, Restoration and Mitigation Framework.

GPS Location	39.502463, -80.523563	GPS Location	39.502333, -80.523209
Description	View of permitted resource impact area during post-construction assessment.	Description	At edge of LOD, view of unimpacted resource area conditions during post-construction assessment.
