# Stream Biological Conditions EA Report

<b>Project Name</b>	H-600 Pipeline Spread A	<b>AFE</b>	124300129	<b>Spread</b>	H-600 Pipeline Spread A
<b>Contractor</b>	Precision	<b>Report #</b>	19		
<b>Environmental Auditor</b>	Samantha Felix	<b>Date/Time</b>	8/4/2023 4:42 PM		
<b>Stream ID</b>	S-A124	<b>Crossing Start Date</b>	8/4/2023	<b>Crossing Completion Date</b>	8/6/2023
<b>Milepost</b>	5.00	<b>Pre-Con Assessment Date</b>	8/3/2023	<b>Post-Con Assessment Date</b>	8/6/2023
<b>Station</b>	264+00	<b>Bankfull Width (ft.)</b>	12.0	<b>Riffle:Pool Complexes Present?</b>	No
<b>State</b>	WV	<b>Stream Classification</b>	Intermittent		
<b>County</b>	Wetzel	<b>303(d) Impairment Listing</b>	No

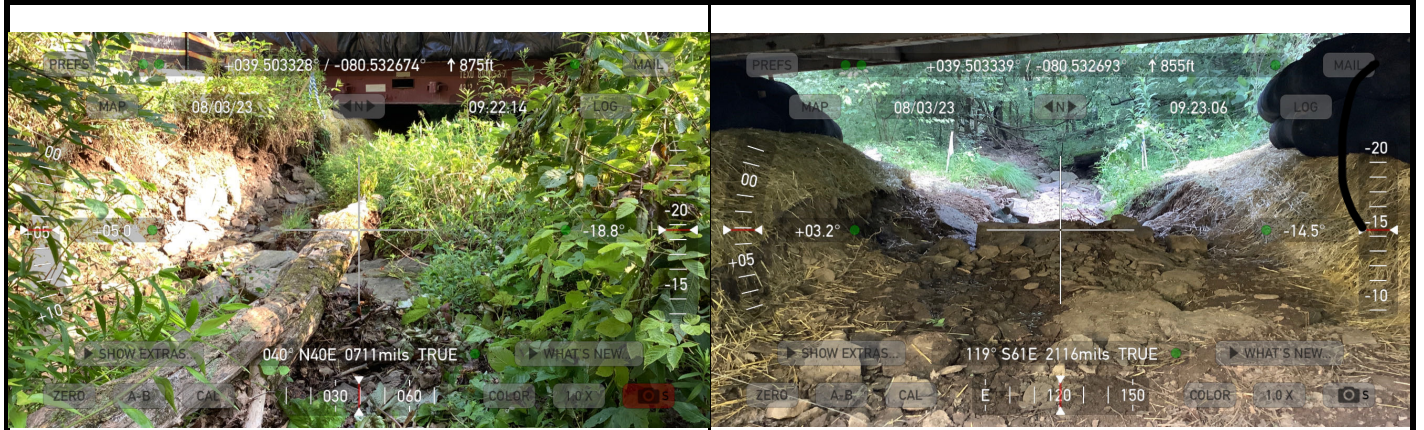
<b>GPS Location</b> see photo	<b>GPS Location</b> see photo
<b>Description</b> Downstream view of permitted impact area during pre-construction assessment.	<b>Description</b> Downstream view of unimpacted area during pre-construction assessment.

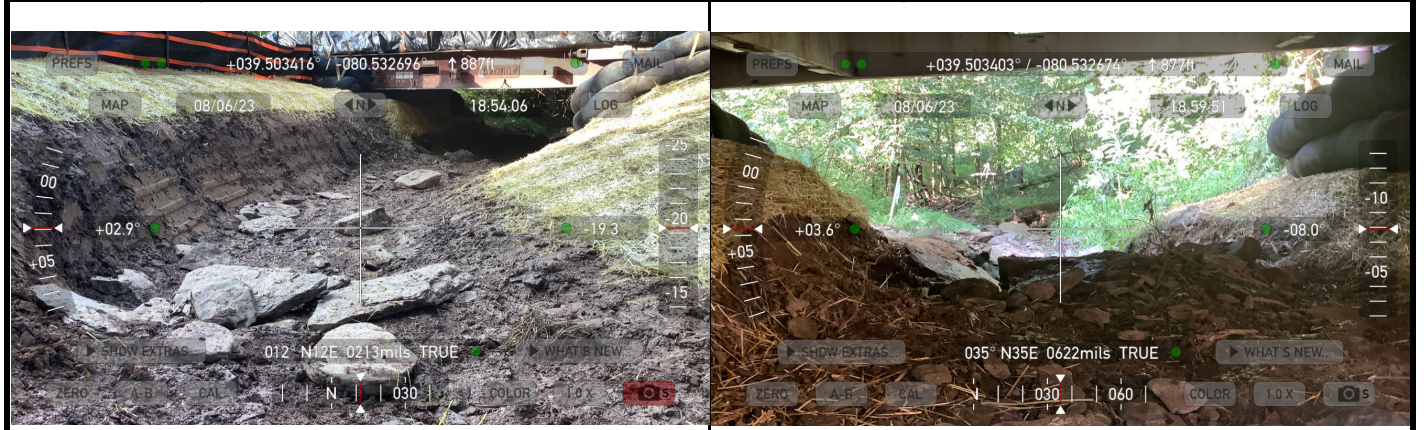
<b>GPS Location</b> see photo	<b>GPS Location</b> see photo
<b>Description</b> Downstream view of permitted impact area during post-construction assessment.	<b>Description</b> Downstream view of unimpacted area during post-construction assessment.

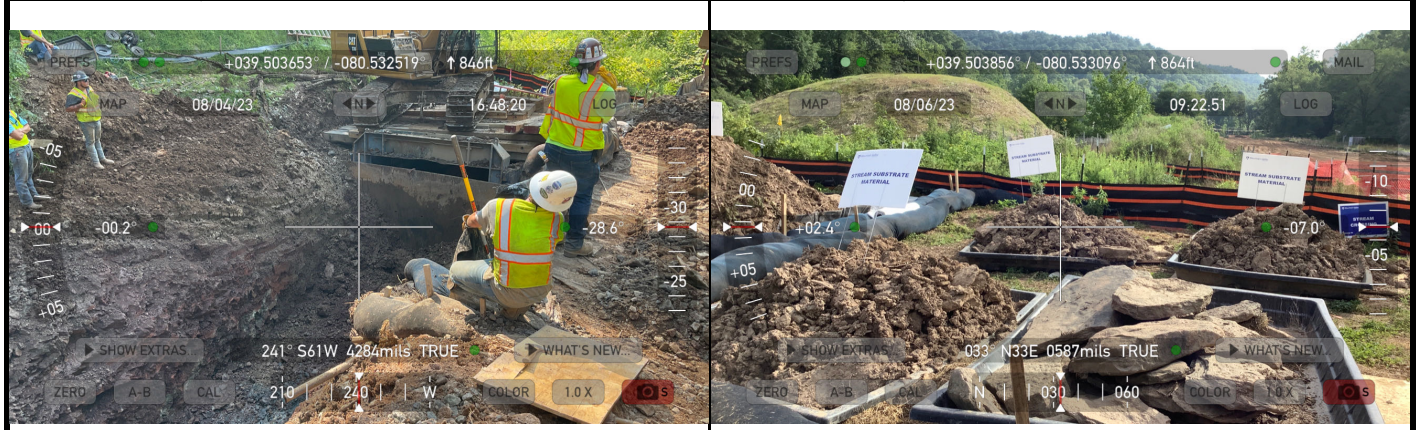
<b>GPS Location</b> see photo	<b>GPS Location</b> see photo
<b>Description</b> This photo shows the contractor working on trench excavation in the water body.	<b>Description</b> This photo shows the segregated and labeled water body substrate stockpiled in a designated upland area.

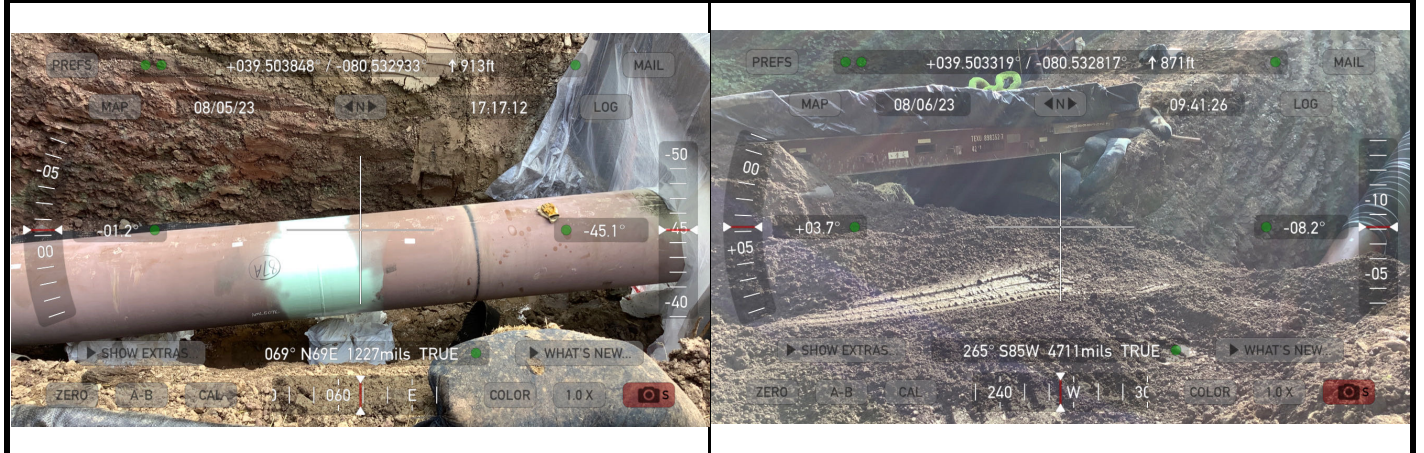
<b>Description</b>	This photo shows the contractor working on installing the pipe.	<b>Description</b>	This photo shows the contractor working on backfilling the trench through the water body after pipe installation.
--------------------	---	--------------------	---
