## Stream Biological Conditions EA Report

<b>Project Name</b>	H-600 Pipeline Spread A	<b>AFE</b>	124300129	<b>Spread</b>	H-600 Pipeline Spread A
<b>Contractor</b>	Precision	<b>Report #</b>	79		
<b>Environmental Auditor</b>	Samantha Felix	<b>Date/Time</b>	8/21/2023 10:09 AM		
<b>Stream ID</b>	S-A3a	<b>Crossing Start Date</b>	8/18/2023	<b>Crossing Completion Date</b>	8/20/2023
<b>Milepost</b>	0.81	<b>Pre-Con Assessment Date</b>	8/17/2023	<b>Post-Con Assessment Date</b>	8/20/2023
<b>Station</b>	42+62	<b>Bankfull Width (ft.)</b>	9.0	<b>Riffle:Pool Complexes Present?</b>	No
<b>State</b>	WV	<b>Stream Classification</b>	Intermittent		
<b>County</b>	Wetzel	<b>303(d) Impairment Listing</b>	No

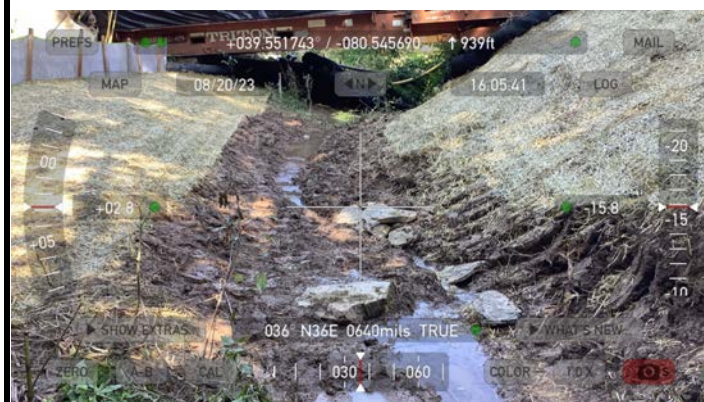
**GPS Location** see photo  
**Description** Downstream view of permitted impact area during pre-construction assessment.

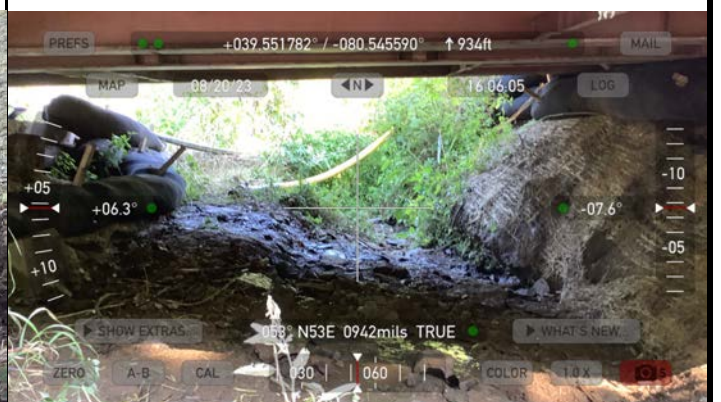
**GPS Location** see photo  
**Description** Downstream view of unimpacted area during pre-construction assessment.

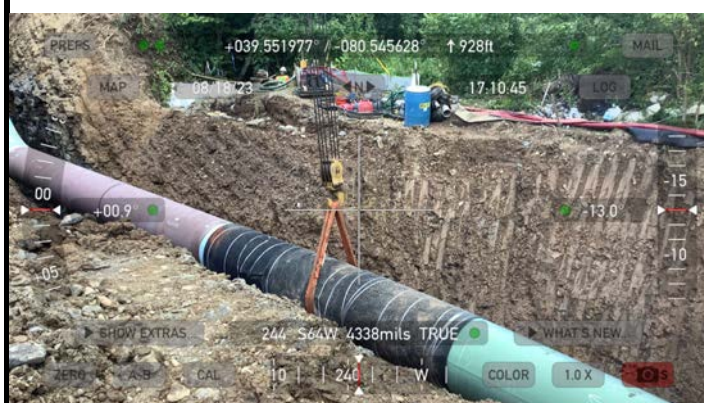
**GPS Location** see photo  
**Description** Downstream view of permitted impact area during post-construction assessment.

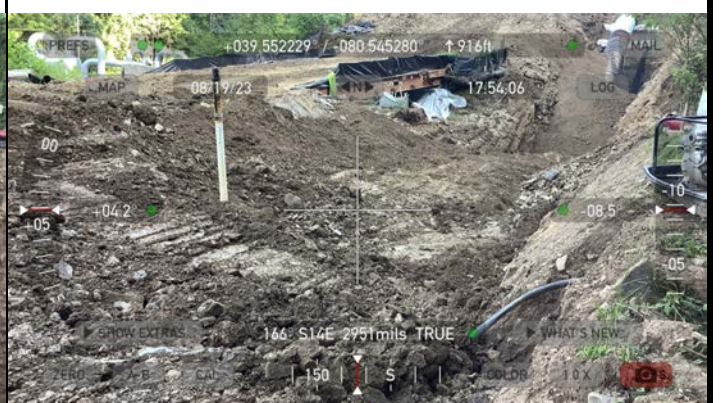
**GPS Location** see photo  
**Description** Downstream view of unimpacted area during post-construction assessment.
