STREAM BIOLOGICAL CONDITIONS ENVIRONMENTAL AUDITOR REPORT

Stream ID: S-AB16	Crossing Start Date: 08/02/2023	Crossing Completion Date: 08/02/2023
Milepost: 235.6	Pre-Con Assessment Date: 07/31/2023	Post-Con Assessment Date: 08/02/2023
Station: 12477+78	Stream Classification: Intermittent (Perennial, Intermittent, Ephemeral)	Bankfull Width (ft.): 5
County: Montgomery	303(d) Impairment Listing: Not Impaired	Riffle:Pool Complexes Present? No

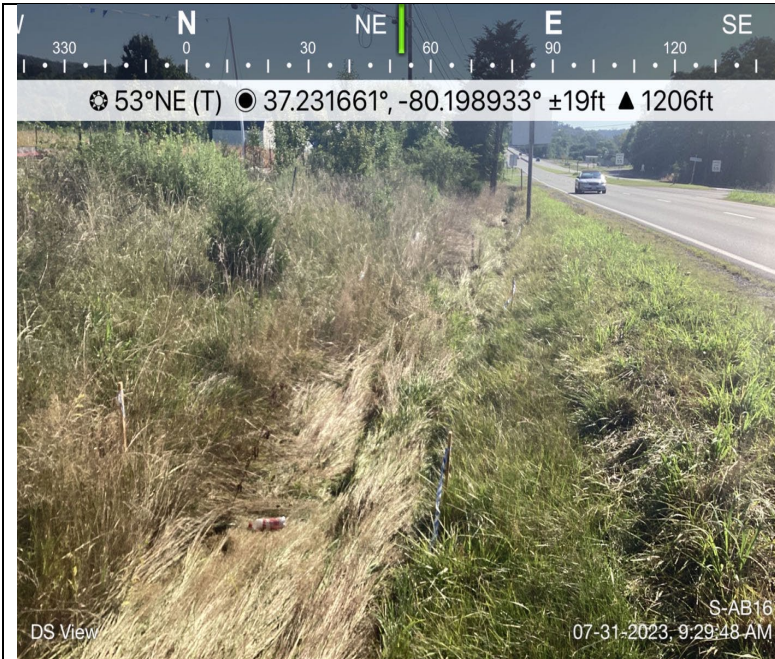
Photo Description: Downstream view of permitted impact area during pre-construction assessment.

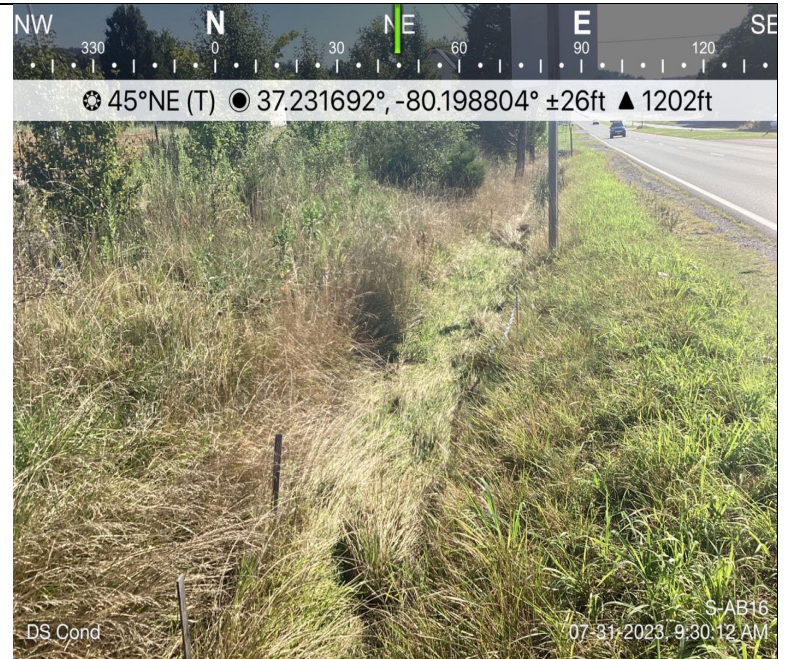
Photo Description: Downstream view of unpermitted area during pre-construction assessment.

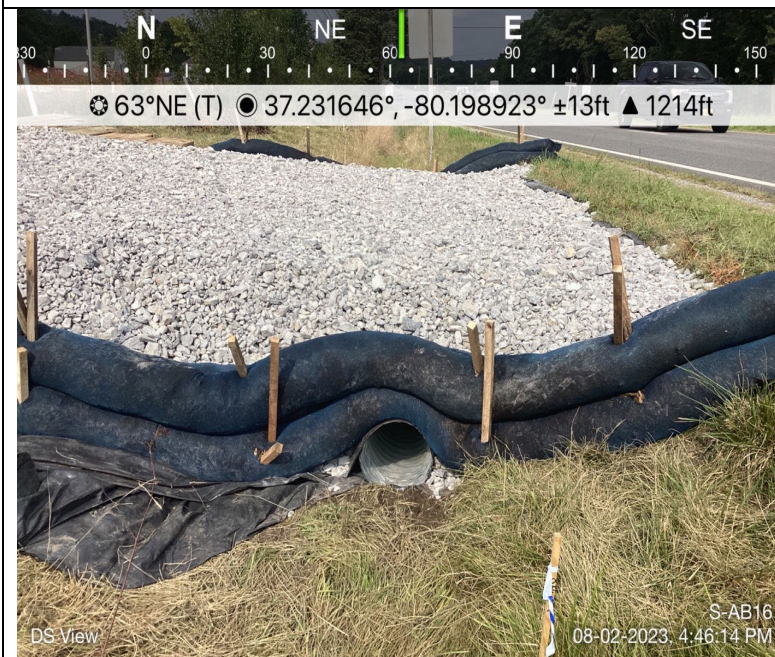
Photo Description: Downstream view of permitted impact area during post-construction assessment.

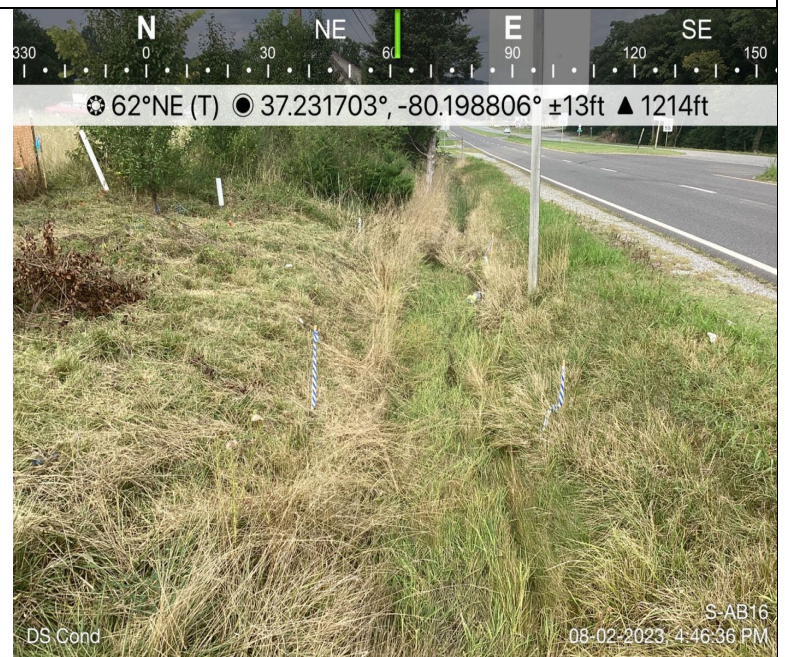
Photo Description: Downstream view of unpermitted area during post-construction assessment.

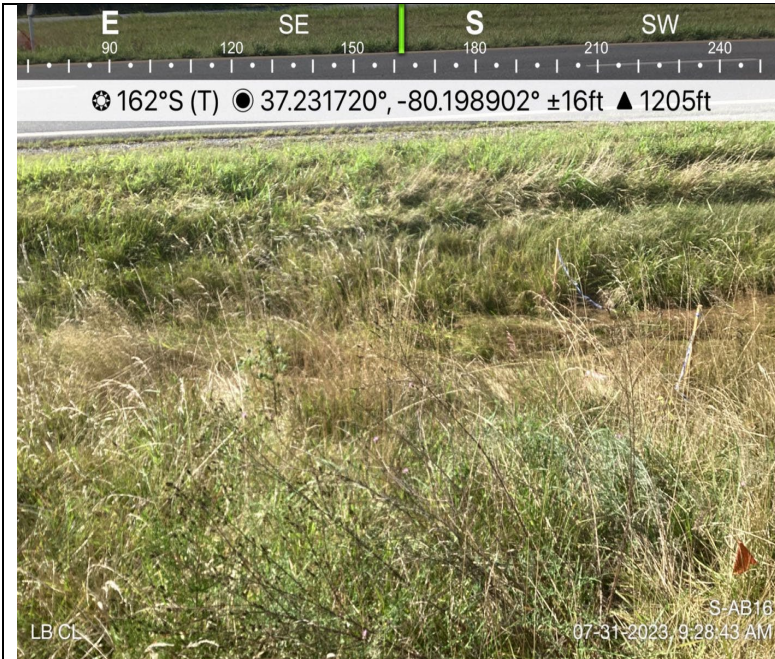
Photo Description: Left bank view during pre-construction assessment

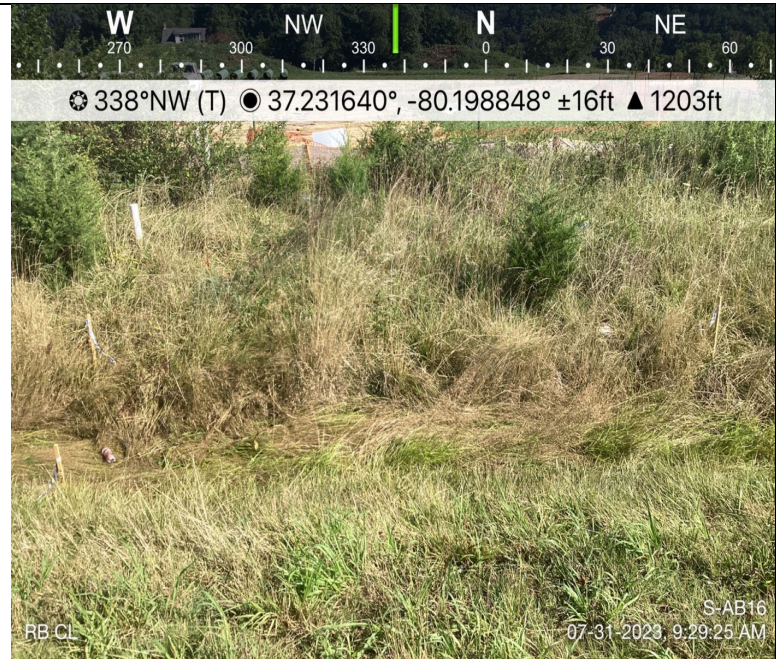
Photo Description: Right bank view during pre-construction assessment.

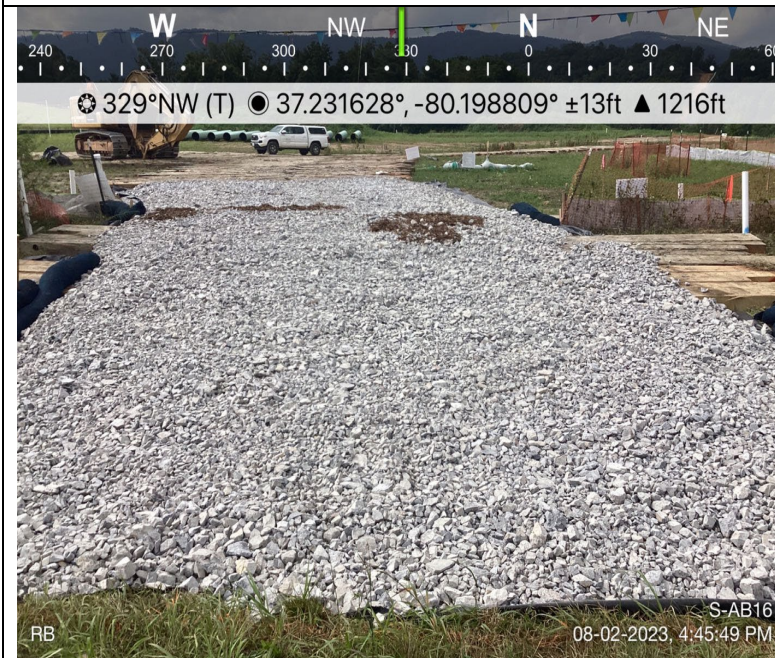
Photo Description: Right bank view during post-construction assessment

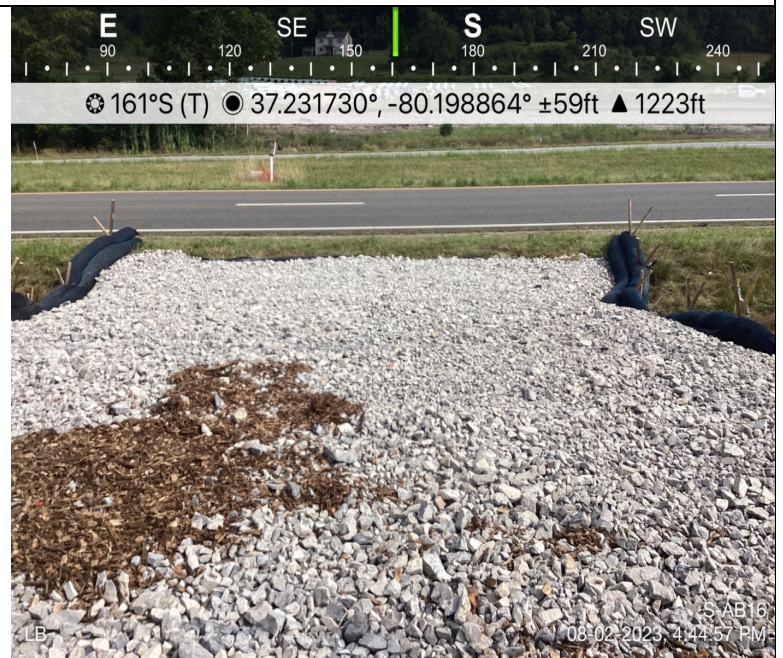
Photo Description: Left bank view during post-construction assessment.
