STREAM BIOLOGICAL CONDITIONS ENVIRONMENTAL AUDITOR REPORT

Stream ID: S-CD1	Crossing Start Date: 08/01/2023	Crossing Completion Date: 08/02/2023
Milepost: 264	Pre-Con Assessment Date: 07/31/2023	Post-Con Assessment Date: 08/03/2023
Station: 13949+85	Stream Classification: Perennial (Perennial, Intermittent, Ephemeral)	Bankfull Width (ft.): 3.5
County: Franklin	303(d) Impairment Listing: Not Impaired	Riffle:Pool Complexes Present? No

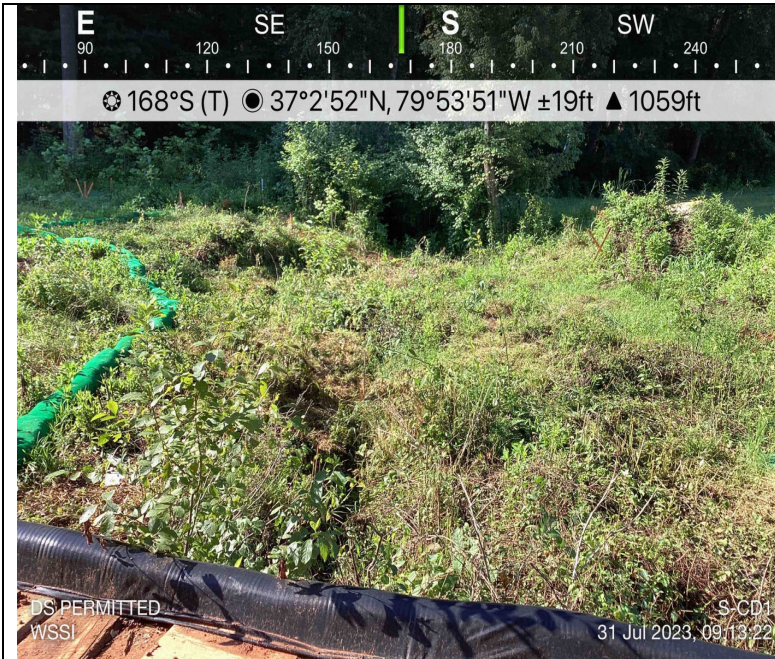
Photo Description: Downstream view of permitted impact area during pre-construction assessment.

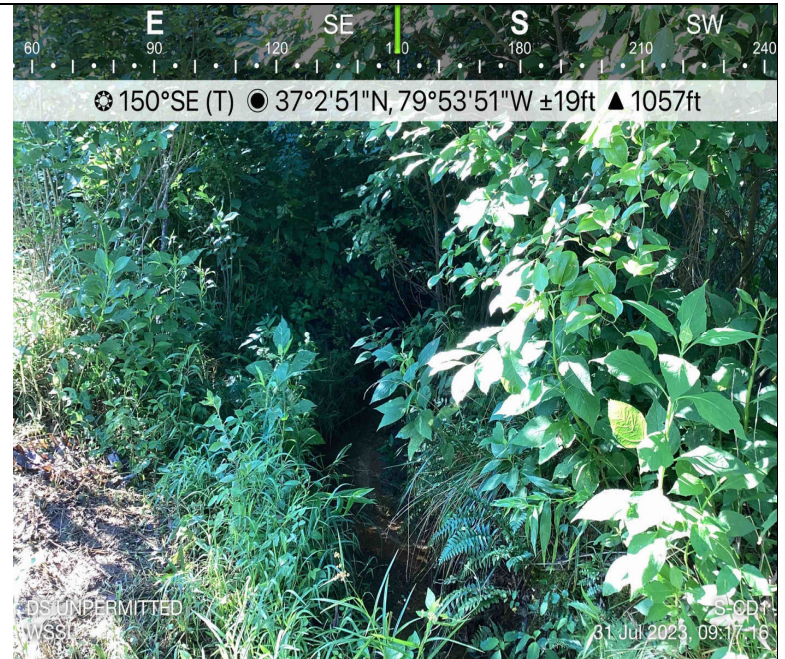
Photo Description: Downstream view of unpermitted area during pre-construction assessment.

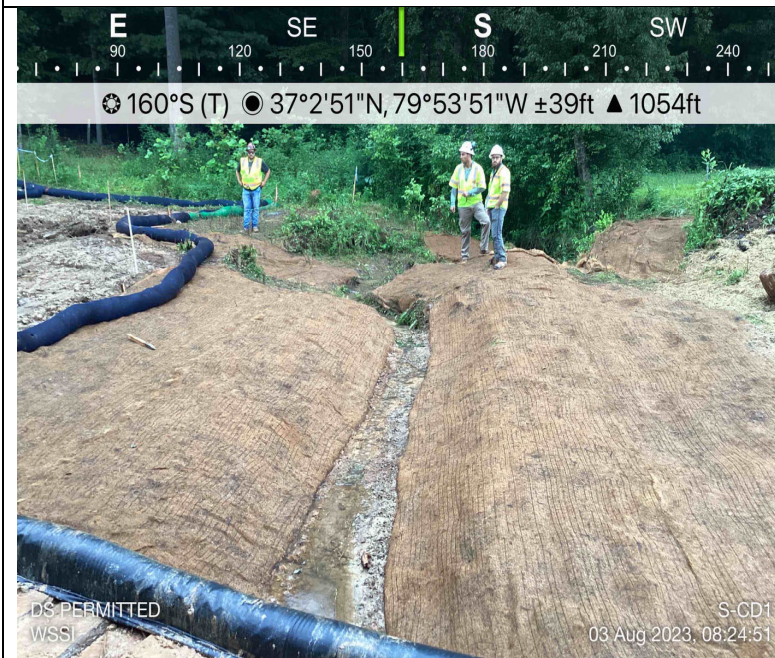
Field modifications were implemented during restoration by MVP personnel to account for inconsistencies with existing undisturbed ground and pre-construction survey data. These field modifications were implemented to ensure a smooth transition between existing undisturbed ground and the disturbed area. Since stakeout conflicts occurred, restoring the stream to a stable configuration as close to pre-existing conditions as possible was prioritized.

Photo Description: Downstream view of permitted impact area during post-construction assessment.

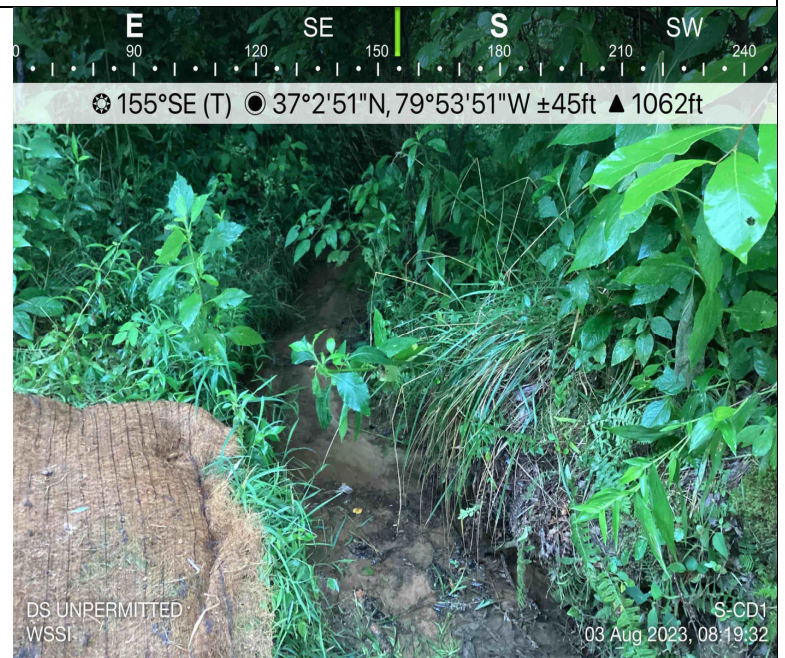
Photo Description: Downstream view of unpermitted area during post-construction assessment.

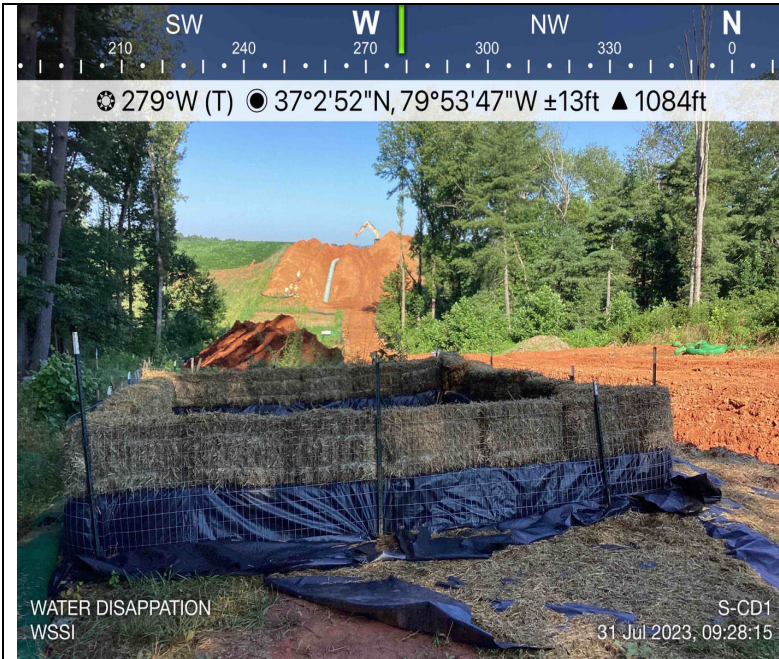
S-CD1
31 Jul 2023, 09:28:15

Photo Description: Dewatering area.

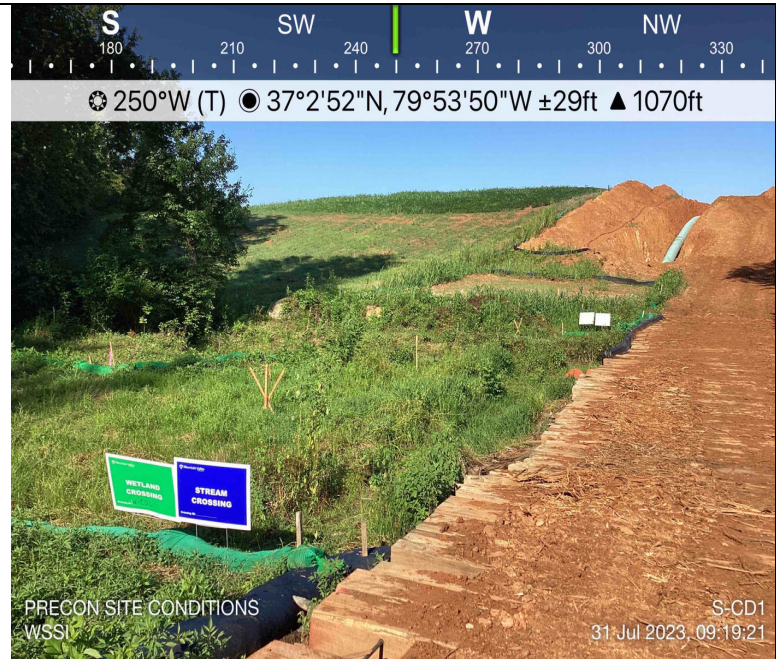
S-CD1
31 Jul 2023, 09:19:21

Photo Description: S-CD1 & W-CD1

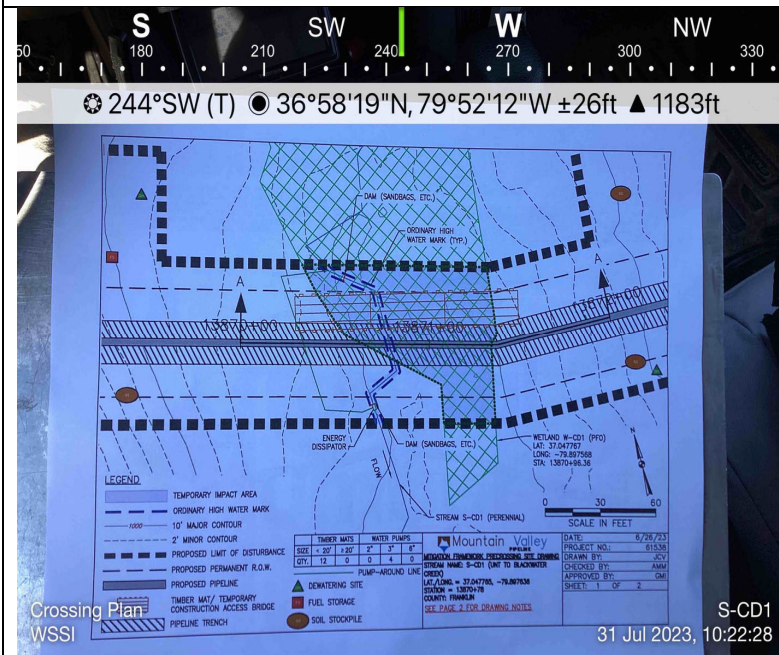
S-CD1
31 Jul 2023, 10:22:28

Photo Description: Pre crossing plan.
