STREAM BIOLOGICAL CONDITIONS ENVIRONMENTAL AUDITOR REPORT

Stream ID: S-D20	Crossing Start Date: 08/12/2023	Crossing Completion Date: 08/15/2023
Milepost: 261.3	Pre-Con Assessment Date: 08/09/2023	Post-Con Assessment Date: 08/17/2023
Station: 13805+52	Stream Classification: Intermittent (Perennial, Intermittent, Ephemeral)	Bankfull Width (ft.): 8
County: Franklin	303(d) Impairment Listing: Not Impaired	Riffle:Pool Complexes Present? No

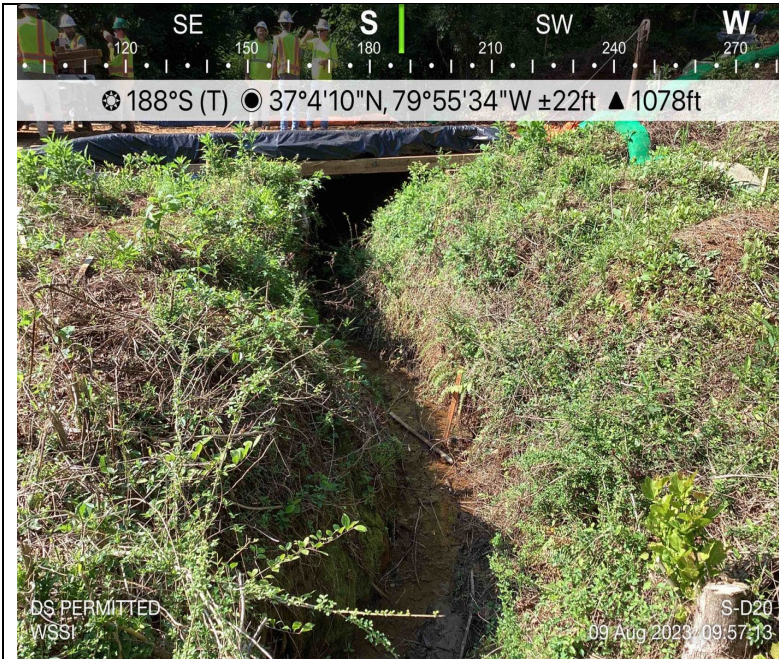
Photo Description: Downstream view of permitted impact area during pre-construction assessment.

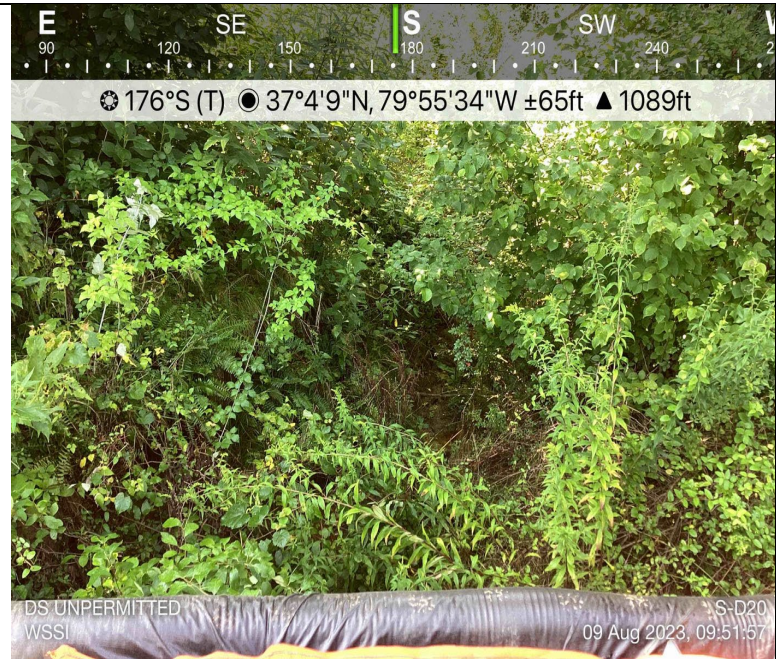
Photo Description: Downstream view of unpermitted area during pre-construction assessment.

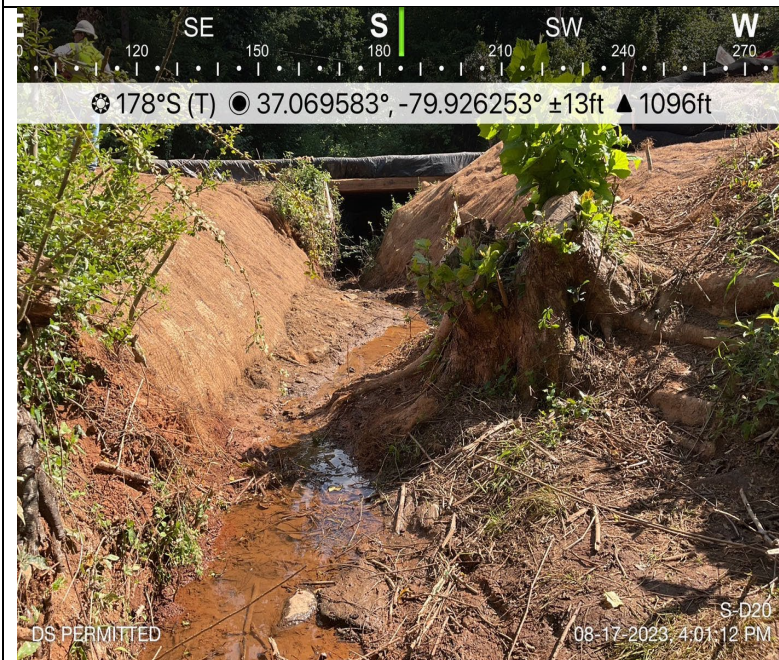
Photo Description: Downstream view of permitted impact area during post-construction assessment.

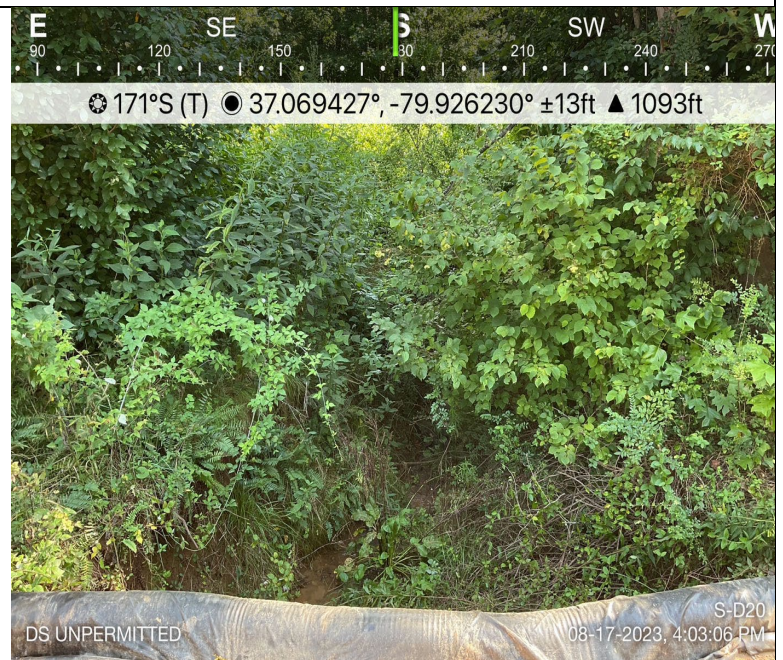
Photo Description: Downstream view of unpermitted area during post-construction assessment.

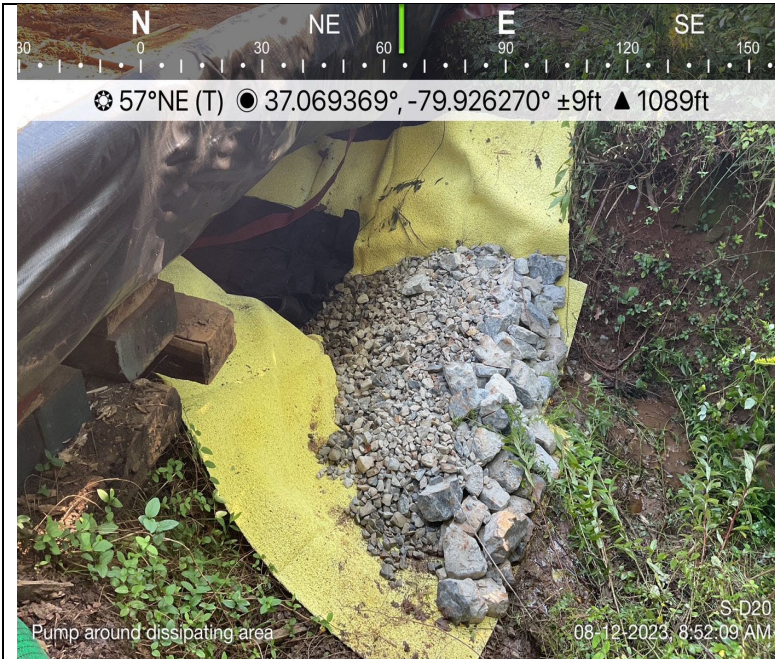
Photo Description: Energy dissipation area for stream dam and pump.

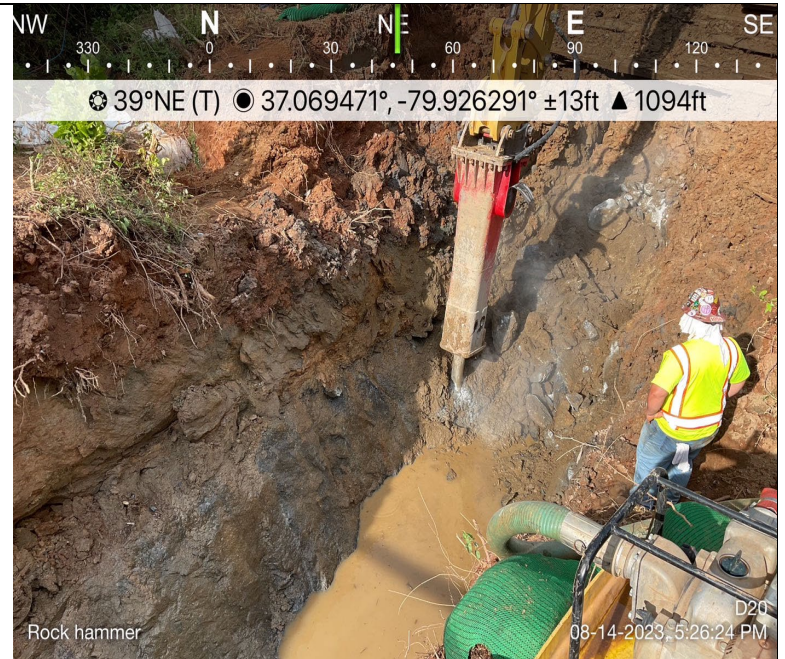
08/14/2023: Resume trench excavation. Full day of bedrock removal in the trench with a rock hammer. Pumps will be monitored again over night. -M. Arbaugh

Photo Description: Removal of bedrock in pipeline trench with rock hammer attachment.

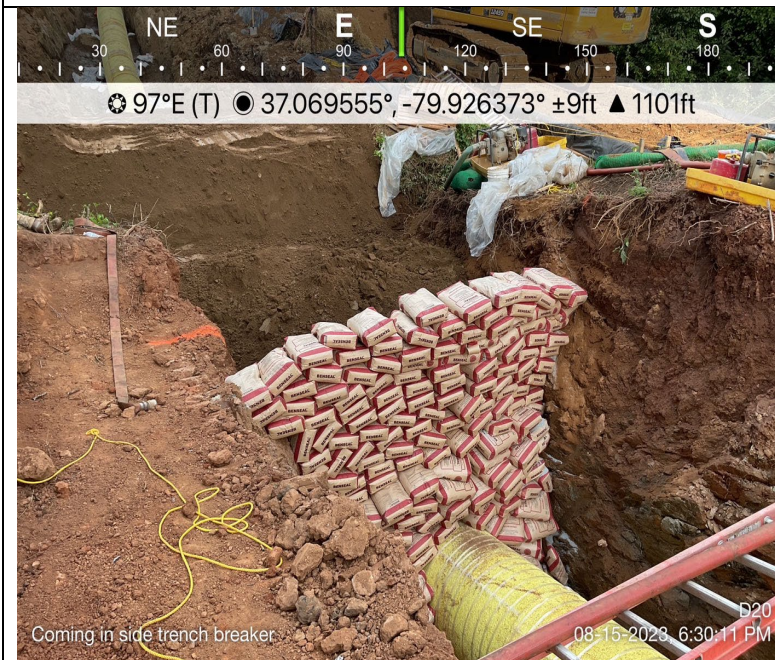
Photo Description: Bentonite trench breaker on coming in side of S-D20.

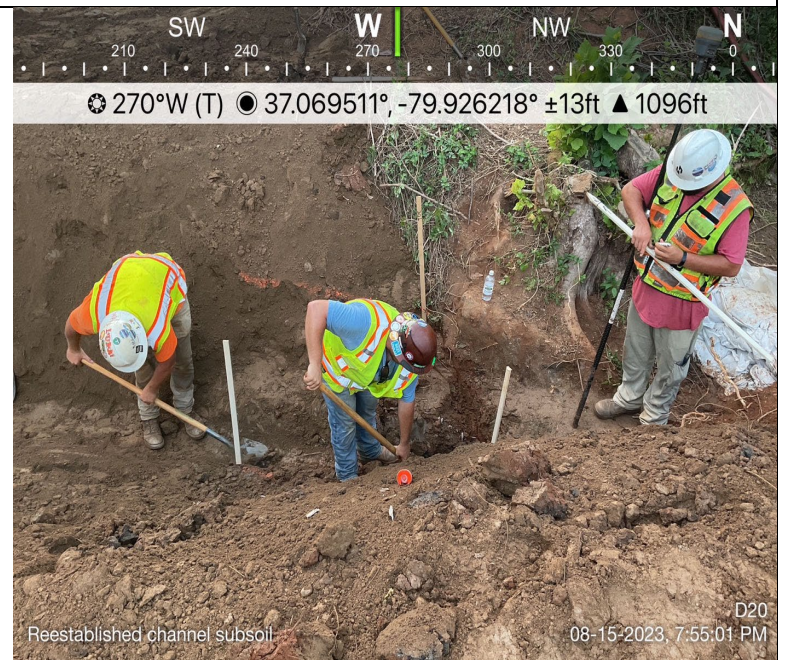
Photo Description: Fine grading of stream channel.
