STREAM BIOLOGICAL CONDITIONS ENVIRONMENTAL AUDITOR REPORT

Stream ID: S-E28-W	Crossing Start Date: 08/11/2023	Crossing Completion Date: 08/12/2023
Milepost: 258.2	Pre-Con Assessment Date: 08/10/2023	Post-Con Assessment Date: 08/14/2023
Station: 13643+35	Stream Classification: Perennial (Perennial, Intermittent, Ephemeral)	Bankfull Width (ft.): 12
County: Franklin	303(d) Impairment Listing: Impaired	Riffle:Pool Complexes Present? Yes

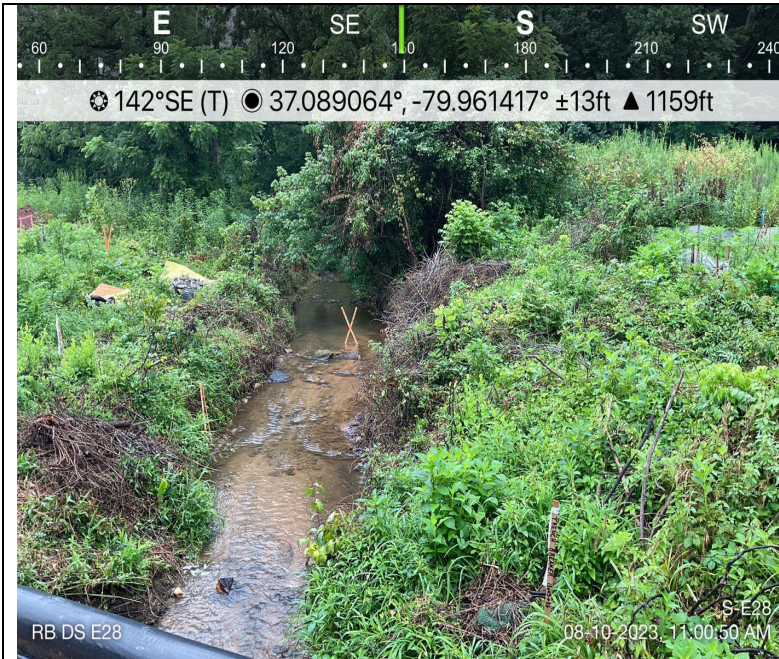
Photo Description: Downstream view of permitted impact area during pre-construction assessment.

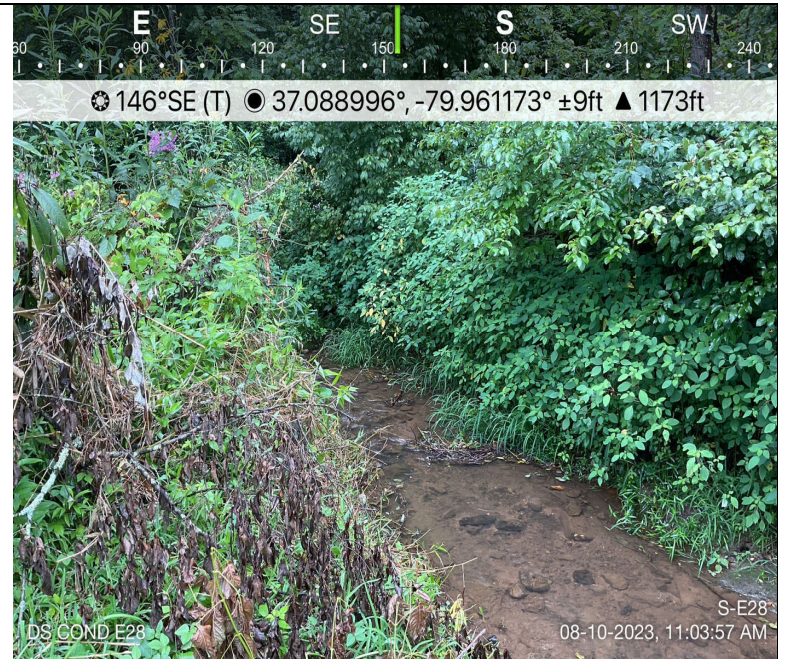
Photo Description: Downstream view of unpermitted area during pre-construction assessment.

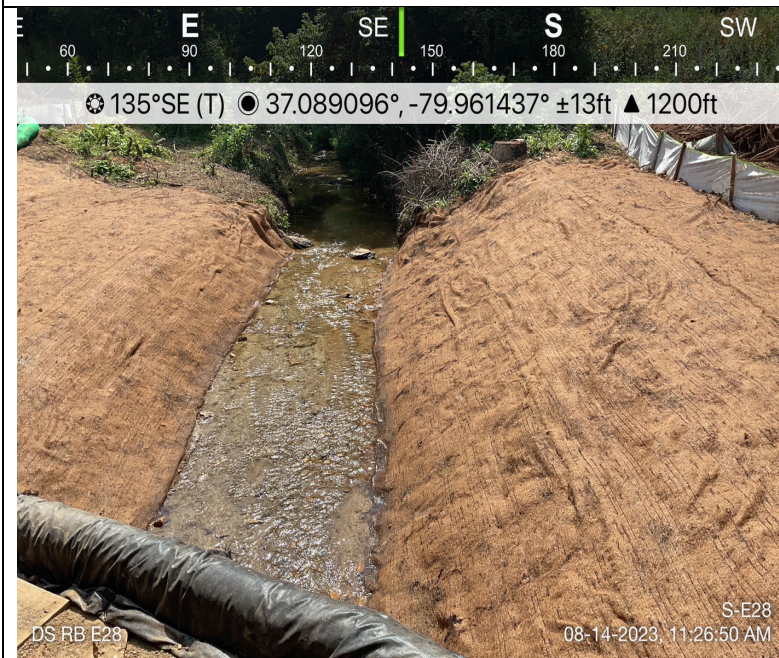
Item #16: Channel conditions improved undercut banks and right bank rill were restored to stable conditions as shown in the photos. -G. Johnson

Photo Description: Downstream view of permitted impact area during post-construction assessment.

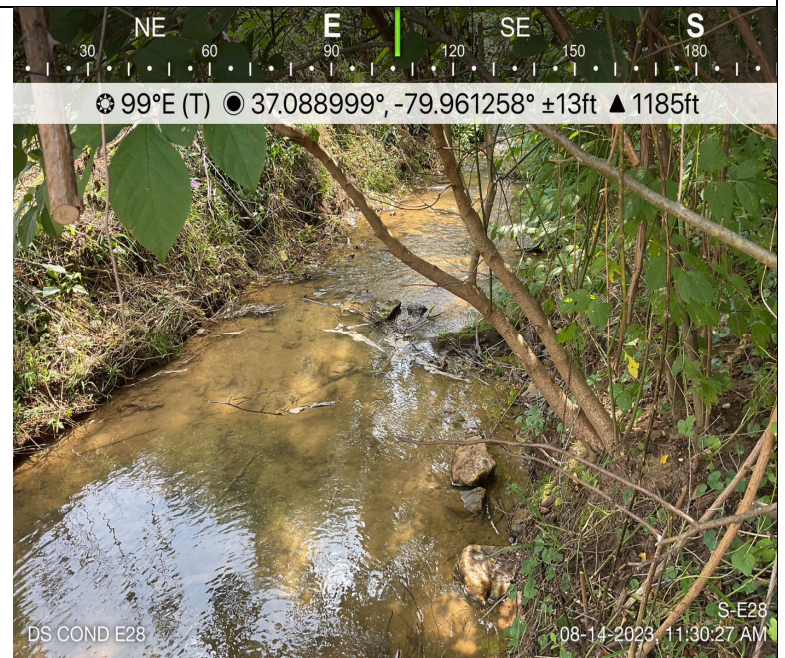
Photo Description: Downstream view of unpermitted area during post-construction assessment.

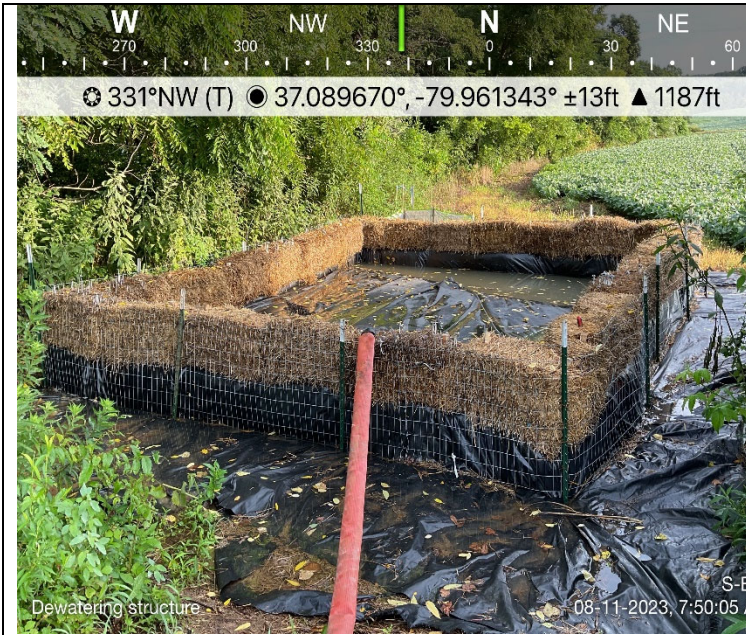
Photo Description: Dewatering structure.

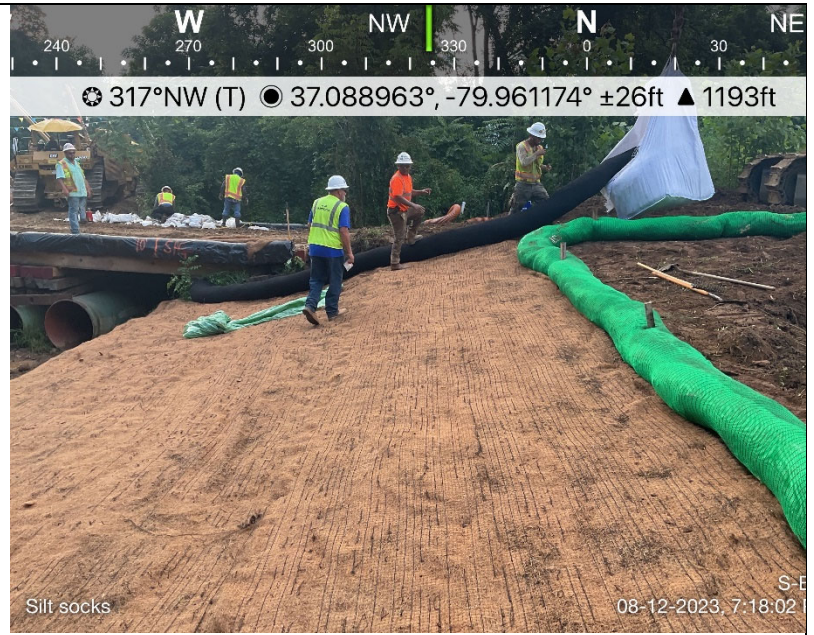
Photo Description: Erosion control matting on banks.

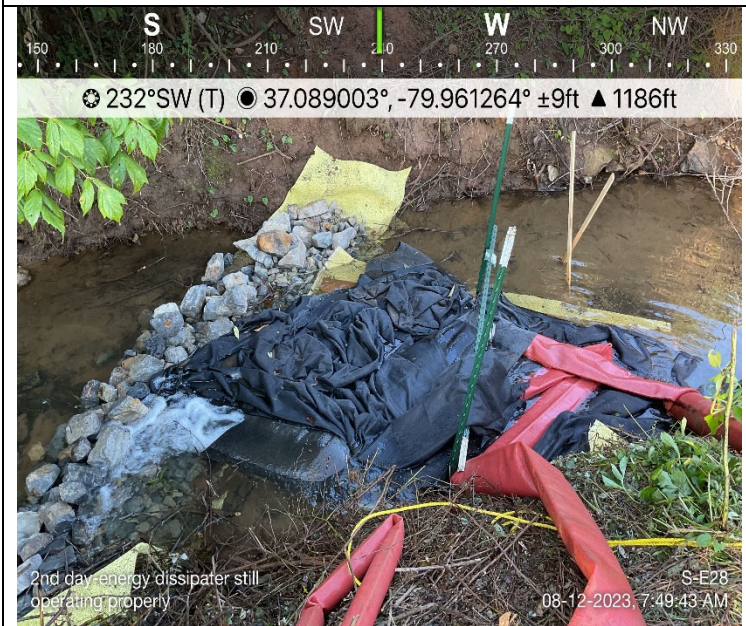
Photo Description: Downstream energy dissipator.

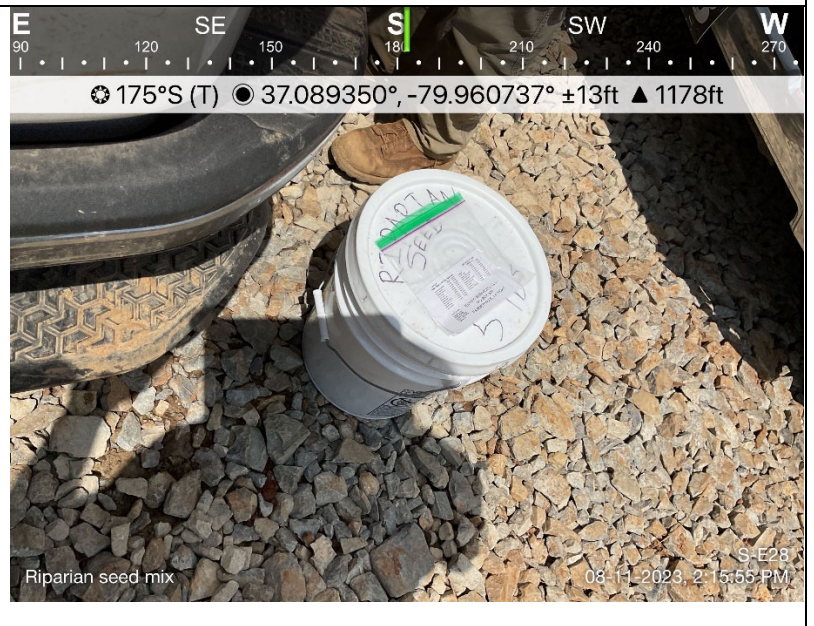
Photo Description: Riparian seed for streambanks.
