STREAM BIOLOGICAL CONDITIONS ENVIRONMENTAL AUDITOR REPORT

Stream ID: S-EF62	Crossing Start Date: 08/08/2023	Crossing Completion Date: 08/16/2023
Milepost: 222.2	Pre-Con Assessment Date: 08/08/2023	Post-Con Assessment Date: 08/16/2023
Station: 11743+97	Stream Classification: Perennial (Perennial, Intermittent, Ephemeral)	Bankfull Width (ft.): 11
County: Montgomery	303(d) Impairment Listing: Not Impaired	Riffle:Pool Complexes Present? No

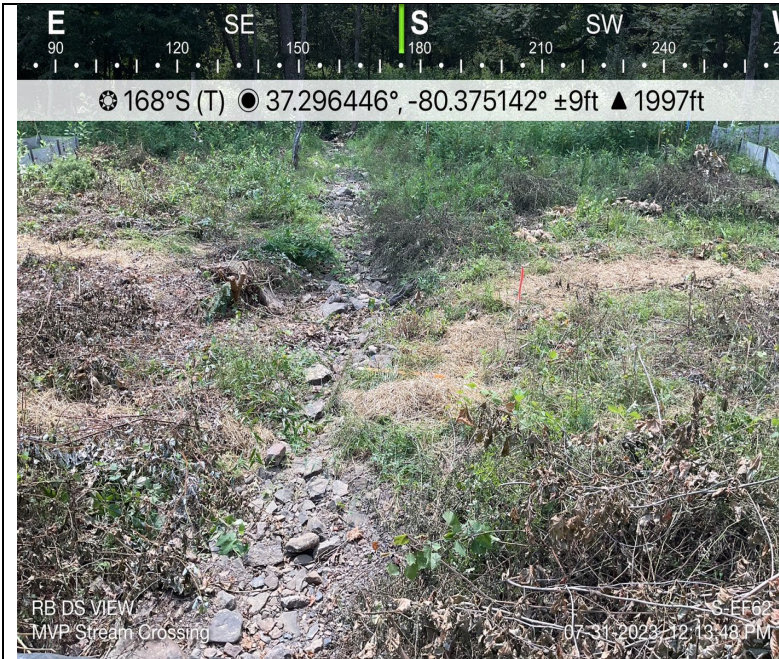
Photo Description: Downstream view of permitted impact area during pre-construction assessment.

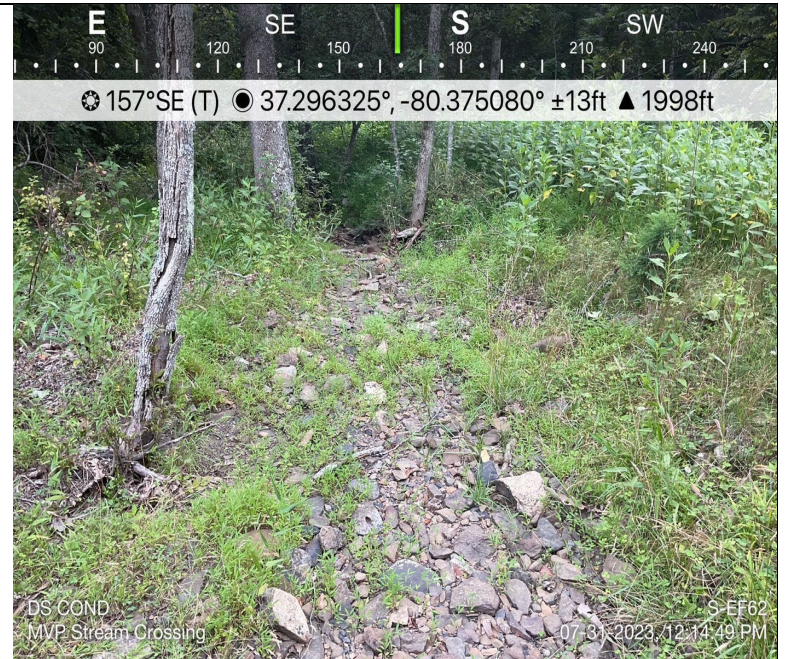
Photo Description: Downstream view of unpermitted area during pre-construction assessment.

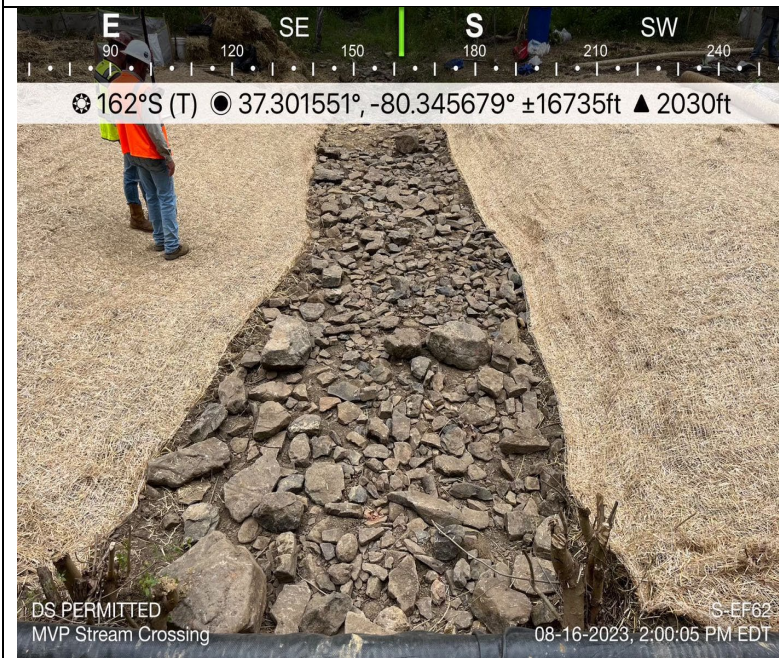
08/16/2023- Finished restoration of stream. Land owner was present and confirmed he had driven through stream historically and would continue to do so in the future. Vegetation was present in stream during PreCon assessment but was removed prior to construction, and therefore, was not present during PostCon assessment. -A. Burgess

Photo Description: Downstream view of permitted impact area during post-construction assessment.

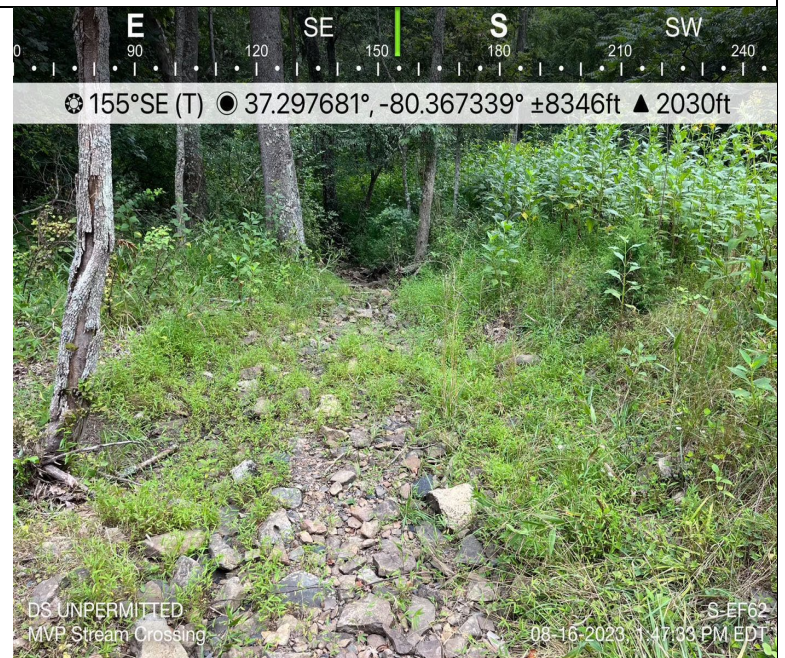
Photo Description: Downstream view of unpermitted area during post-construction assessment.

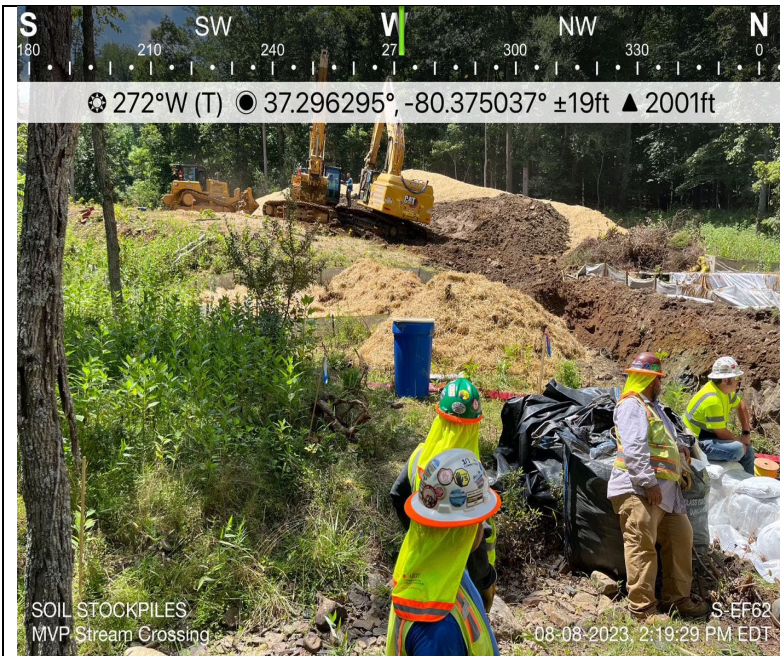
08/08/2023- Excavation of trench was completed. Topsoil was stored inside 50ft buffer with a 6in straw barrier to separate from existing topsoil. Excess fill dirt was stored in proper upland area. Top 12 inches of stream substrate were stored in Super Sack to prevent mixing. -A. Burgess

Photo Description: Soil Stockpiles

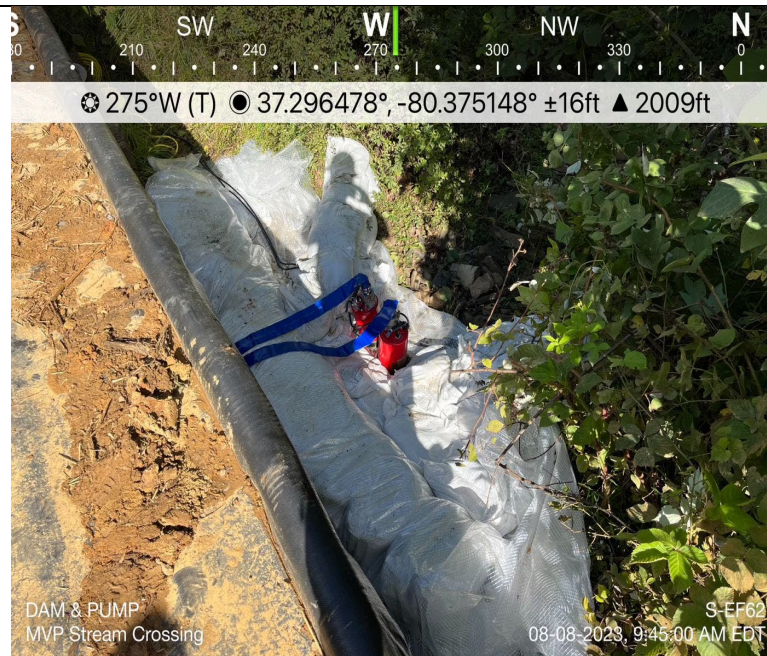
Photo Description: Dam Pumps

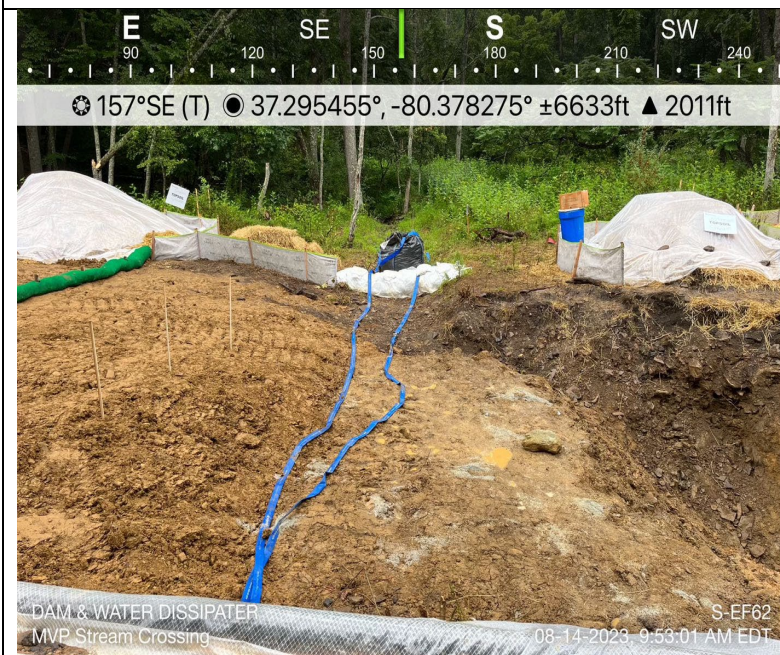
Photo Description: Dam Energy Dissipator and topsoil stockpiles.

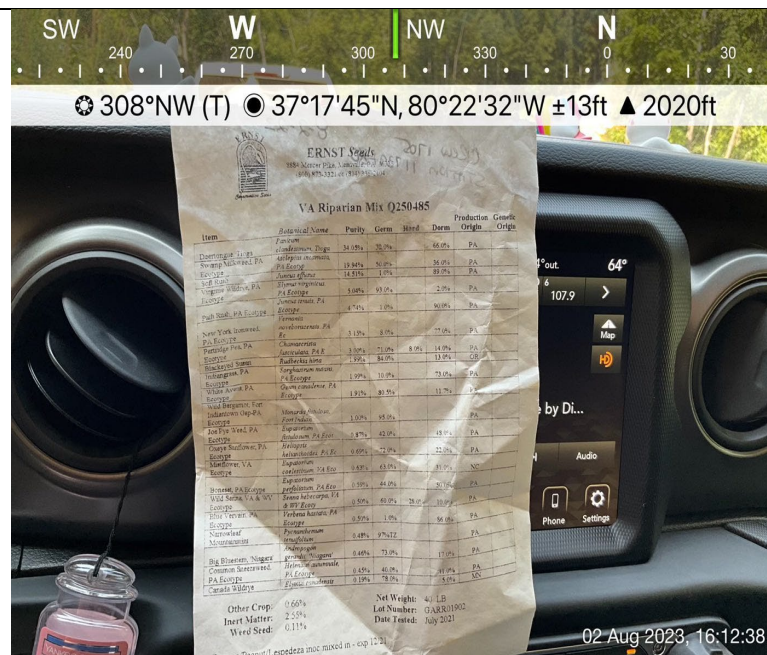
Photo Description: Seed Mix Tag
