Stream Biological Conditions EA Report

Project Name	H-600 Pipeline Spread C	AFE	124300131	Spread	H-600 Pipeline Spread C
Contractor	Precision	Report #	33		
Environmental Auditor	Jeffrey Arbogast	Date/Time	8/5/2023 8:50 AM		
Stream ID	S-H123N	Crossing Start Date	8/4/2023	Crossing Completion Date	8/10/2023
Milepost	74.12	Pre-Con Assessment Date	8/1/2023	Post-Con Assessment Date	8/10/2023
Station	3913+58	Bankfull Width (ft.)	2.0	Riffle:Pool Complexes Present?	No
State	WV	Stream Classification	Perennial		
County	Braxton	303(d) Impairment Listing	No

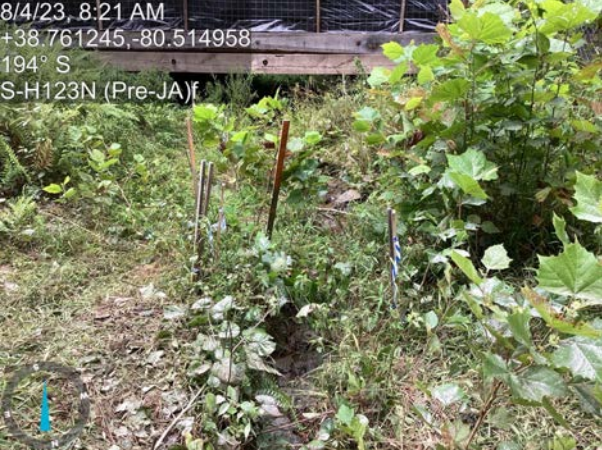
<p>8/4/23, 8:21 AM +38.761245, -80.514958 194° S S-H123N (Pre-JA)f</p>

GPS Location	See Photo Caption	GPS Location	See Photo Caption
Description	Downstream view of permitted impact area during pre-construction assessment.	Description	Downstream view of unimpacted area during pre-construction assessment.
<p>8/10/23, 7:43 AM +38.761312, -80.514888 185° S S-H123N (Post-JA)f</p>

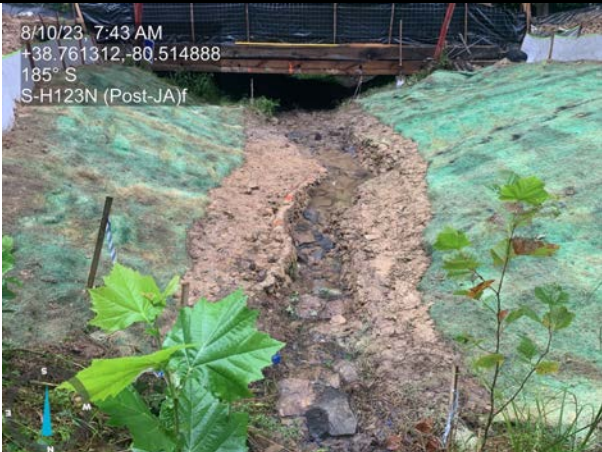
GPS Location	See Photo Caption	GPS Location	See Photo Caption
Description	Downstream view of permitted impact area during post-construction assessment.	Description	Downstream view of unimpacted area during post-construction assessment.
<p>8/4/23, 8:23 AM +38.761186, -80.514895 119° SE S-H123N (Pre-JA)f</p>

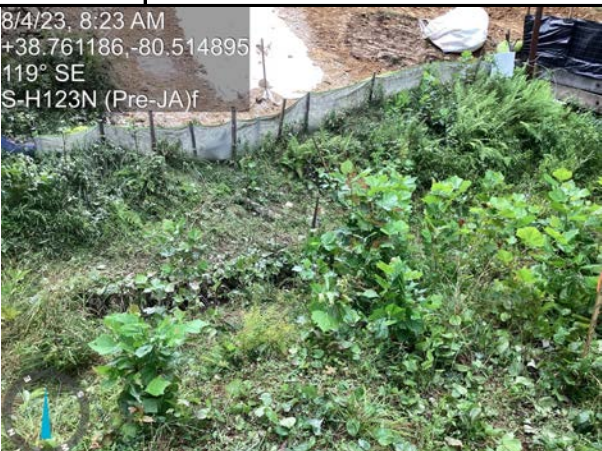
GPS Location	See Photo Caption	GPS Location	See Photo Caption
Description	Crossing from the coming in side pre-construction	Description	Crossing from the going away side pre-construction
