Stream Biological Conditions EA Report

Project Name	H-600 Pipeline Spread B	AFE	124300130	Spread	H-600 Pipeline Spread B
Contractor	Precision	Report #	18		
Environmental Auditor	Devin Jen	Date/Time	8/3/2023 8:48 AM		
Stream ID	S-H153	Crossing Start Date	8/3/2023	Crossing Completion Date	8/6/2023
Milepost	59.40	Pre-Con Assessment Date	8/3/2023	Post-Con Assessment Date	8/6/2023
Station	3145+31	Bankfull Width (ft.)	15.0	Riffle:Pool Complexes Present?	No
State	WV	Stream Classification	Perennial		
County	Lewis	303(d) Impairment Listing	No

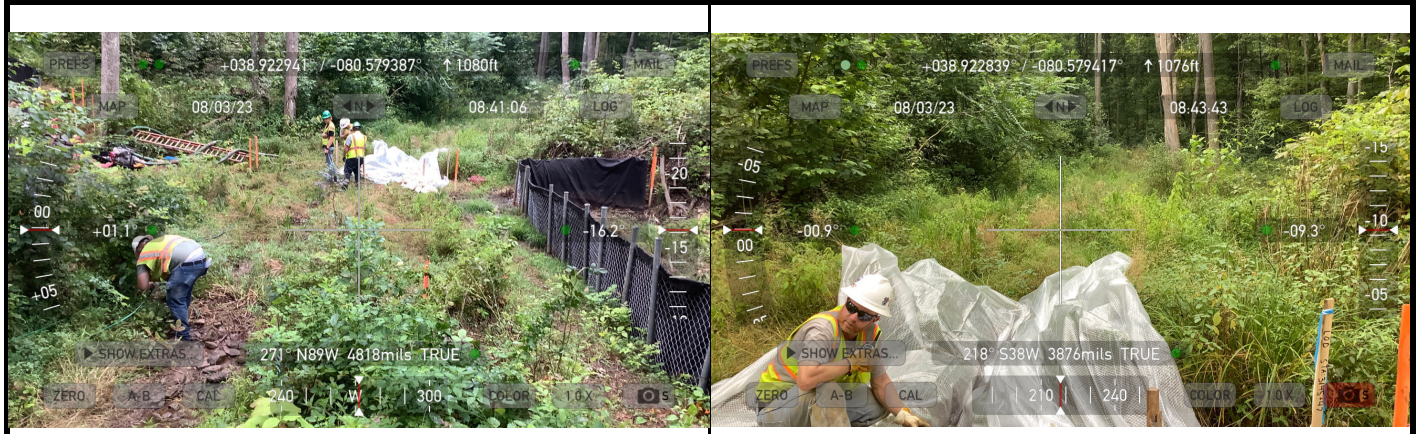
GPS Location See photograph.	GPS Location See photograph.
Description Downstream view of permitted impact area during pre-construction assessment.	Description Downstream view of unimpacted area during pre-construction assessment.

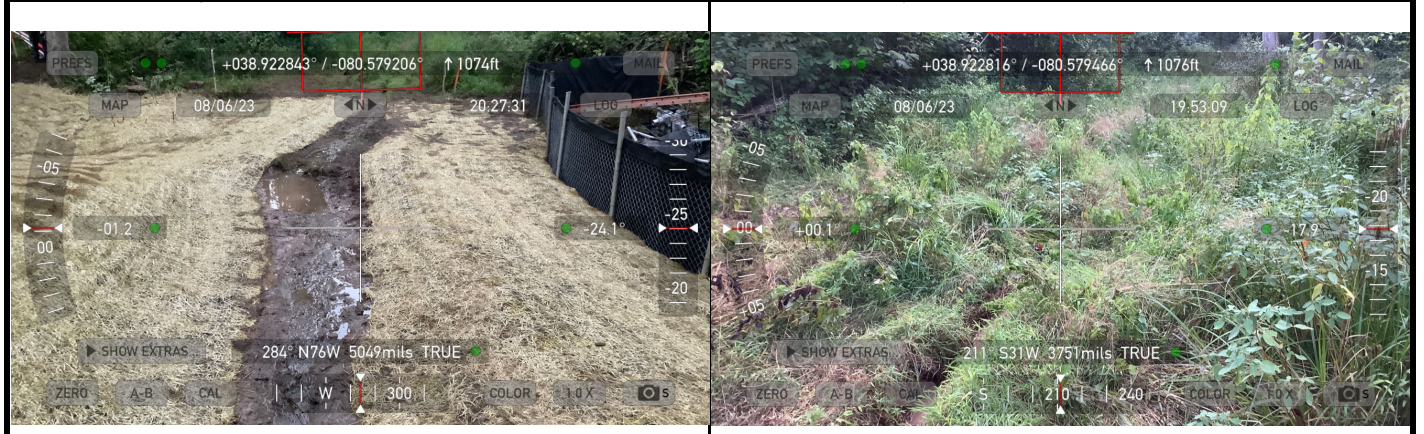
GPS Location See photograph.	GPS Location See photograph.
Description Downstream view of permitted impact area during post-construction assessment.	Description Downstream view of unimpacted area during post-construction assessment.

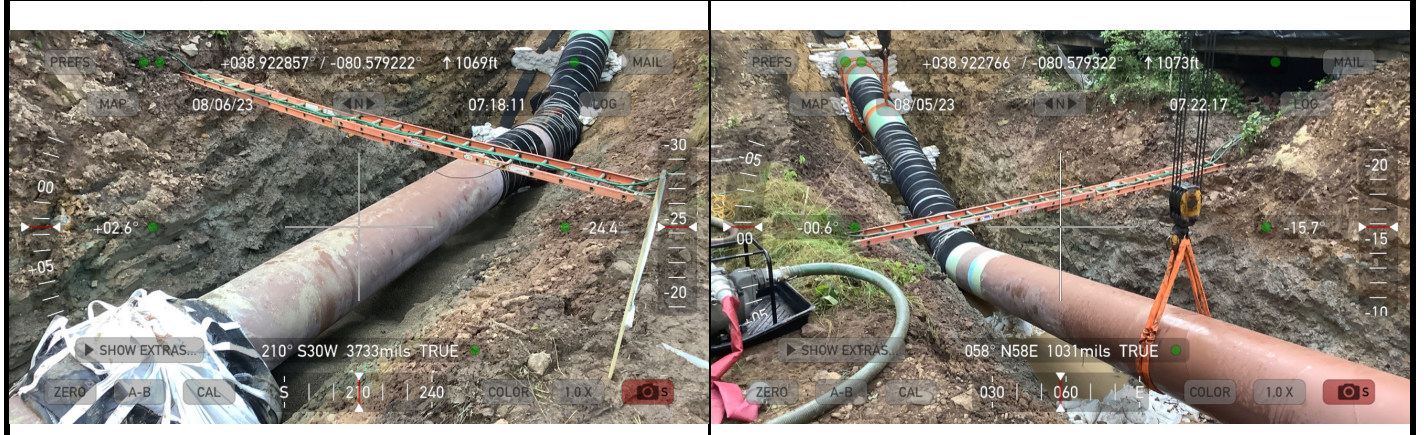
GPS Location See photograph.	GPS Location See photograph.
Description Impacted area at start of work day 8/6/2023.	Description Impacted area at start of work day 8/5/2023.

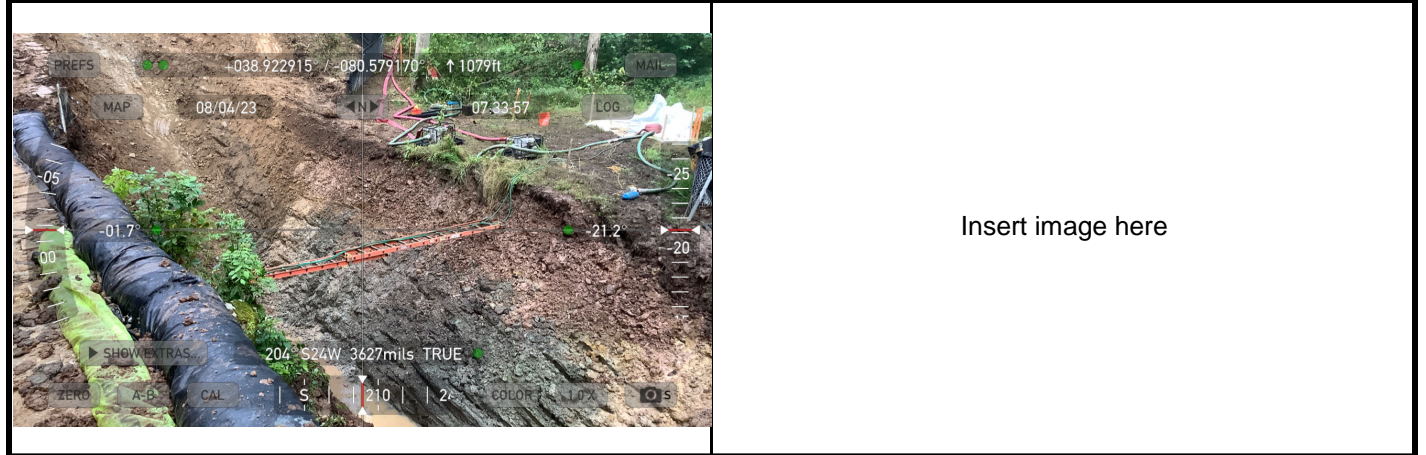
Description	Impacted area at start of work day on 8/4/2023.	Description	
--------------------	---	--------------------	--
