STREAM BIOLOGICAL CONDITIONS ENVIRONMENTAL AUDITOR REPORT

Stream ID: S-PP4	Crossing Start Date: 08/02/2023	Crossing Completion Date: 08/08/2023
Milepost: 218	Pre-Con Assessment Date: 07/31/2023	Post-Con Assessment Date: 08/08/2023
Station: 11518+32	Stream Classification: Intermittent (Perennial, Intermittent, Ephemeral)	Bankfull Width (ft.): 3
County: Craig	303(d) Impairment Listing: Not Impaired	Riffle:Pool Complexes Present? No

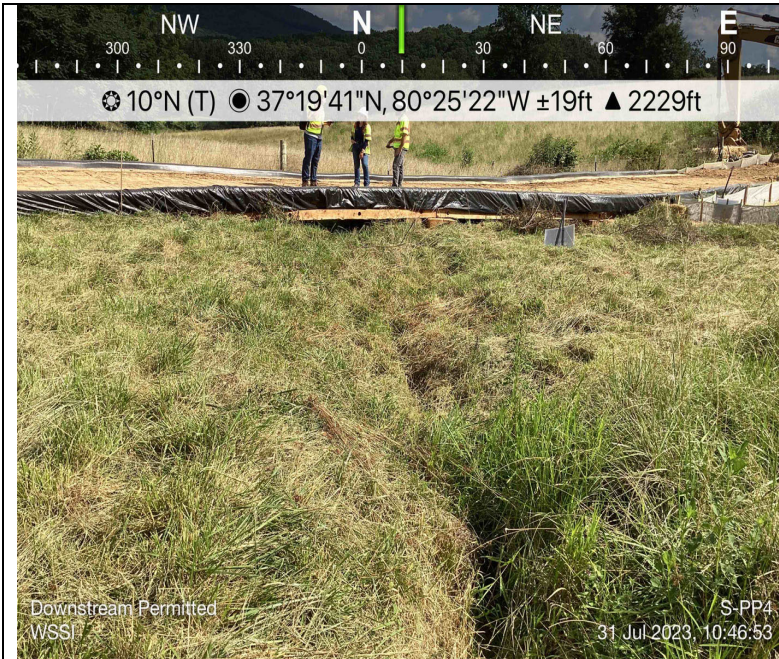
Photo Description: Downstream view of permitted impact area during pre-construction assessment.

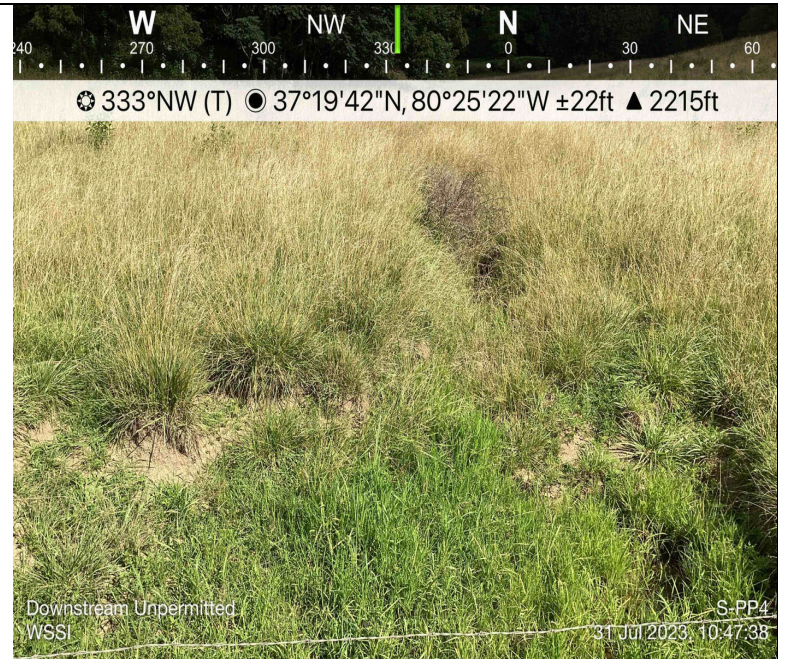
Photo Description: Downstream view of unpermitted area during pre-construction assessment.

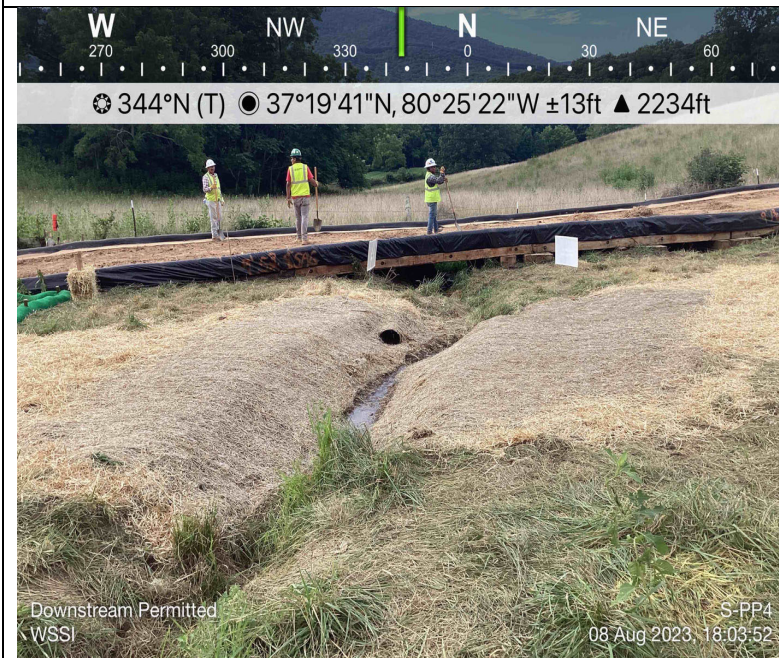
Photo Description: Downstream view of permitted impact area during post-construction assessment.

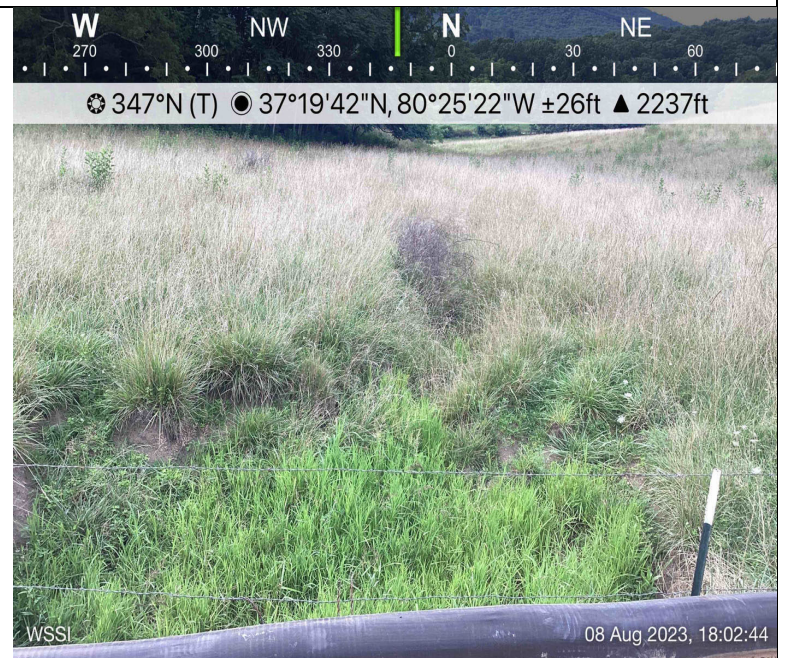
Photo Description: Downstream view of unpermitted area during post-construction assessment.

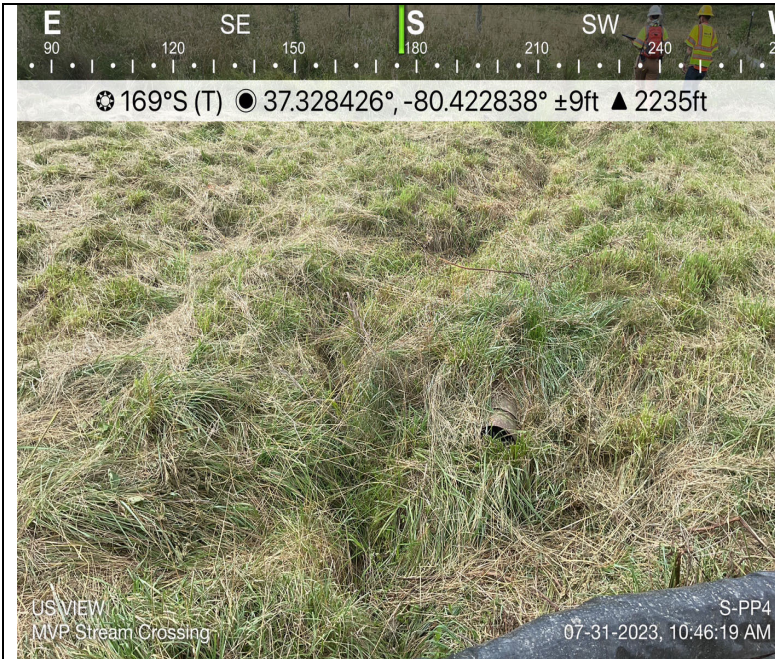
Item 19: Pre-existing channel alteration observed during pre-construction assessment. Landowner-installed flume crossing present and remained installed throughout crossing activity. –A. Breeding

Photo Description: Existing flume in S-PP4. Not conveying water at time of photo.

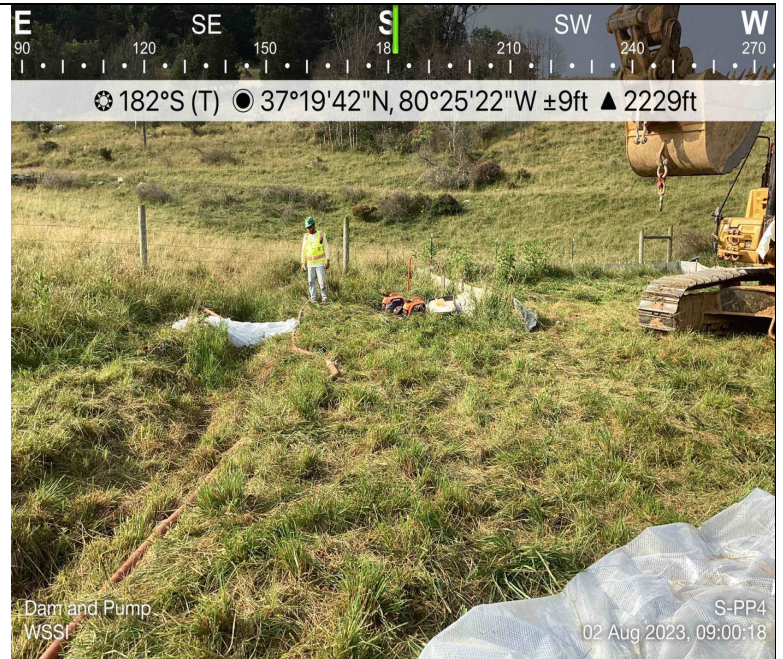
Photo Description: Dam and pumps in place and functioning.

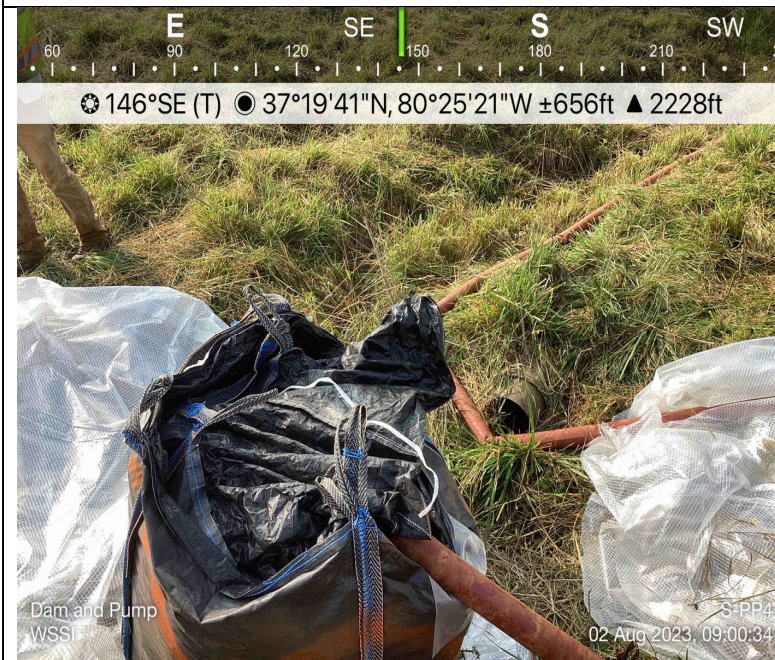
Photo Description: Existing flume and material to be used staged within buffer.

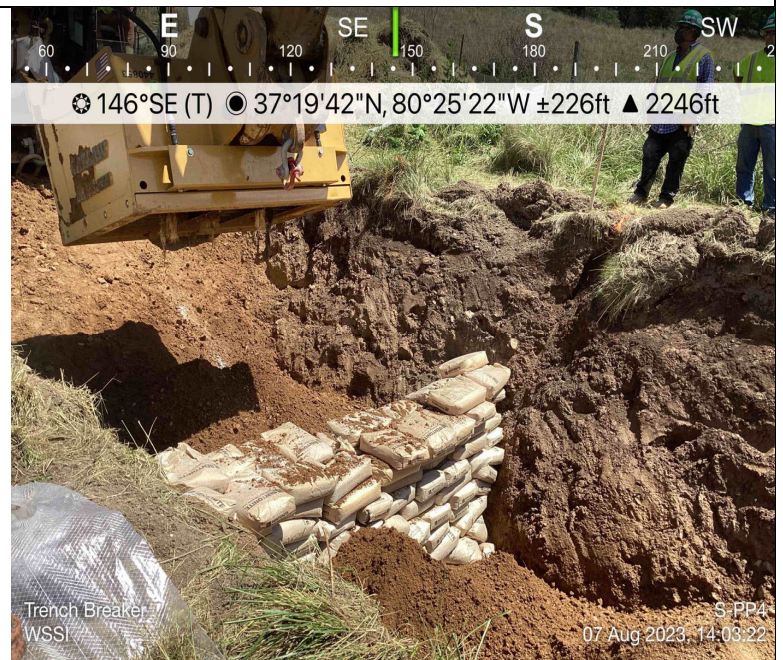
Photo Description: Trench breakers installed and backfilling underway.
