WETLAND BIOLOGICAL CONDITIONS ENVIRONMENTAL AUDITOR REPORT

Wetland ID: W-C5	Crossing Start Date: 08/01/2023	Crossing Completion Date: 08/05/2023
Milepost: 229.8	Pre-Con Assessment Date: 07/31/2023	Post-Con Assessment Date: 08/07/2023
Station: 12143+59	Cowardin Classification: PEM (PEM, PFO, PSS, POW)	Wetland Impact Area (sq ft.): 1977.62
County: Montgomery

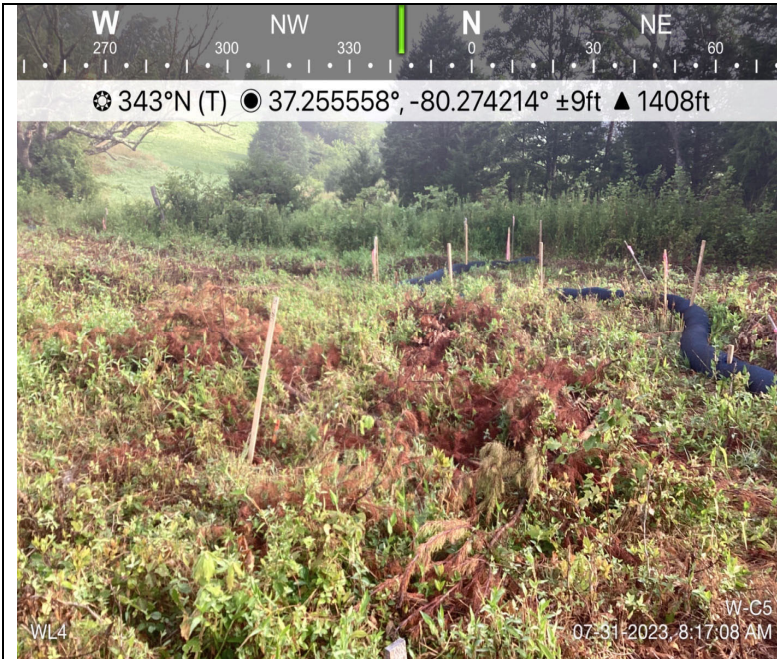
Photo Description: View of permitted resource impact area during pre-construction assessment.

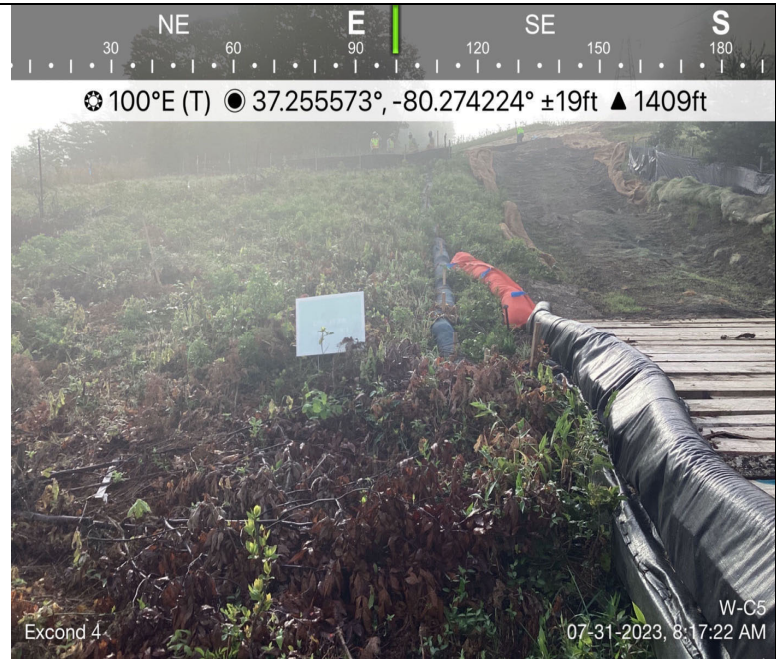
Photo Description: At edge of LOD, view of unpermitted resource area conditions during pre-construction assessment.

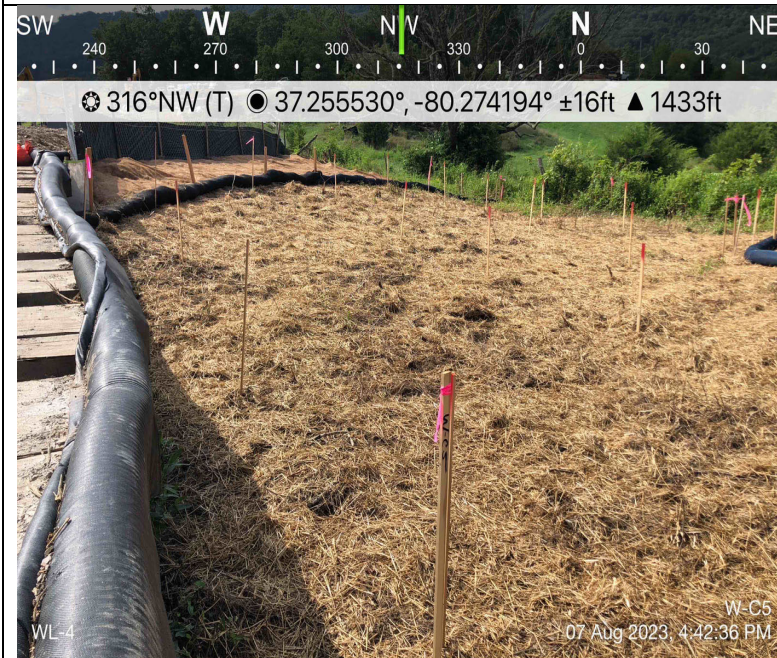
Photo Description: View of permitted resource impact area during post-construction assessment.

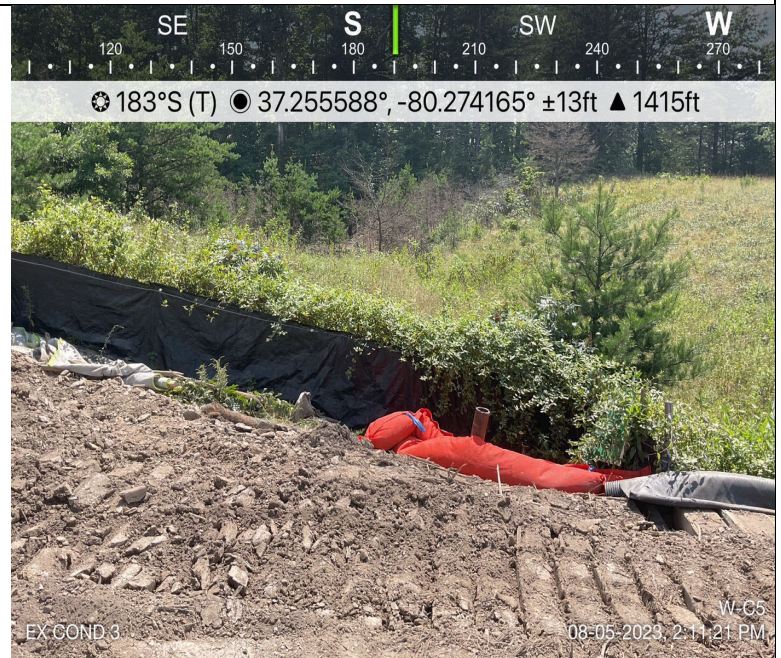
Photo Description: At edge of LOD, view of unpermitted resource area conditions during post-construction assessment.

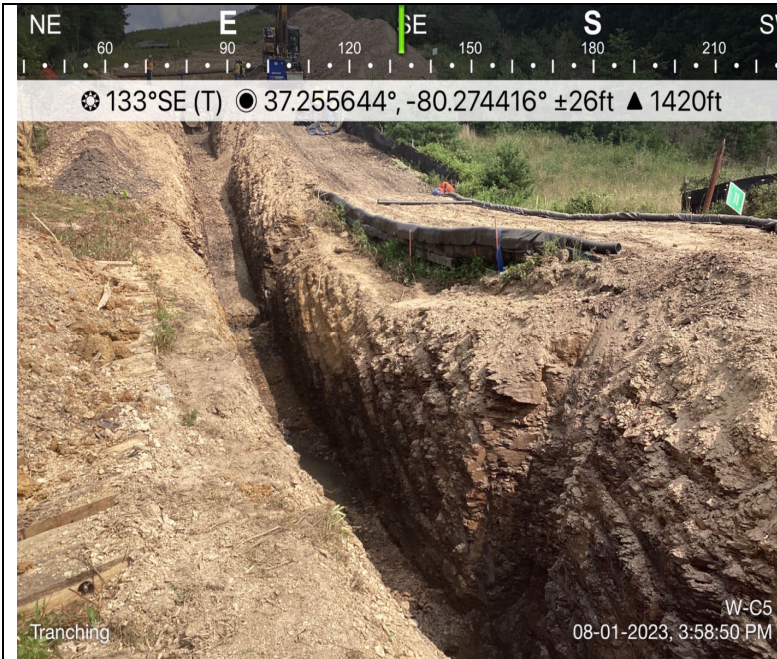
8/01/2023- Trenching was completed within the buffer zones. -T. Cullop

Photo Description: Trenching complete with keys cut for trench breaker

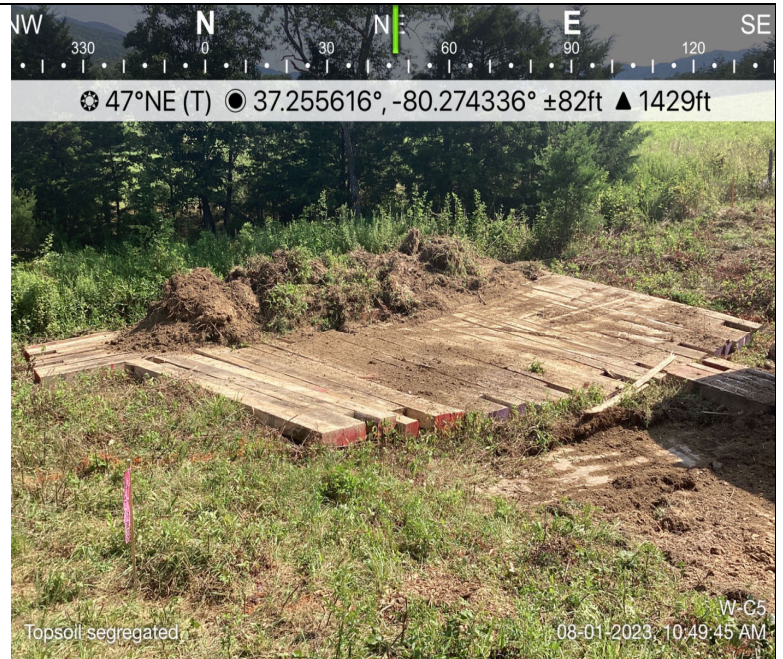
8/01/2023- Topsoil and top 1 ft. of wetland material has been segregated on timber mats.

Photo Description: Topsoil was segregated and placed on timber mats

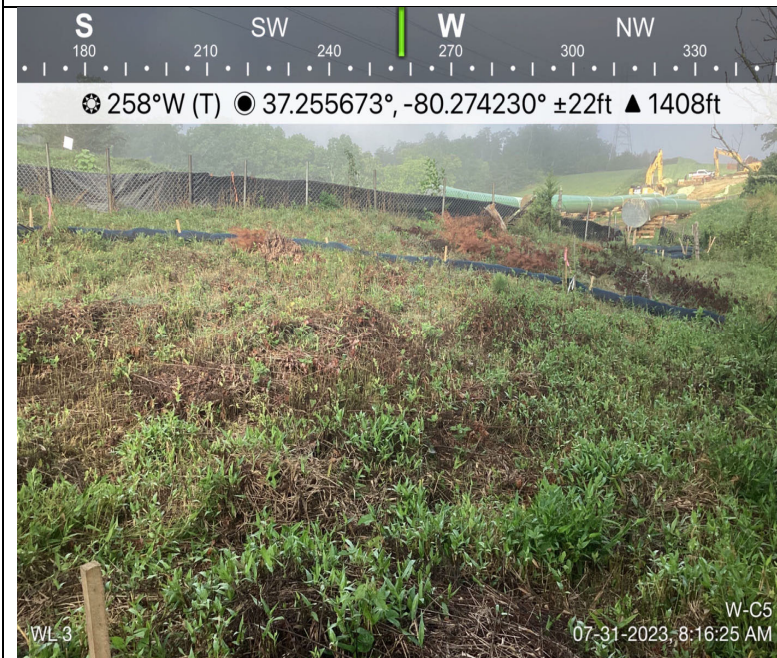
Photo Description: Pre-construction view of wetland impact area.

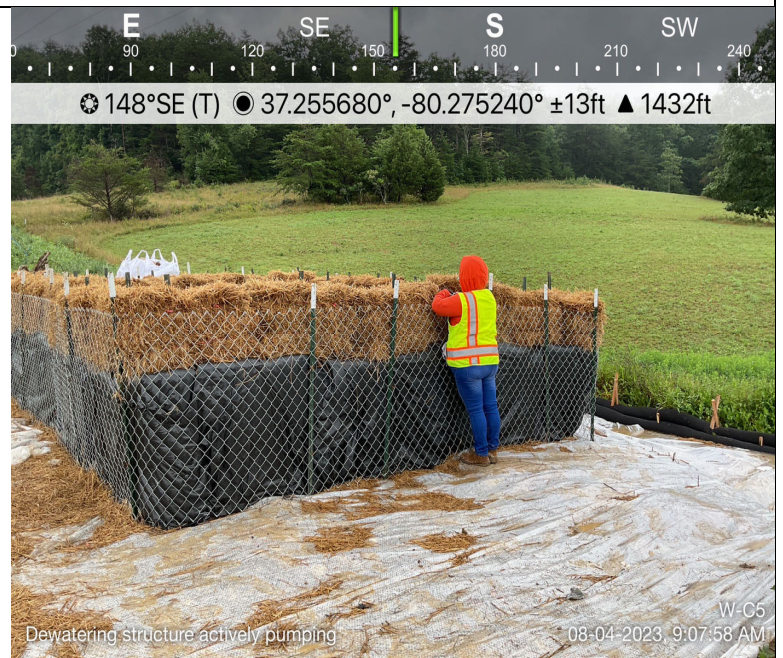
8/04/2023- 8:45 am actively pumping water from trench into dewatering station, everything is functioning properly. - S. Frost

Photo Description: Dewatering structure actively functioning
