Wetland Biological Conditions EA Report

Project Name	H-600 Pipeline Spread D	AFE	124300132	Spread	H-600 Pipeline Spread D
Contractor	Precision	Report #	21		
Environmental Auditor	Caroline Cope			Date/Time	8/18/2023 4:51 PM
Wetland ID	W-E21	Crossing Start Date	8/8/2023	Crossing Completion Date	8/12/2023
Milepost	109.63	Pre-Con Assessment Date	8/8/2023	Post-Con Assessment Date	8/12/2023
Station	5788+46	Cowardin Classification	PEM	Wetland Impact Area(acres)	0.0389
State	WV				
County	Webster

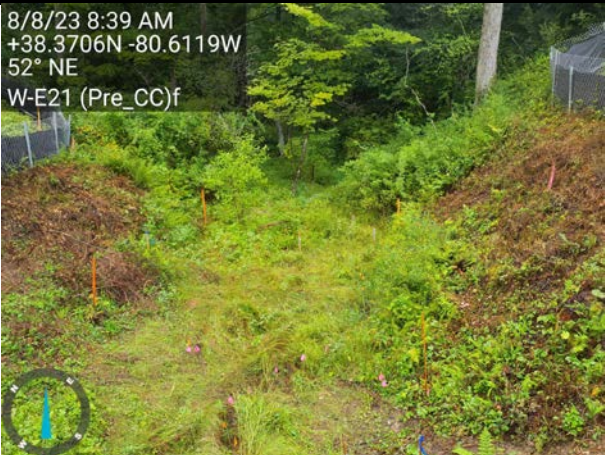
AFE 124300132		Date/Time 8/18/2023 4:51 PM		Report # 21	
Required Photos					
<p>8/8/23 8:39 AM +38.3706N -80.6119W 52° NE W-E21 (Pre_CC)f</p>

GPS Location 38.3706, -80.6119		GPS Location 38.3707, -80.6118			
Description View of permitted resource impact area during pre-construction assessment. W-E21		Description At edge of LOD, view of unimpacted resource area conditions during pre-construction assessment. W-E21			
<p>8/12/23 7:38 PM +38.3706N -80.6119W 56° NE W-E21 (Post_CC)</p>

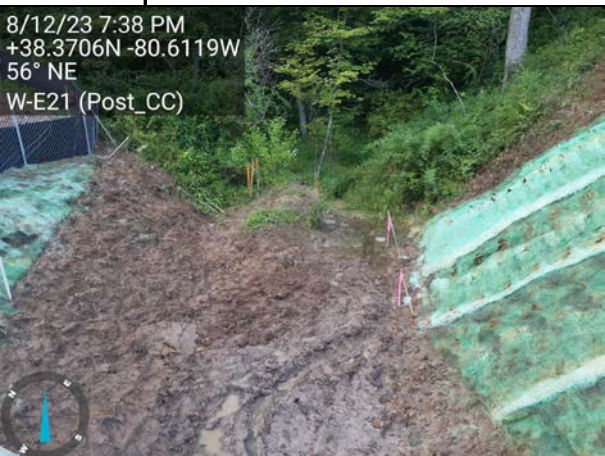
GPS Location 38.3706, -80.6119		GPS Location 38.3706, -80.6119			
Description View of permitted resource impact area during post-construction assessment. W-E21		Description At edge of LOD, view of unimpacted resource area conditions during post-construction assessment. W-E21

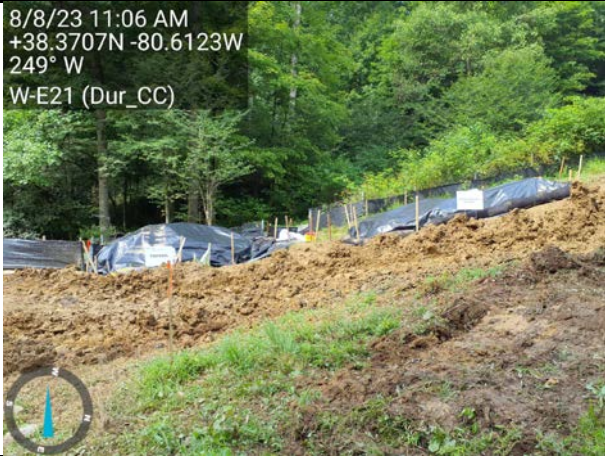
<p>8/8/23 11:06 AM +38.3707N -80.6123W 249° W W-E21 (Dur_CC)</p>

<p>Insert image here</p>			
GPS Location 38.3707, -80.6123		GPS Location			
Description View of wetland topsoil and stream substrate stored within the ROW during construction. W-E21.		Description
