# Wetland Biological Conditions EA Report

<b>Project Name</b>	H-600 Pipeline Spread E	<b>A/E</b>	124300134	<b>Spread</b>	H-600 Pipeline Spread E
<b>Contractor</b>	Price Gregory	<b>Report #</b>	7		
<b>Environmental Auditor</b>	Christina Moore			<b>Date/Time</b>	7/31/2023 9:29 AM
<b>Wetland ID</b>	W-J6	<b>Crossing Start Date</b>	7/31/2023	<b>Crossing Completion Date</b>	8/7/2023
<b>Milepost</b>	137.70	<b>Pre-Con Assessment Date</b>	7/31/2023	<b>Post-Con Assessment Date</b>	8/7/2023
<b>Station</b>	7270+56	<b>Cowardin Classification</b>	PFO	<b>Wetland Impact Area(acres)</b>	0.0744
<b>State</b>	WV				
<b>County</b>	Greenbrier

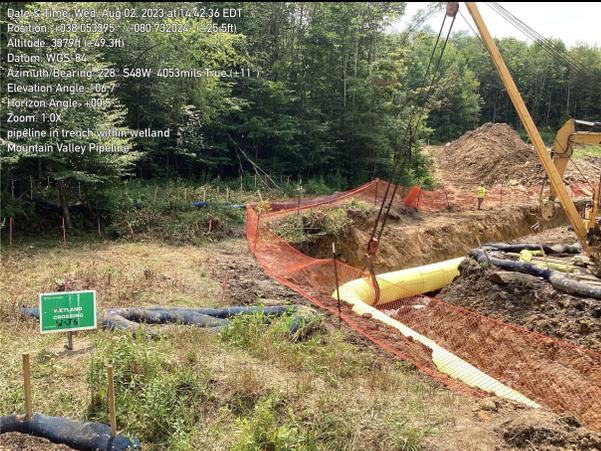
<p><small>Date &amp; Time: Wed, Aug 02, 2023 at 17:42:36 EDT Position: +038.053395° / -080.732024° (-25.5ft) Altitude: 3379ft (±47.3ft) Datum: WGS-84 Azimuth/Bearing: 228° S48W 4053mils True (±1°) Elevation Angle: -06.7° Horizon Angle: +09.5° Zoom: 1.0X Pipeline in trench within wetland Mountain Valley Pipeline</small></p>

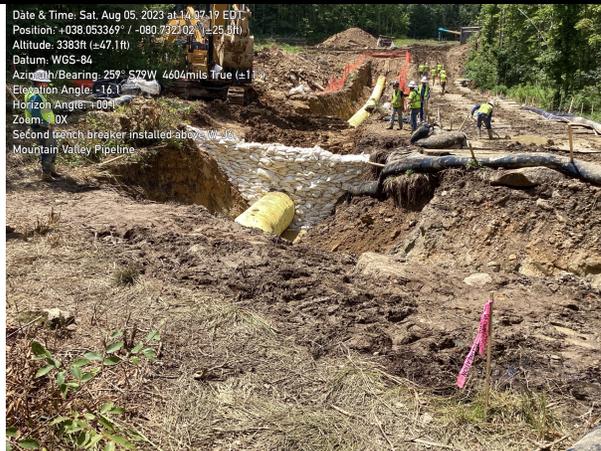
<p><small>Date &amp; Time: Sat, Aug 05, 2023 at 16:07:19 EDT Position: +038.053369° / -080.732102° (-25.5ft) Altitude: 3383ft (±47.1ft) Datum: WGS-84 Azimuth/Bearing: 259° S79W 4604mils True (±1°) Elevation Angle: -16.1° Horizon Angle: +06.1° Zoom: 1.0X Second trench breaker installed above Mountain Valley Pipeline</small></p>

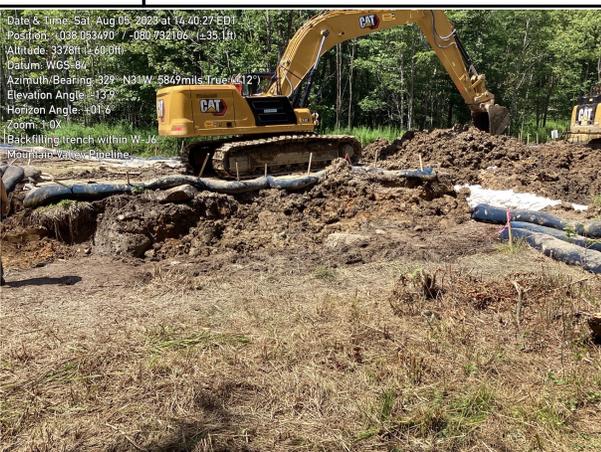
<b>GPS Location</b>	38.053395,-80.732024	<b>GPS Location</b>	38.053539, -80.732102
<b>Description</b>	Placing pipe into the trench	<b>Description</b>	Installation of trench breaks
<p><small>Date &amp; Time: Sat, Aug 05, 2023 at 14:40:27 EDT Position: +038.053490° / -080.732106° (-25.1ft) Altitude: 3378ft (±50.0ft) Datum: WGS-84 Azimuth/Bearing: 329° N31W 5849mils True (±4.2°) Elevation Angle: -13.9° Horizon Angle: +01.6° Zoom: 1.0X Backfilling trench within W-J6 Mountain Valley Pipeline</small></p>

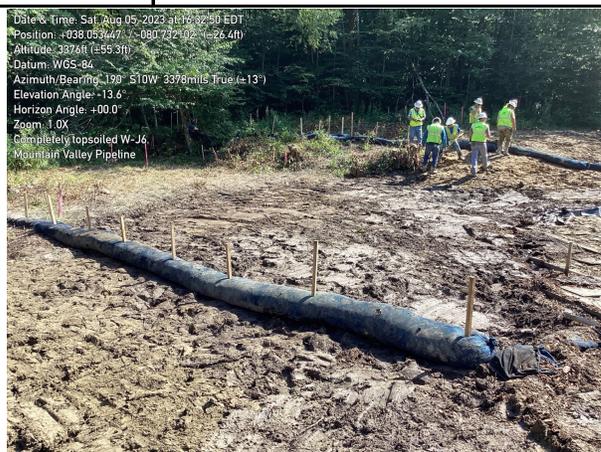
<p><small>Date &amp; Time: Sat, Aug 05, 2023 at 16:32:50 EDT Position: +038.053447° / -080.732102° (-26.4ft) Altitude: 3376ft (±55.3ft) Datum: WGS-84 Azimuth/Bearing: 190° S10W 3398mils True (±13°) Elevation Angle: -13.6° Horizon Angle: +00.0° Zoom: 1.0X Completely topsoiled W-J6 Mountain Valley Pipeline</small></p>

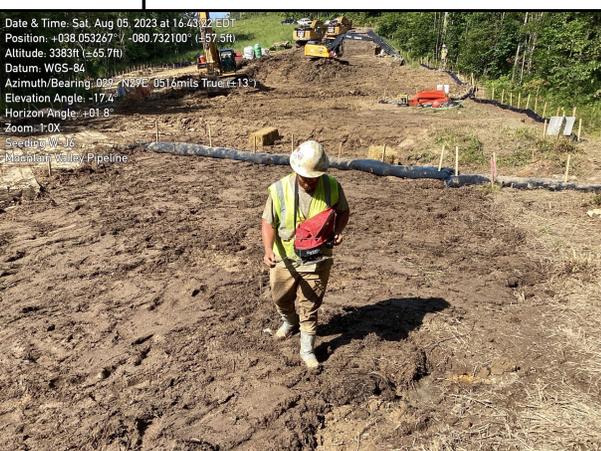
<b>GPS Location</b>	38.053490, -80.732106	<b>GPS Location</b>	38.053447, -80.732102
<b>Description</b>	Backfilling the trench	<b>Description</b>	Post-installation grading of the wetland crossing
<p><small>Date &amp; Time: Sat, Aug 05, 2023 at 16:43:02 EDT Position: +038.053267° / -080.732100° (-25.7ft) Altitude: 3363ft (±65.7ft) Datum: WGS-84 Azimuth/Bearing: 088° N89E 0514mils True (±13°) Elevation Angle: -17.4° Horizon Angle: +01.8° Zoom: 1.0X Seeding W-J6 Mountain Valley Pipeline</small></p>
