Stream Biological Conditions EA Report

Project Name	H-600 Pipeline Spread A	AFE	124300129	Spread	H-600 Pipeline Spread A
Contractor	Precision	Report #	210		
Environmental Auditor	Samantha Felix	Date/Time	8/26/2023 2:07 PM		
Stream ID	S-A1a	Crossing Start Date	8/26/2023	Crossing Completion Date	9/2/2023
Milepost	0.65	Pre-Con Assessment Date	8/22/2023	Post-Con Assessment Date	9/5/2023
Station	34+19	Bankfull Width (ft.)	35.0	Riffle:Pool Complexes Present?	Yes
State	WV	Stream Classification	Perennial		
County	Wetzel	303(d) Impairment Listing	Biological, Fecal, Iron

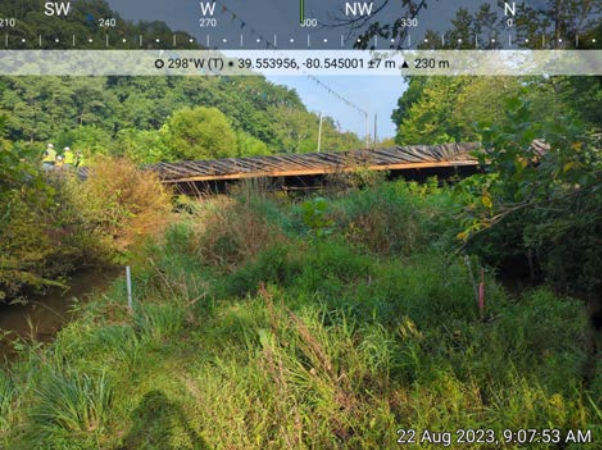
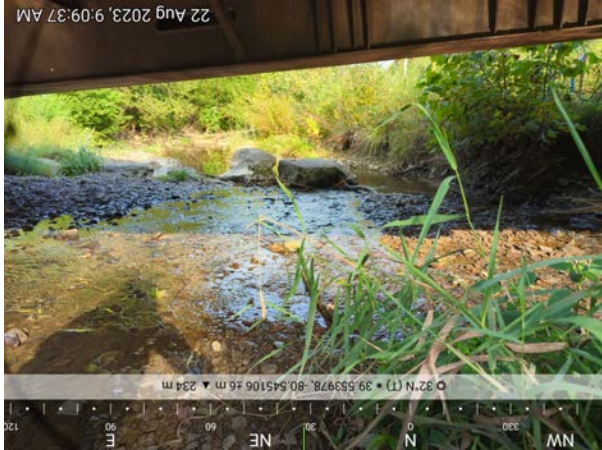
GPS Location	See above.	GPS Location	See above.
Description	Downstream view of permitted impact area during pre-construction assessment.	Description	Downstream view of unimpacted area during pre-construction assessment.

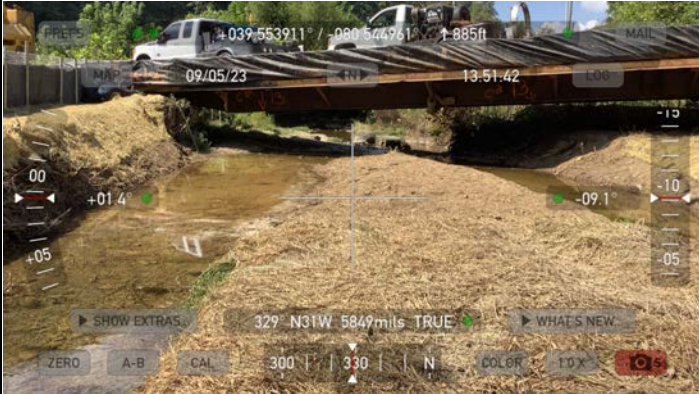
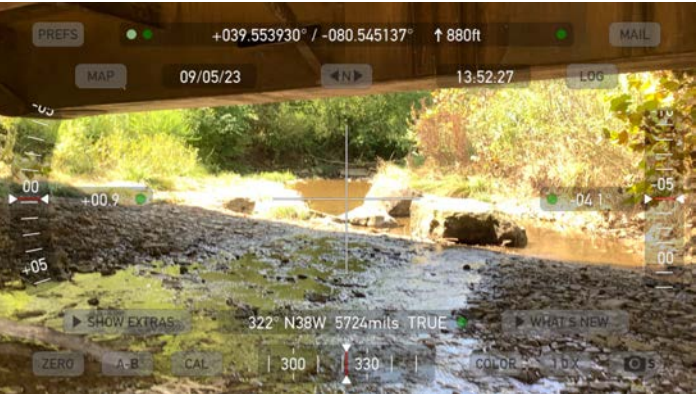
GPS Location	See above.	GPS Location	See above.
Description	Downstream view of permitted impact area during post-construction assessment.	Description	Downstream view of unimpacted area during post-construction assessment.

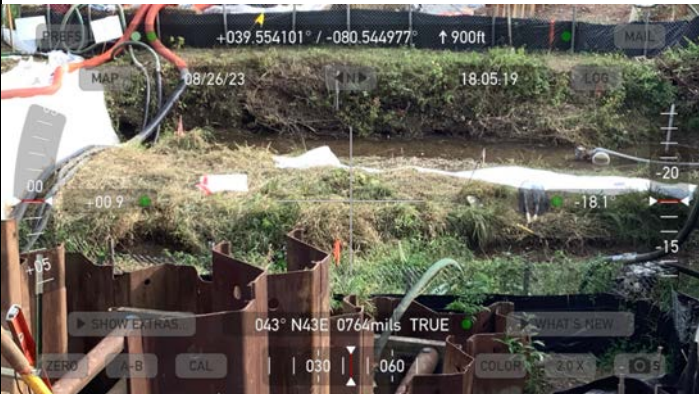
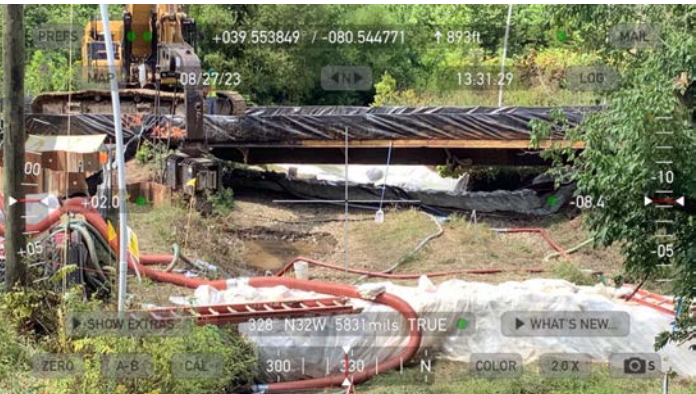
GPS Location	See above.	GPS Location	See above.
Description	This photo shows the dam and pump installed for the stream and wetland crossing.	Description	This photo shows the contractor working on installing sheet piling.

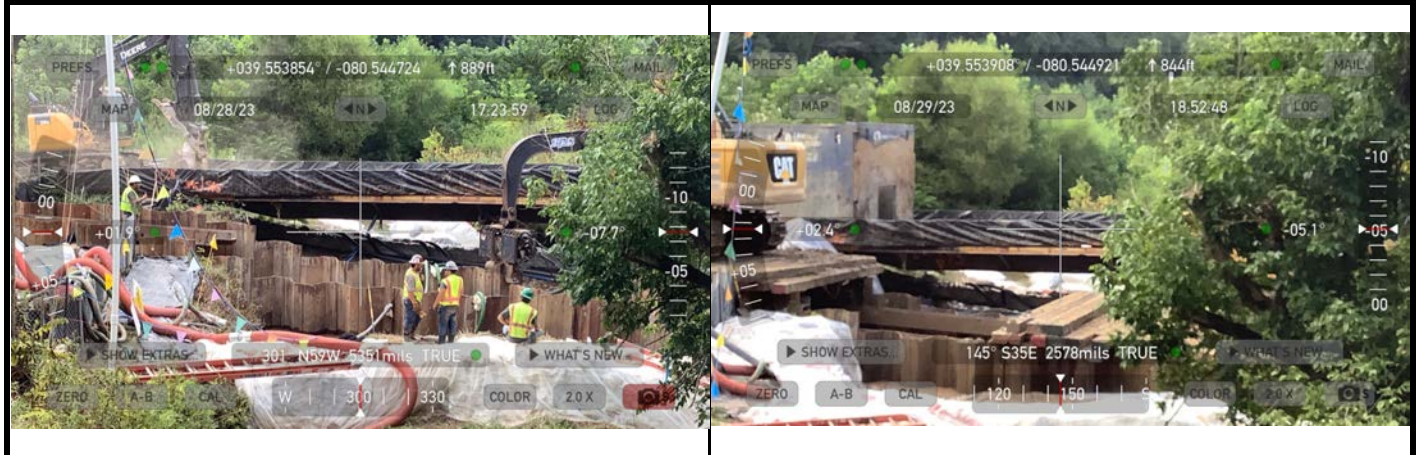
GPS Location See above.	GPS Location See above.
Description This photo shows the contractor continuing working on sheet piling installation.	Description This photo shows the contractor continuing working on sheet piling installation.

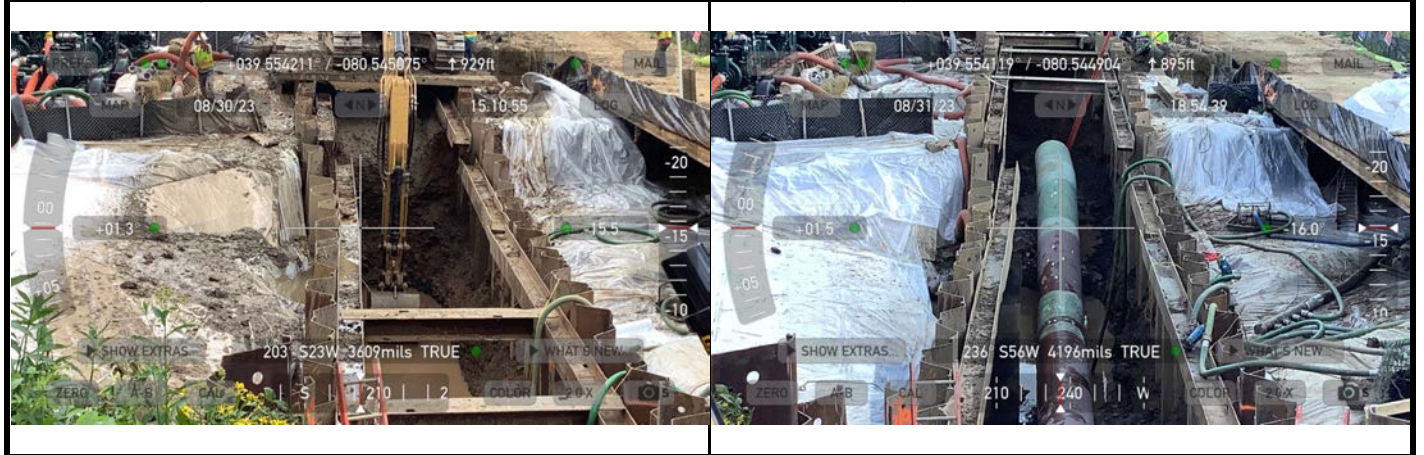
GPS Location See above.	GPS Location See above.
Description This photo shows the contractor working on trench excavation.	Description This photo shows the contractor working on installing the pipe.

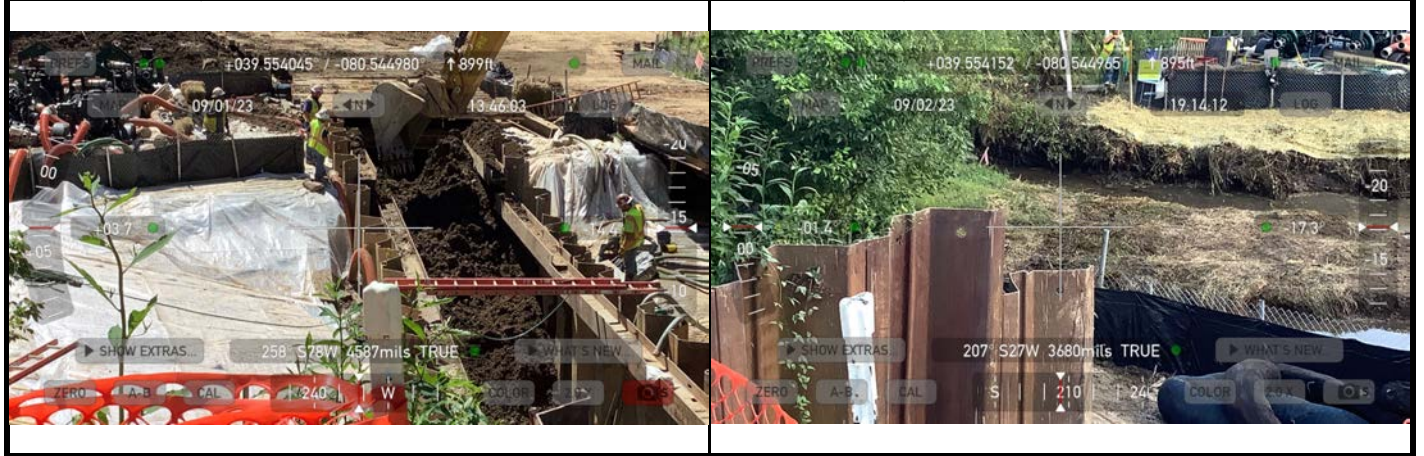
GPS Location See above.	GPS Location See above.
Description This photo shows the contractor working on backfilling the trench with soil.	Description This photo shows the completed crossing.
