Stream Biological Conditions EA Report

Project Name	H-600 Pipeline Spread A	AFE	124300129	Spread	H-600 Pipeline Spread A
Contractor	Precision	Report #	230		
Environmental Auditor	Rachel Ellis	Date/Time	9/7/2023 7:09 AM		
Stream ID	S-B2a	Crossing Start Date	9/10/2023	Crossing Completion Date	9/14/2023
Milepost	18.90	Pre-Con Assessment Date	9/7/2023	Post-Con Assessment Date	9/15/2023
Station	998+10	Bankfull Width (ft.)	8.0	Riffle:Pool Complexes Present?	No
State	WV	Stream Classification	Ephemeral		
County	Harrison	303(d) Impairment Listing	No

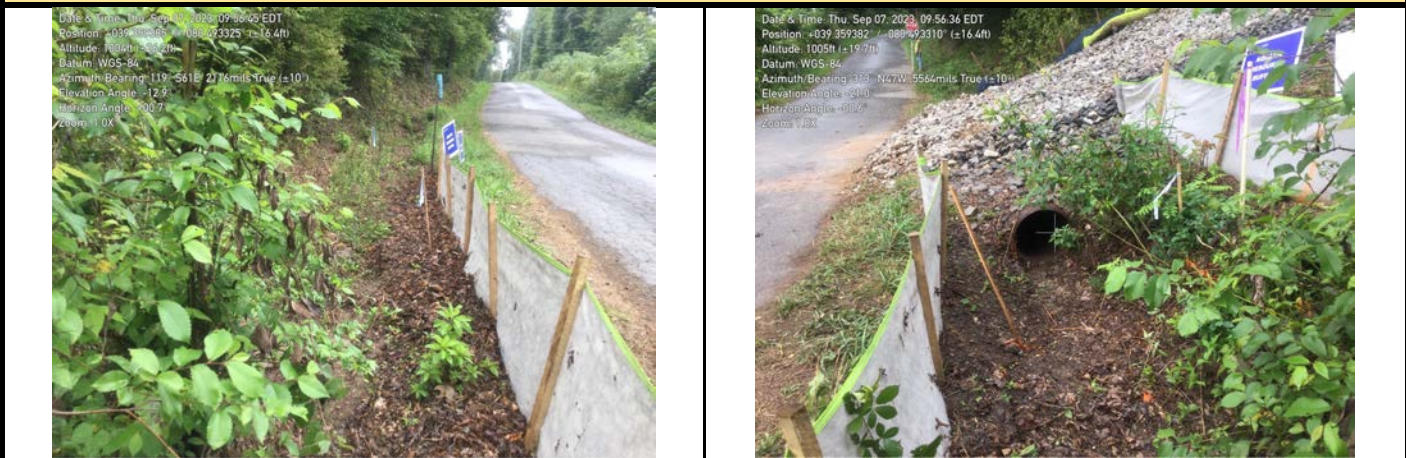
GPS Location Refer to photograph.	GPS Location Refer to photograph.
Description Downstream view of permitted impact area during pre-construction assessment.	Description Downstream view of unimpacted area during pre-construction assessment.

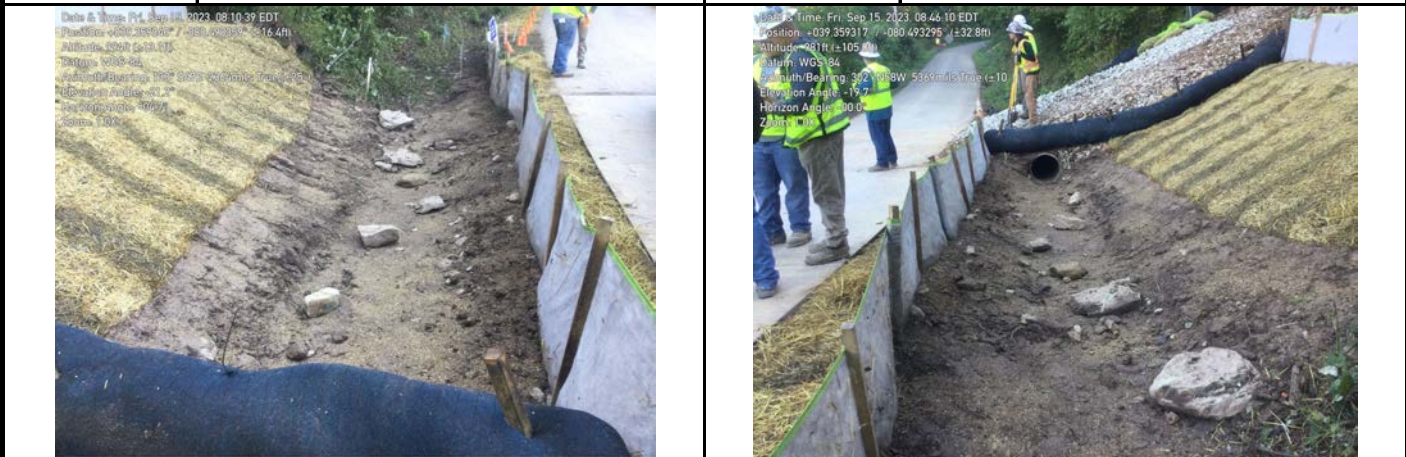
GPS Location Refer to photograph.	GPS Location Refer to photograph.
Description Downstream view of permitted impact area during post-construction assessment.	Description Downstream view of unimpacted area during post-construction assessment.

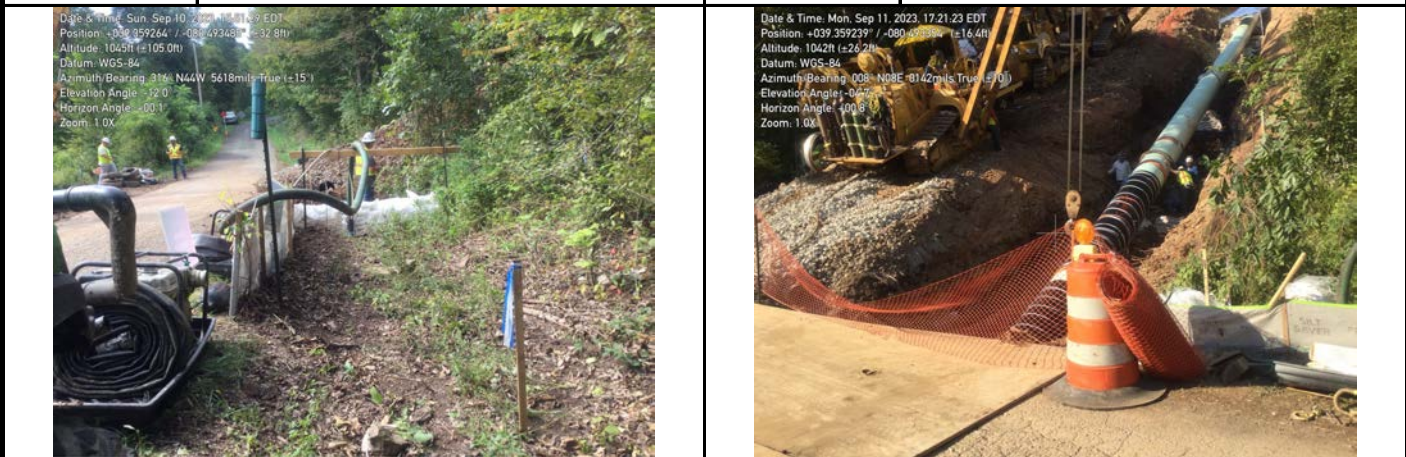
GPS Location Refer to photograph.	GPS Location Refer to photograph.
Description The dam and pump were prepared as excavation through crossing began.	Description The pipe was lowered into the crossing.

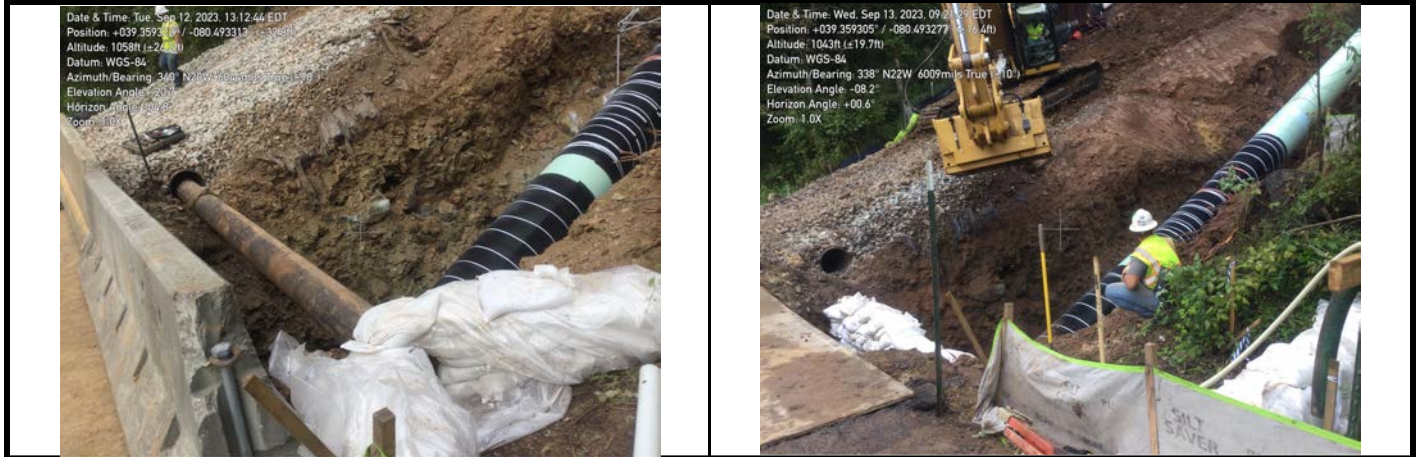
GPS Location	Refer to photograph.	GPS Location	Refer to photograph.
Description	The flume was installed.	Description	The trench breaker was installed.

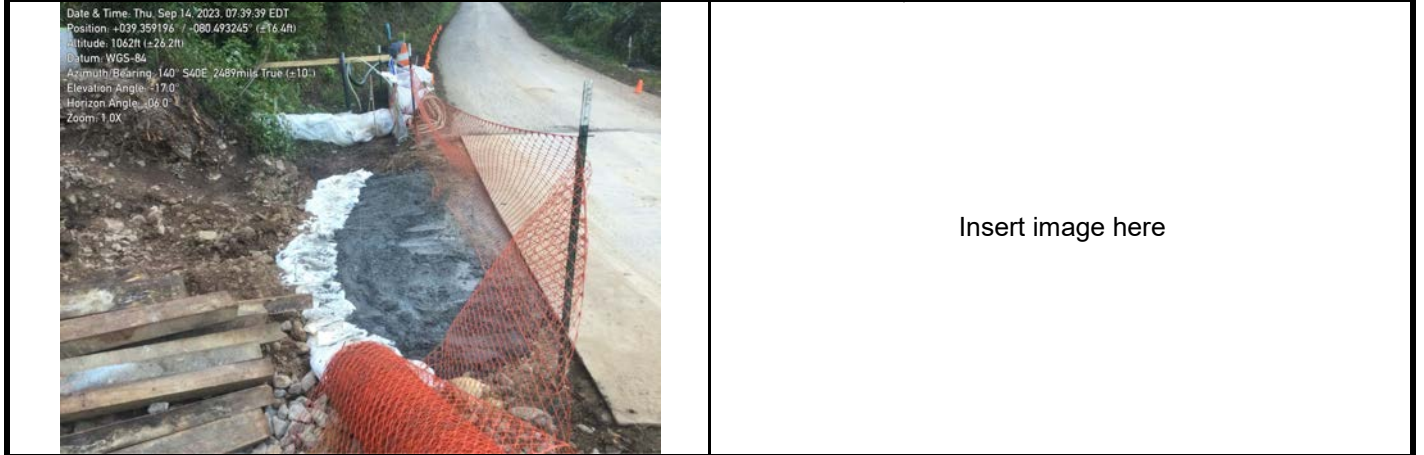
GPS Location	Refer to photograph.	GPS Location	
Description	Flowable fill was put in to replace road adjacent to stream and pushed trench breakers into the crossing.	Description
