STREAM BIOLOGICAL CONDITIONS ENVIRONMENTAL AUDITOR REPORT

Stream ID: S-C8	Crossing Start Date: 08/23/2023	Crossing Completion Date: 08/25/2023
Milepost: 267.6	Pre-Con Assessment Date: 08/21/2023	Post-Con Assessment Date: 08/26/2023
Station: 14141+57	Stream Classification: Intermittent (Perennial, Intermittent, Ephemeral)	Bankfull Width (ft.): 5
County: Franklin	303(d) Impairment Listing: Not Impaired	Riffle:Pool Complexes Present? No

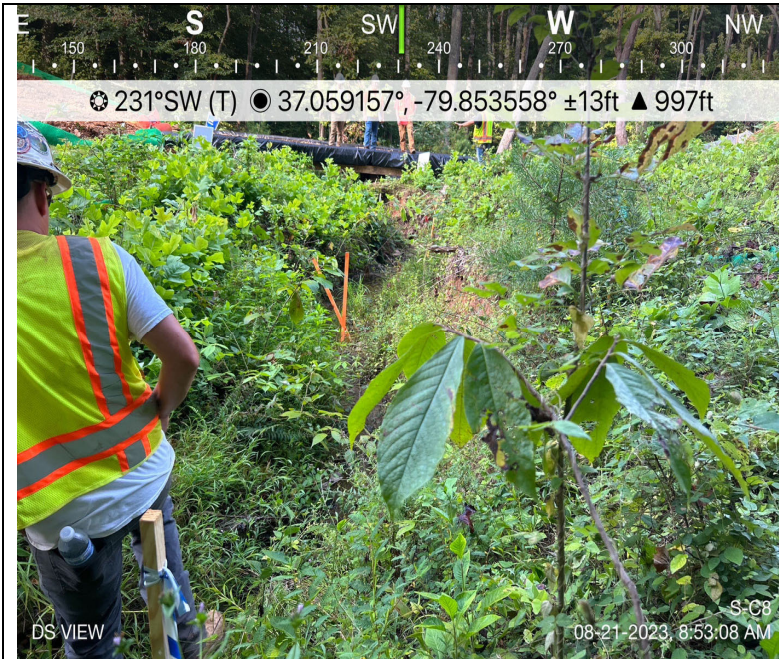
Photo Description: Downstream view of permitted impact area during pre-construction assessment.

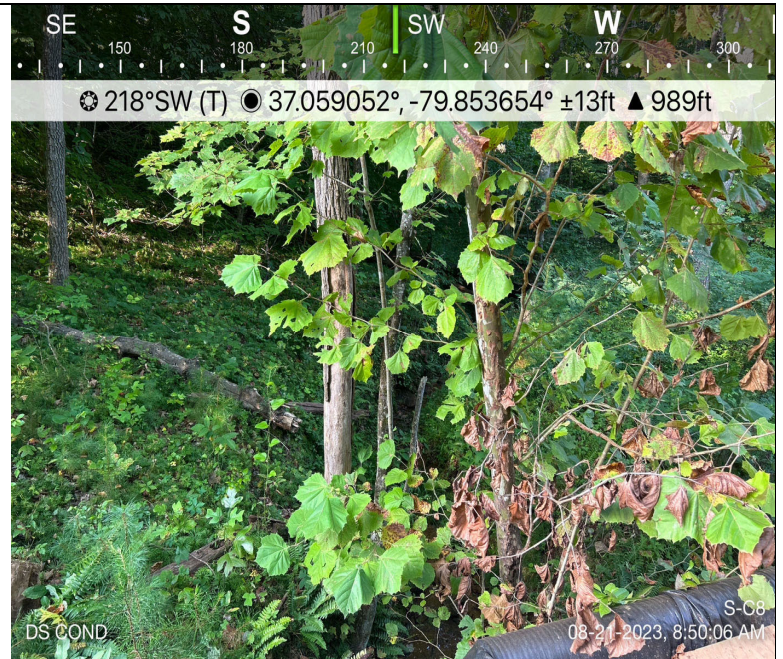
Photo Description: Downstream view of unpermitted area during pre-construction assessment.

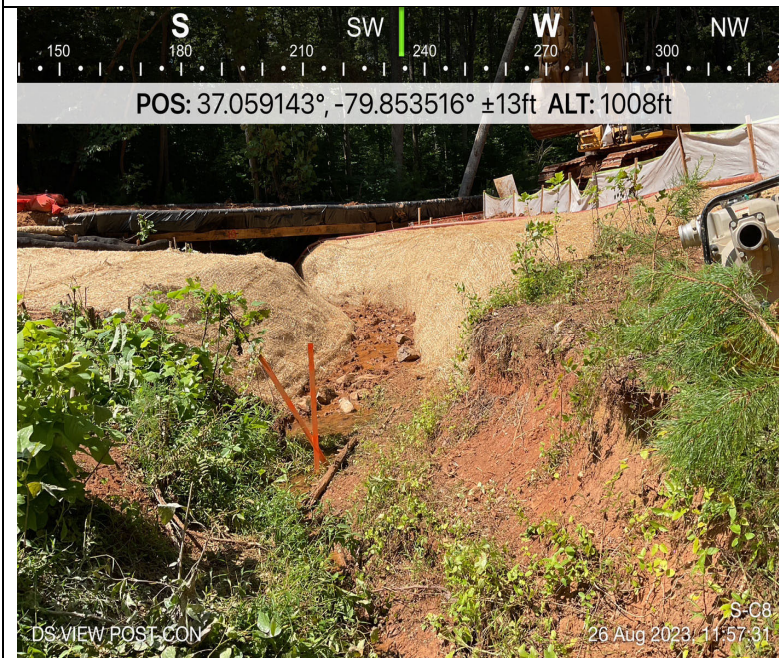
Photo Description: Downstream view of permitted impact area during post-construction assessment.

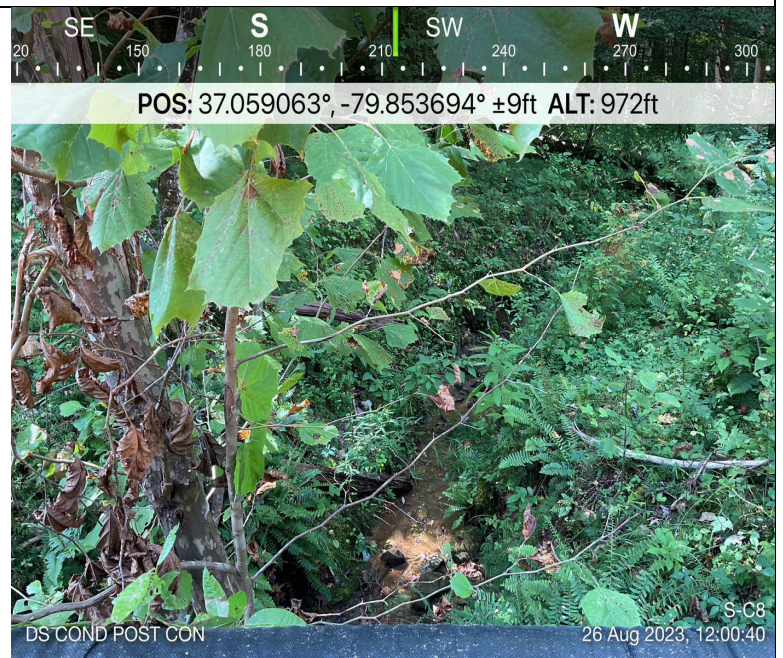
Photo Description: Downstream view of unpermitted area during post-construction assessment.

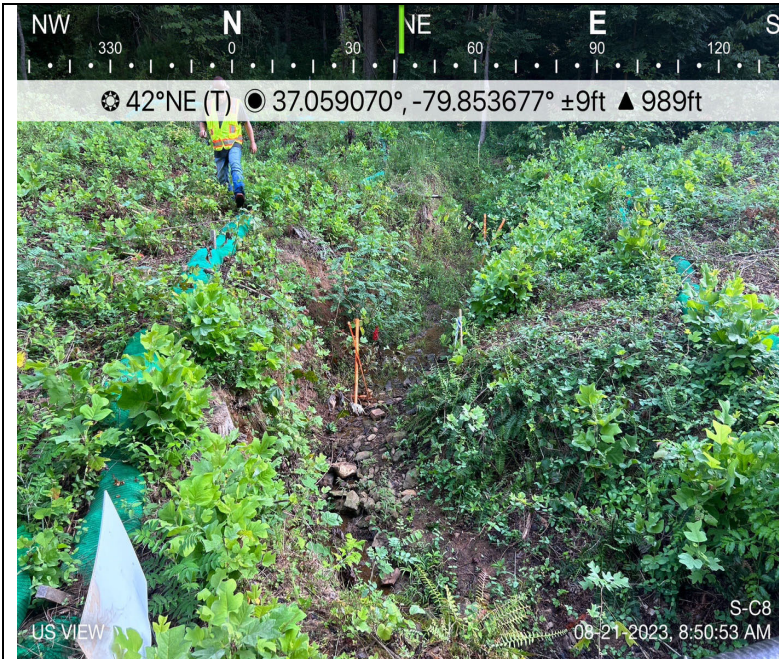
Photo Description: Upstream view of resource prior to construction.

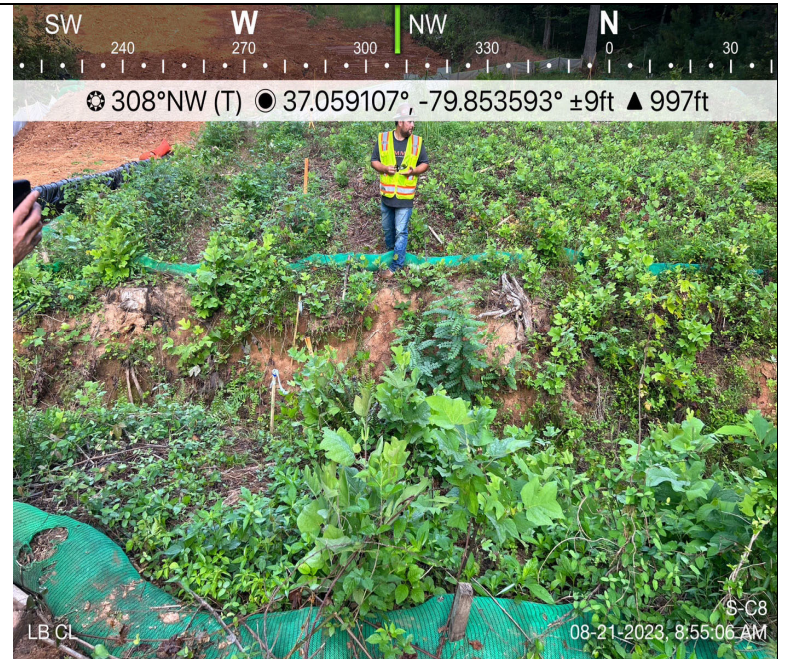
Photo Description: Pipe centerline view of the resource from the left bank prior to construction.

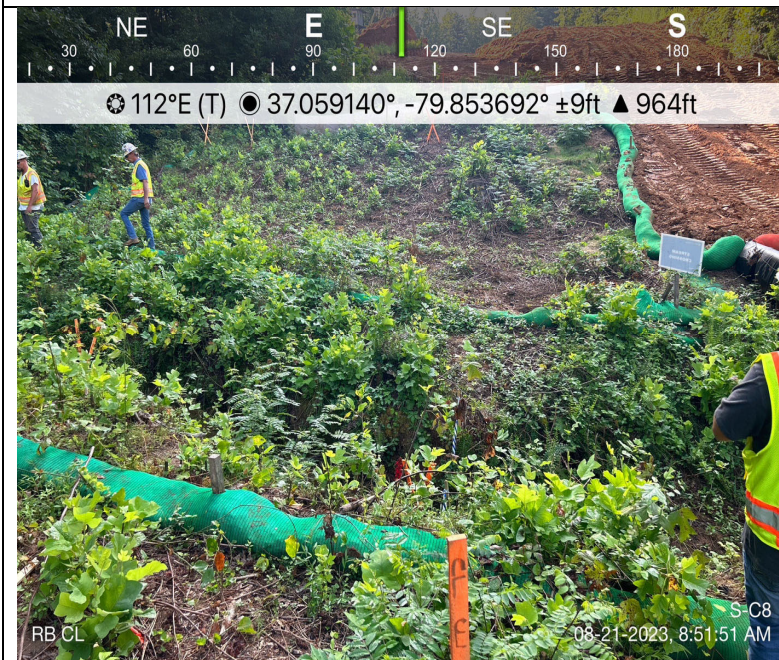
Photo Description: Pipe centerline view of the resource from the right bank prior to construction.

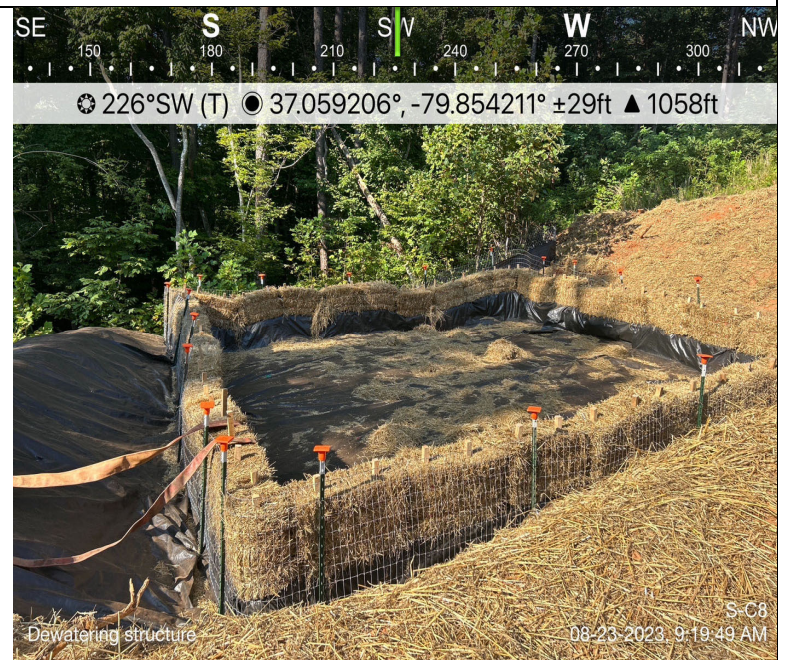
Photo Description: Dewatering operation set up for use, as needed.
