STREAM BIOLOGICAL CONDITIONS ENVIRONMENTAL AUDITOR REPORT

Stream ID: S-D22	Crossing Start Date: 08/22/2023	Crossing Completion Date: 08/23/2023
Milepost: 261.1	Pre-Con Assessment Date: 08/19/2023	Post-Con Assessment Date: 08/23/2023
Station: 13794+36	Stream Classification: Intermittent (Perennial, Intermittent, Ephemeral)	Bankfull Width (ft.): 8
County: Franklin	303(d) Impairment Listing: Not Impaired	Riffle:Pool Complexes Present? No

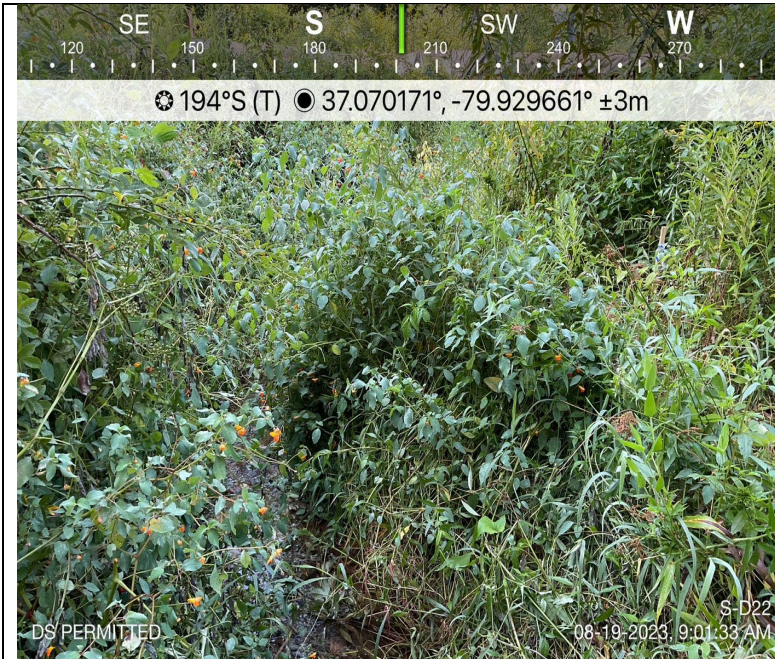
Photo Description: Downstream view of permitted impact area during pre-construction assessment.

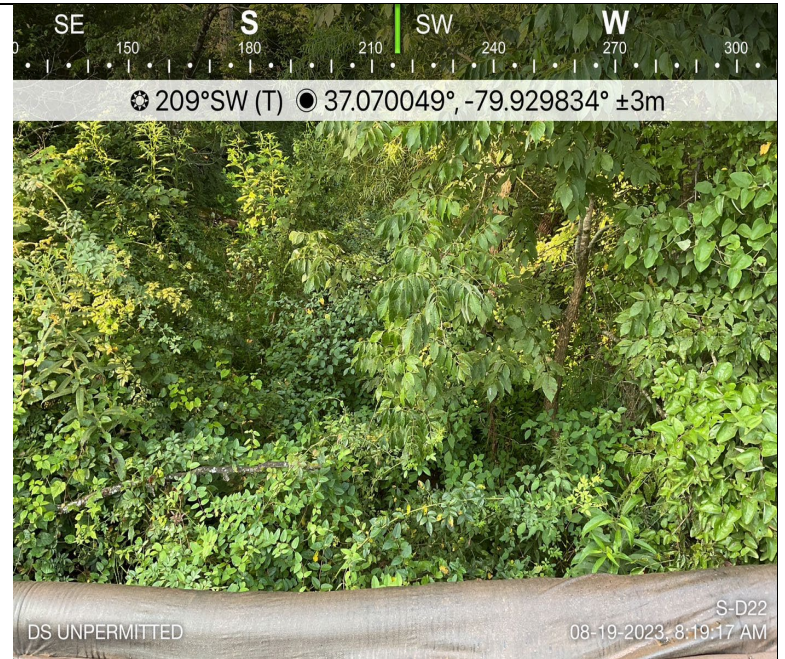
Photo Description: Downstream view of unpermitted area during pre-construction assessment.

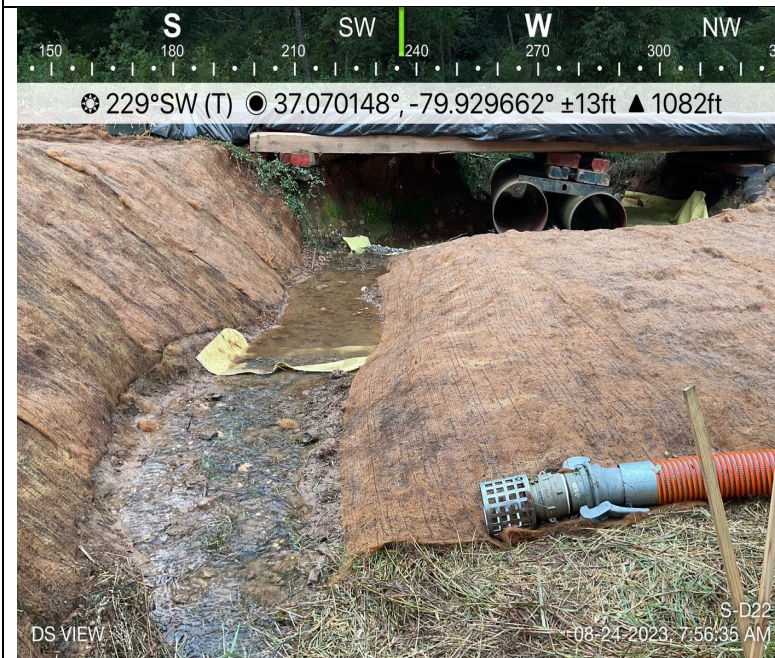
Photo Description: Downstream view of permitted impact area during post-construction assessment.

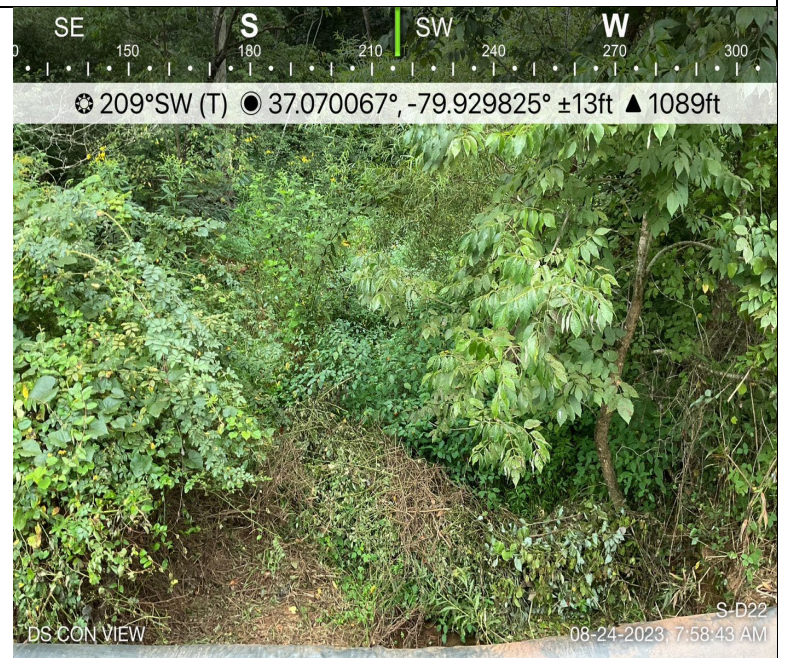
Photo Description: Downstream view of unpermitted area during post-construction assessment.

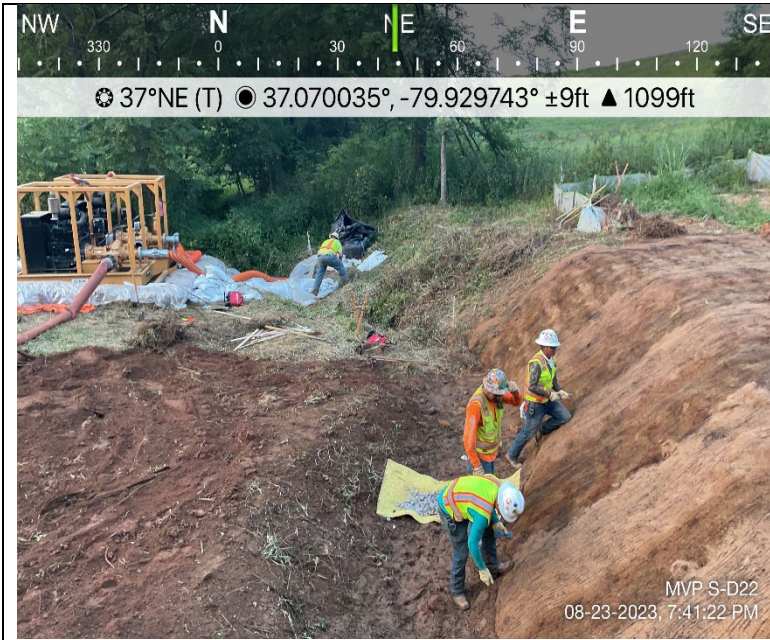
Photo Description: Bank stabilization and pump around

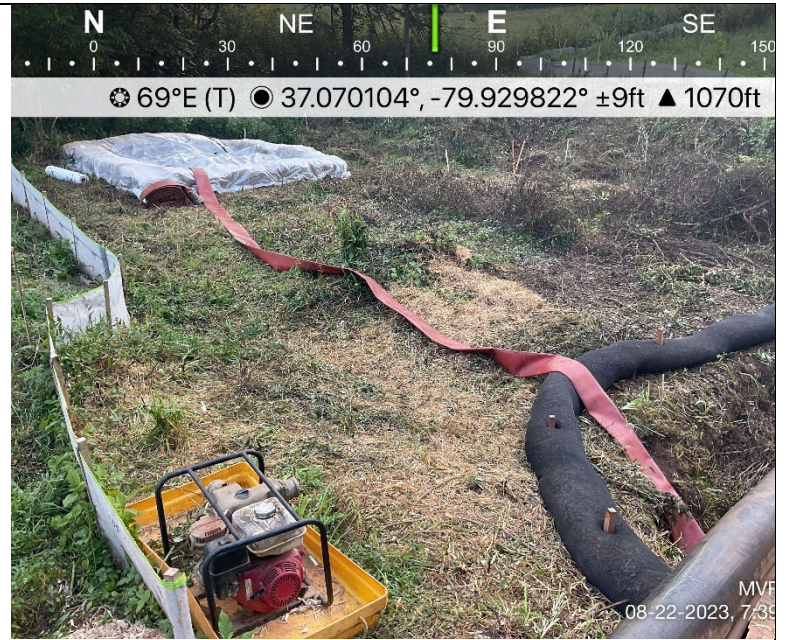
Photo Description: Trench dewatering area

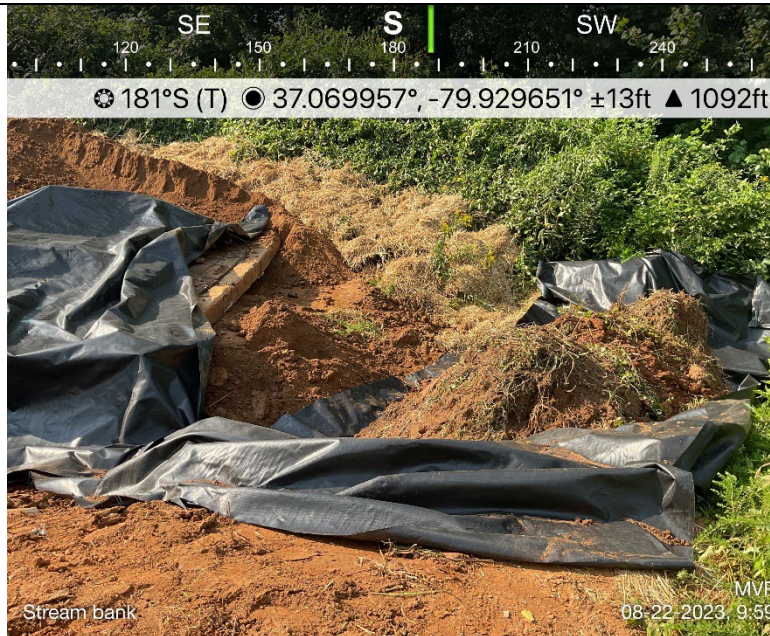
Photo Description: Topsoil Stockpile
