# STREAM BIOLOGICAL CONDITIONS ENVIRONMENTAL AUDITOR REPORT

<b>Stream ID:</b> S-E29	<b>Crossing Start Date:</b> 08/14/2023	<b>Crossing Completion Date:</b> 08/19/2023
<b>Milepost:</b> 258.9	<b>Pre-Con Assessment Date:</b> 08/14/2023	<b>Post-Con Assessment Date:</b> 08/21/2023
<b>Station:</b> 13679+04	<b>Stream Classification:</b> Perennial (Perennial, Intermittent, Ephemeral)	<b>Bankfull Width (ft.):</b> 8
<b>County:</b> Franklin	<b>303(d) Impairment Listing:</b> Not Impaired	<b>Riffle:Pool Complexes Present?</b> No

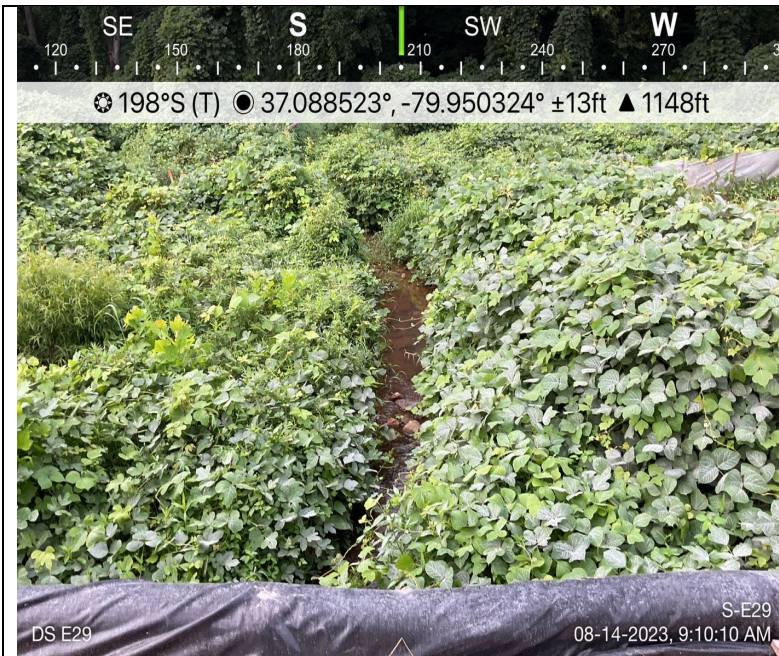
**Photo Description:** Downstream view of permitted impact area during pre-construction assessment.

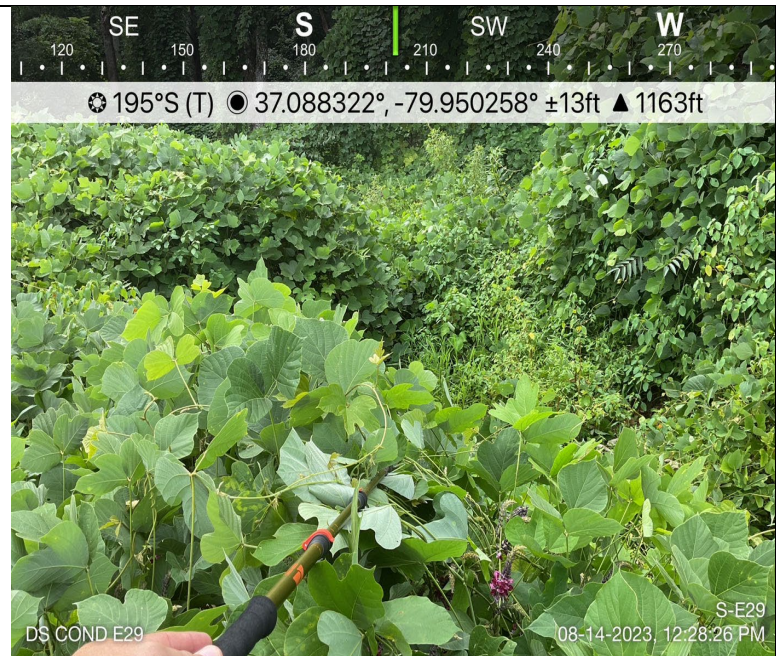
**Photo Description:** Downstream view of unpermitted area during pre-construction assessment.

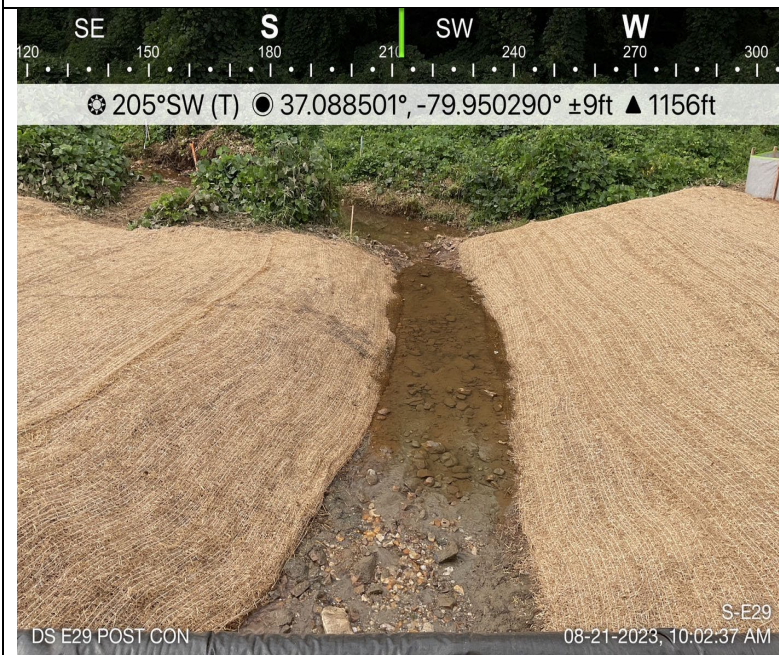
**Photo Description:** Downstream view of permitted impact area during post-construction assessment.

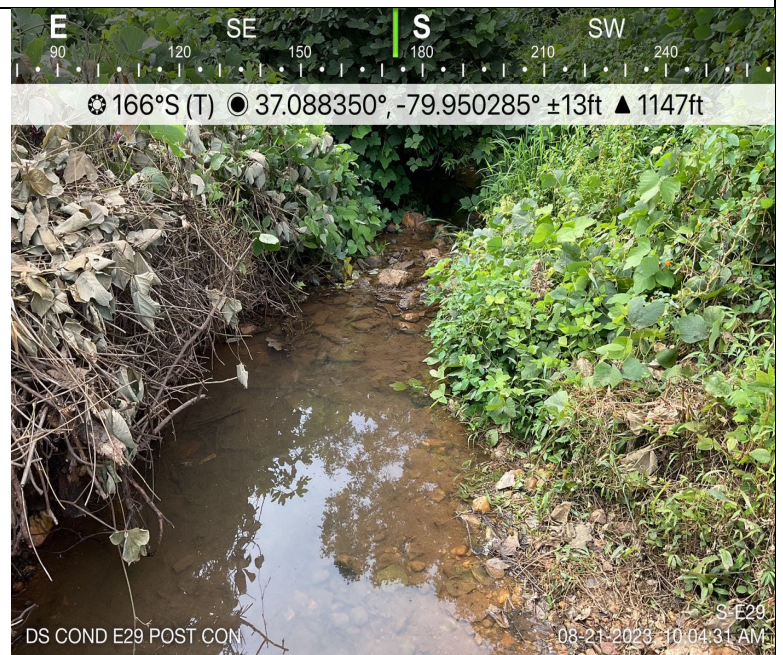
**Photo Description:** Downstream view of unpermitted area during post-construction assessment.

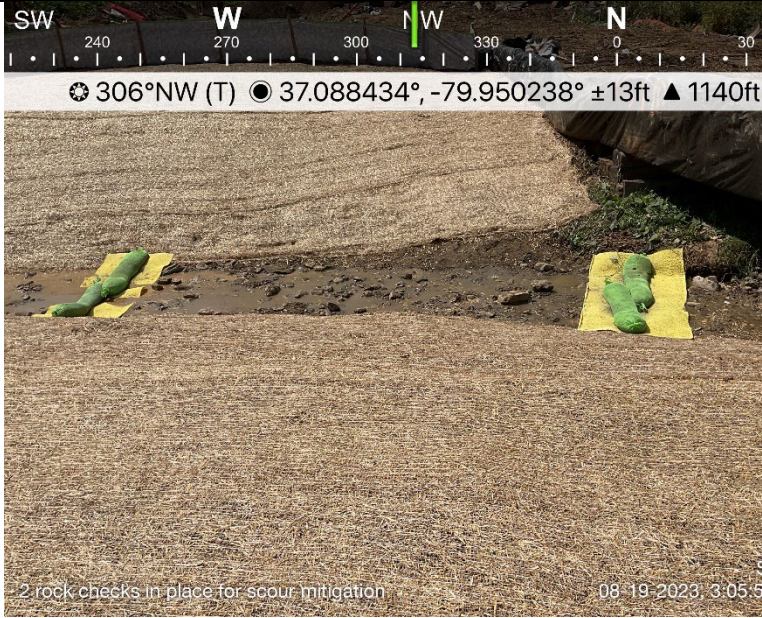
**Photo Description:** Temporary check dams to slow initial flows returning to stream

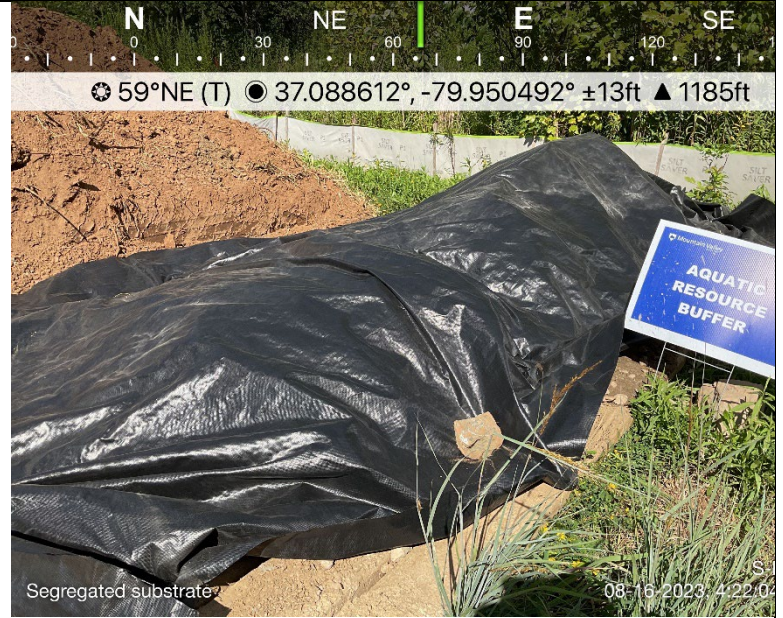
**Photo Description:** Segregated stream substrate

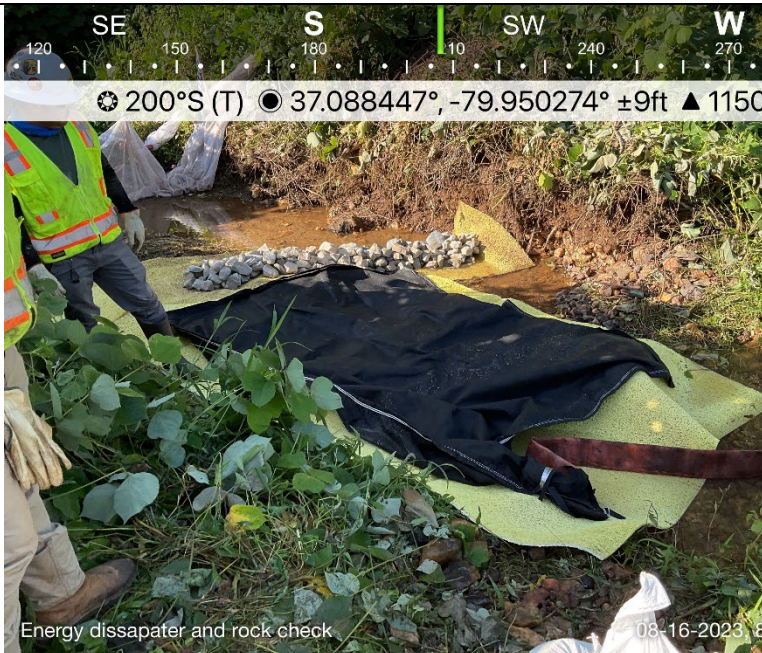
**Photo Description:** Energy dissipater and temporary check for clean water bypass.

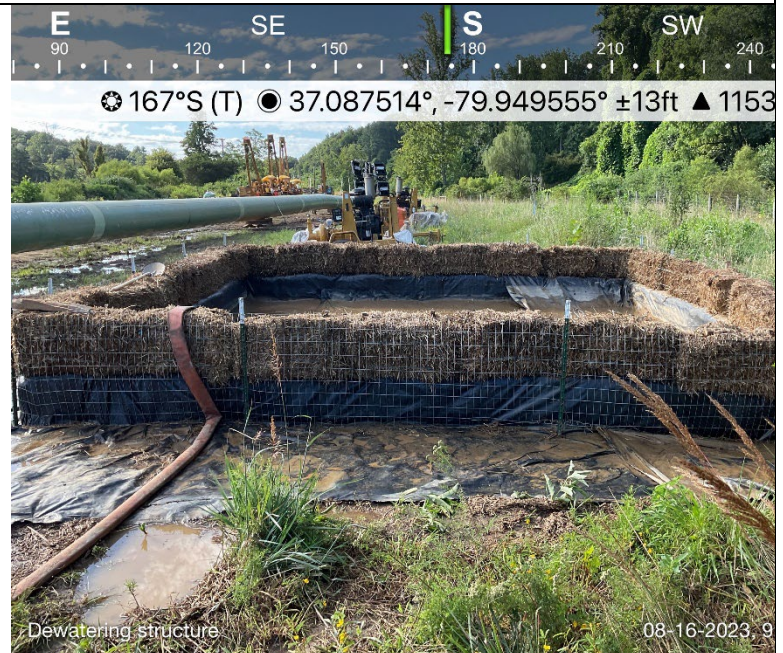
**Photo Description:** Trench dewatering area.
