# Stream Biological Conditions EA Report

<b>Project Name</b>	H-600 Pipeline Spread D	<b>AFE</b>	124300134	<b>Spread</b>	H-600 Pipeline Spread D
<b>Contractor</b>	Precision	<b>Report #</b>	222		
<b>Environmental Auditor</b>	Josh Guy	<b>Date/Time</b>	8/22/2023 1:26 PM		
<b>Stream ID</b>	S-E50s	<b>Crossing Start Date</b>	8/22/2023	<b>Crossing Completion Date</b>	9/1/2023
<b>Milepost</b>	109.68	<b>Pre-Con Assessment Date</b>	8/19/2023	<b>Post-Con Assessment Date</b>	9/2/2023
<b>Station</b>	5791+10	<b>Bankfull Width (ft.)</b>	1.2	<b>Riffle:Pool Complexes Present?</b>	No
<b>State</b>	WV	<b>Stream Classification</b>	Perennial		
<b>County</b>	Webster	<b>303(d) Impairment Listing</b>	No

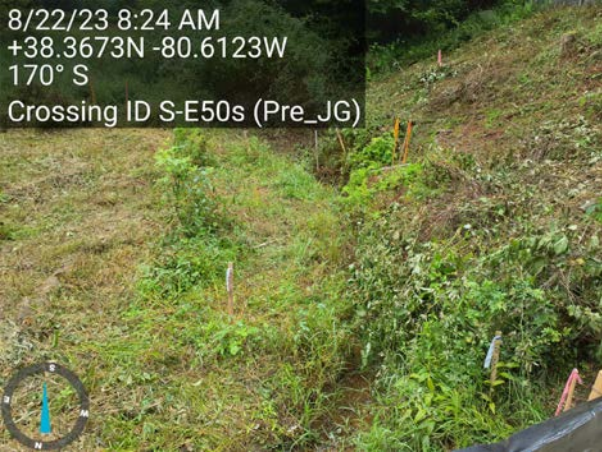
<p>8/22/23 8:24 AM +38.3673N -80.6123W 170° S Crossing ID S-E50s (Pre_JG)</p>

<p><b>GPS Location</b> See above in photo</p>	<p><b>GPS Location</b> See above in photo</p>
<p><b>Description</b> Downstream view of permitted impact area during pre-construction assessment. Downstream on bridge LOD looking downstream pre-construction.</p>	<p><b>Description</b> Downstream view of unimpacted area during pre-construction assessment. Downstream LOD unimpacted area pre-construction.</p>
<p>09/01/2023 15:48:23 +38.367391,-80.612306 181° S S-E50s-(Post_JGf)</p>

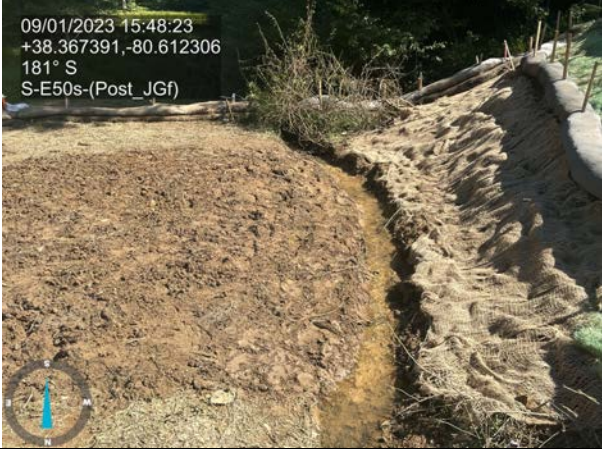
<p><b>GPS Location</b> See above in photo</p>	<p><b>GPS Location</b> See above in photo</p>
<p><b>Description</b> Downstream view of permitted impact area during post-construction assessment. Downstream on bridge LOD looking downstream post-construction.</p>	<p><b>Description</b> Downstream view of unimpacted area during post-construction assessment. Downstream LOD unimpacted downstream post-construction.</p>

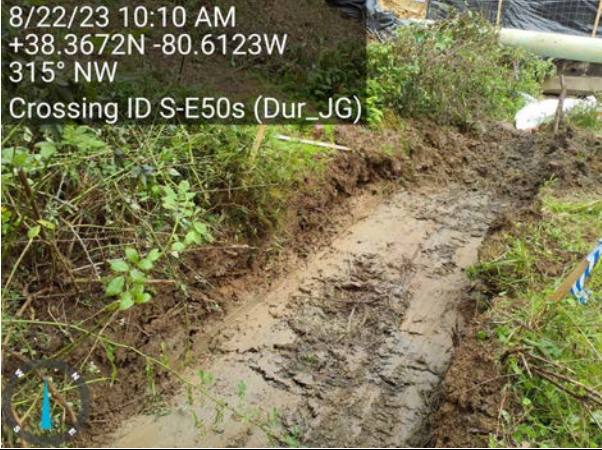
<p>8/22/23 10:10 AM +38.3672N -80.6123W 315° NW Crossing ID S-E50s (Dur_JG)</p>

<p><b>GPS Location</b> See above in photo</p>	<p><b>GPS Location</b> See above in photo.</p>
<p><b>Description</b> Downstream LOD looking upstream during construction. View of top 12in of stream bed/bank removal.</p>	<p><b>Description</b> Upstream on bridge looking downstream during construction. View of flume installed with sandbag seal.</p>

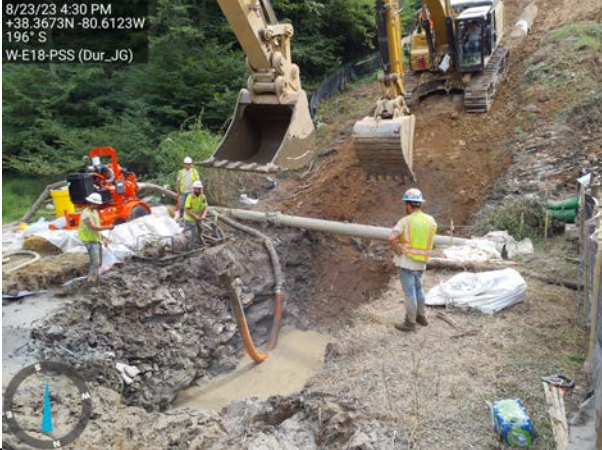
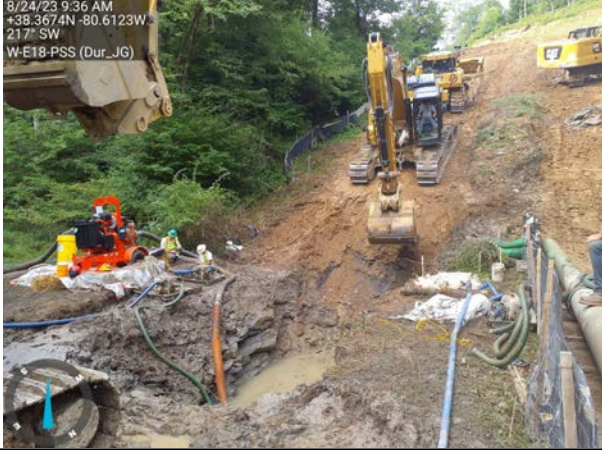
<p>8/24/23 9:36 AM +38.3674N -80.6123W 217° SW W-E18-PSS (Dur_JG)</p>
<b>GPS Location</b> See above in photo	<b>GPS Location</b> See above in photo
<b>Description</b> Viewing from bridge on CIS of resource. View of contractor dewatering ditch line and ditching S-E50s.	<b>Description</b> Viewing from bridge on CIS of resource. View of contractor dewatering ditch line and ditching S-E50s.

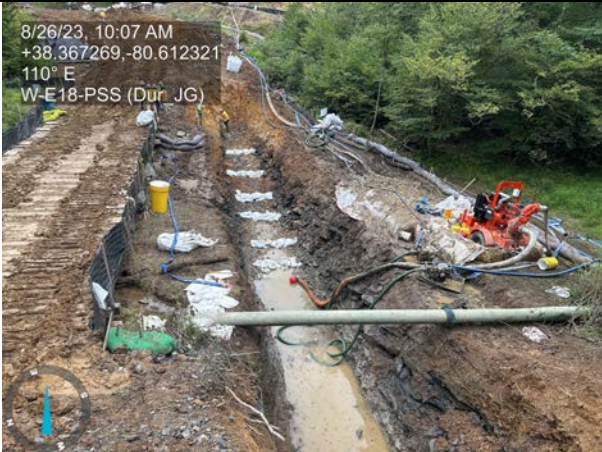
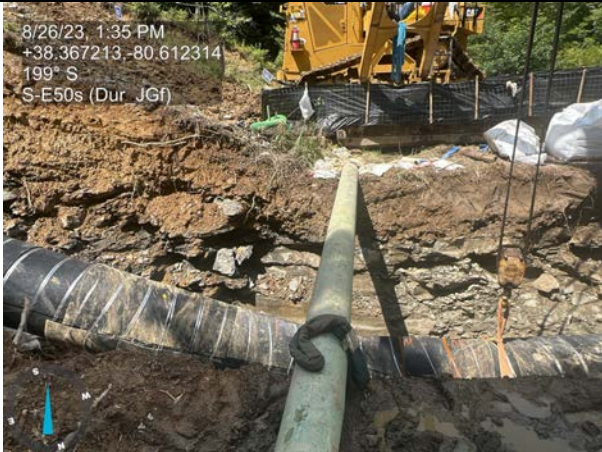
<p>8/26/23, 1:35 PM +38.367213, -80.612314 199° S S-E50s (Dur_JGf)</p>
<b>GPS Location</b> See above in photo	<b>GPS Location</b> See above in photo
<b>Description</b> Viewing from upland area on GAS of resource. View of excavated ditch dewatering and bottom pad installation.	<b>Description</b> Downstream LOD looking upstream. View of resource pipe section being lowered in.

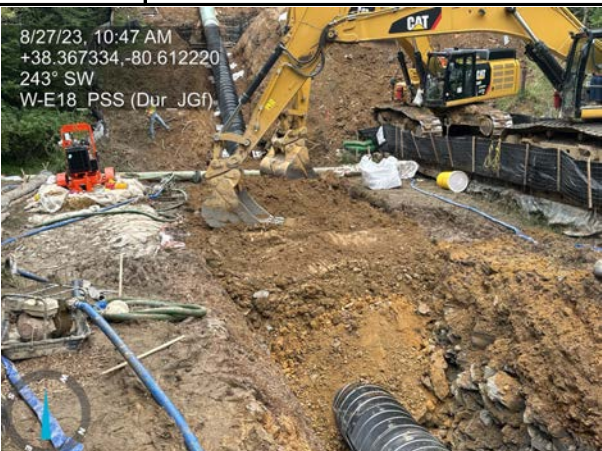
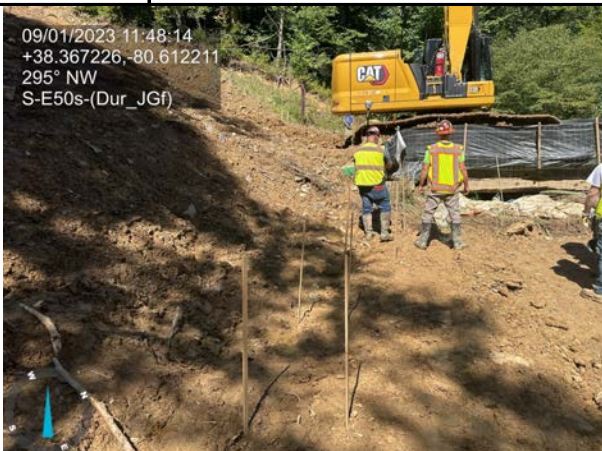
<p>09/01/2023 11:48:14 +38.367226, -80.612211 295° NW S-E50s-(Dur_JGf)</p>
<b>GPS Location</b> See above in photo	<b>GPS Location</b> See above in photo
<b>Description</b> Viewing from CIS wetland W-E18-PSS boundary. View of contractor backfilling S-E50s/W-E18-PSS combo.	<b>Description</b> Downstream LOD looking upstream. View of survey crew identifying resource channel, toe and top of bank.
