STREAM BIOLOGICAL CONDITIONS ENVIRONMENTAL AUDITOR REPORT

Stream ID: S-EF33	Crossing Start Date: 08/15/2023	Crossing Completion Date: 08/19/2023
Milepost: 241.5	Pre-Con Assessment Date: 08/08/2023	Post-Con Assessment Date: 08/19/2023
Station: 12776+75	Stream Classification: Intermittent (Perennial, Intermittent, Ephemeral)	Bankfull Width (ft.): 9
County: Roanoke	303(d) Impairment Listing: Not Impaired	Riffle:Pool Complexes Present? No

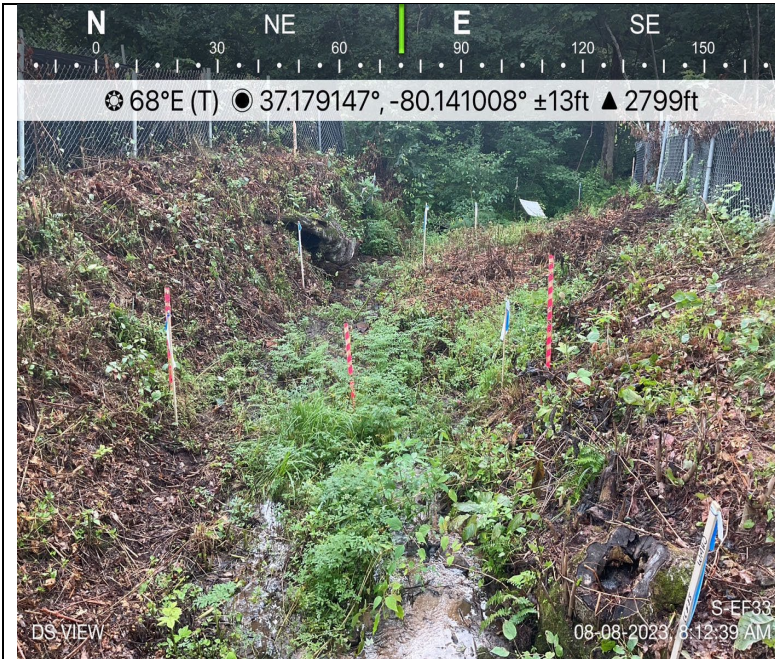
Photo Description: Downstream view of permitted impact area during pre-construction assessment.

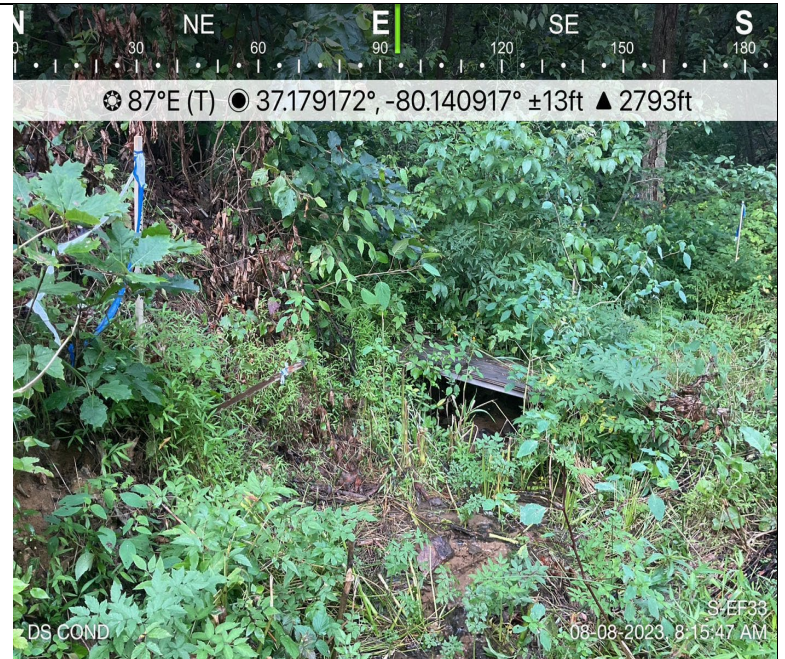
Photo Description: Downstream view of unpermitted area during pre-construction assessment.

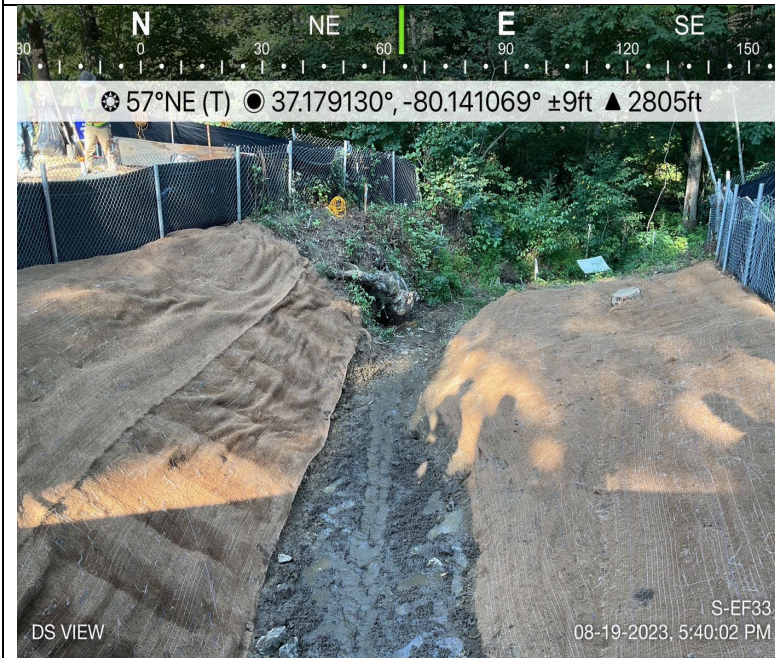
Photo Description: Downstream view of permitted impact area during post-construction assessment.

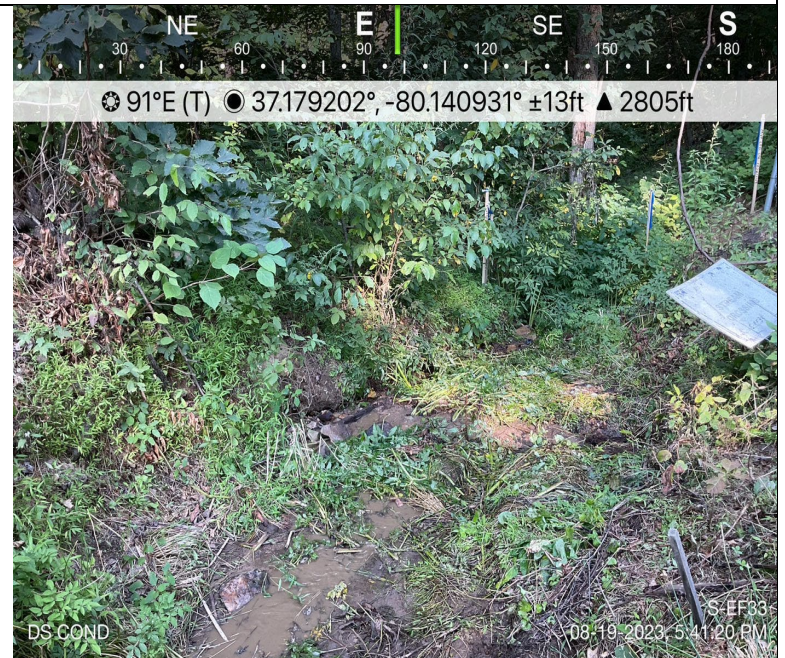
Photo Description: Downstream view of unpermitted area during post-construction assessment.

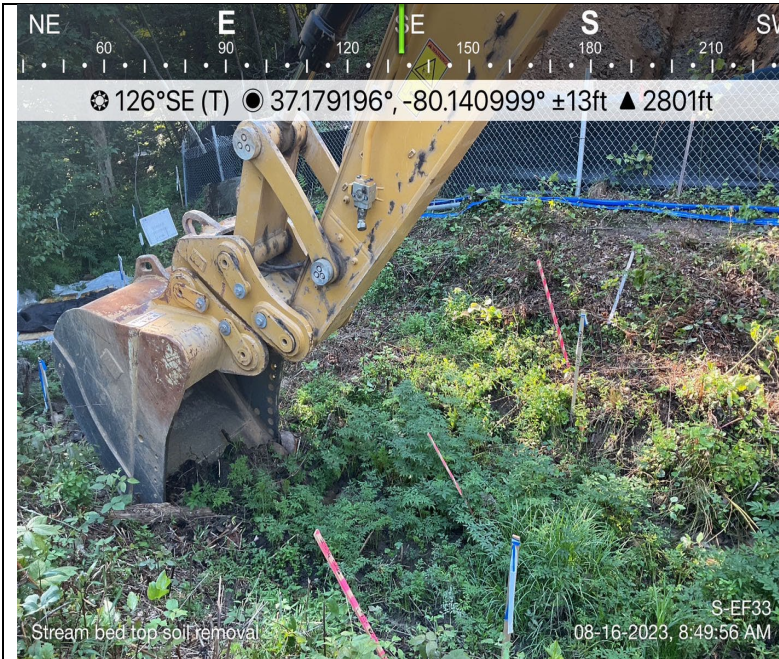
Photo Description: First scoop of stream bed top soil being removed.

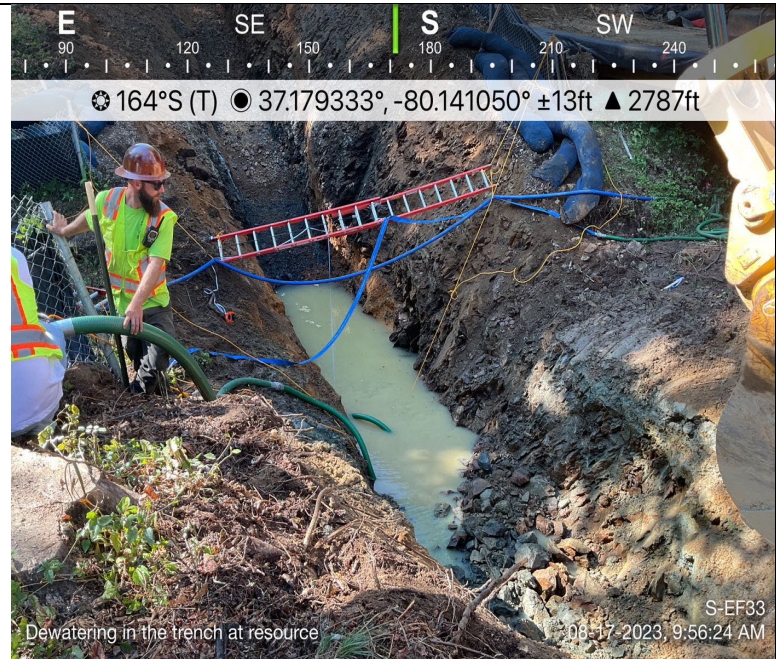
Photo Description: Trenching; dam and pump, and dewatering operation

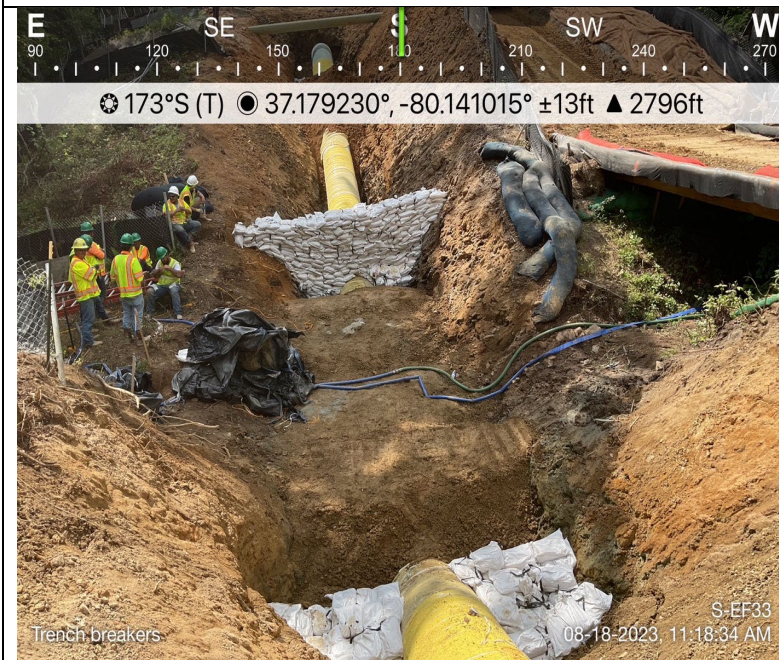
Photo Description: Trench breakers in progress, partial back fill, and dam and pump around active.

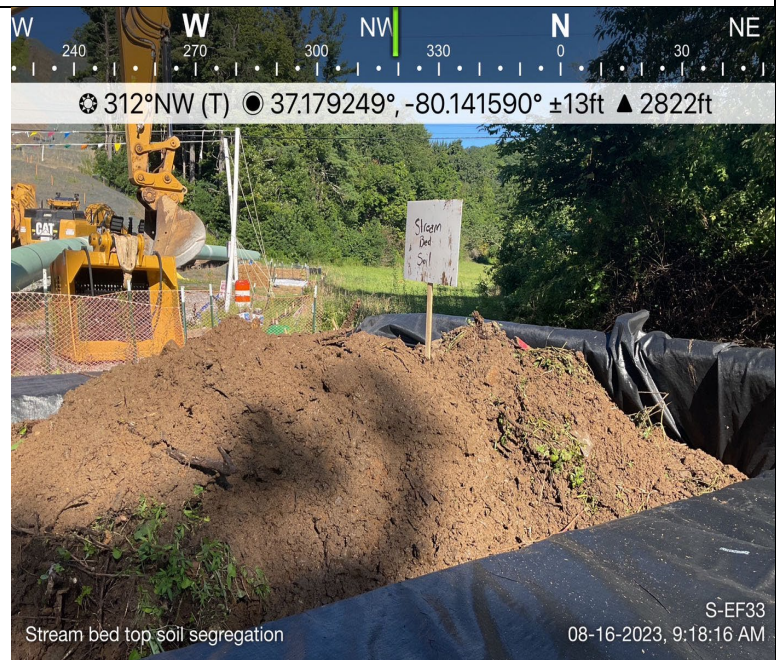
Photo Description: Stream bed top soil segregation and labeled.
