# STREAM BIOLOGICAL CONDITIONS ENVIRONMENTAL AUDITOR REPORT

Version 2.3

<b>Stream ID:</b> S-EF65	<b>Crossing Start Date:</b> 08/17/2023	<b>Crossing Completion Date:</b> 09/03/2023
<b>Milepost:</b> 222.2	<b>Pre-Con Assessment Date:</b> 07/31/2023	<b>Post-Con Assessment Date:</b> 09/03/2023
<b>Station:</b> 11740+42	<b>Stream Classification:</b> Intermittent (Perennial, Intermittent, Ephemeral)	<b>Bankfull Width (ft.):</b> 12
<b>County:</b> Montgomery	<b>303(d) Impairment Listing:</b> Not Impaired	<b>Riffle:Pool Complexes Present?</b> No

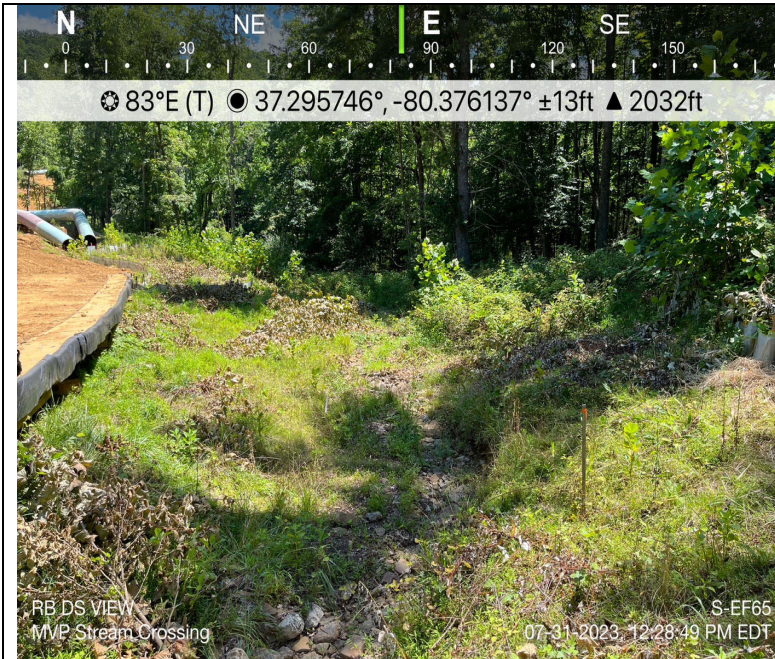
**Photo Description:** Downstream view of permitted impact area during pre-construction assessment.

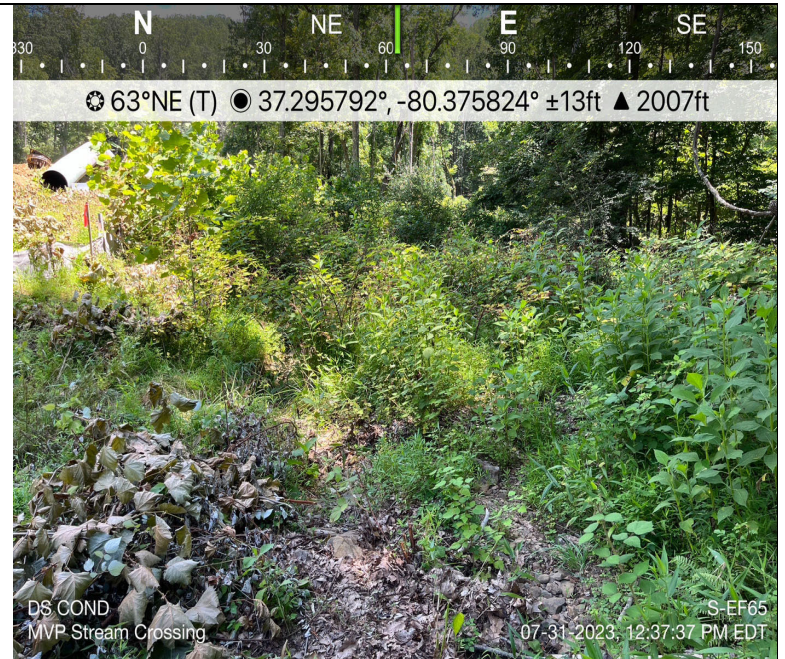
**Photo Description:** Conditions of the downstream area outside the ROW during pre-construction assessment.

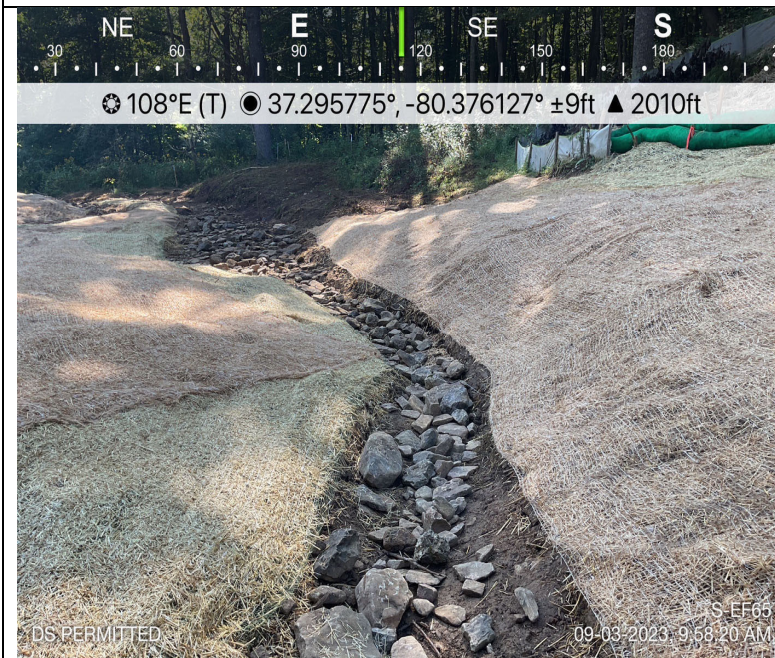
**Photo Description:** Downstream view of permitted impact area during post-construction assessment.

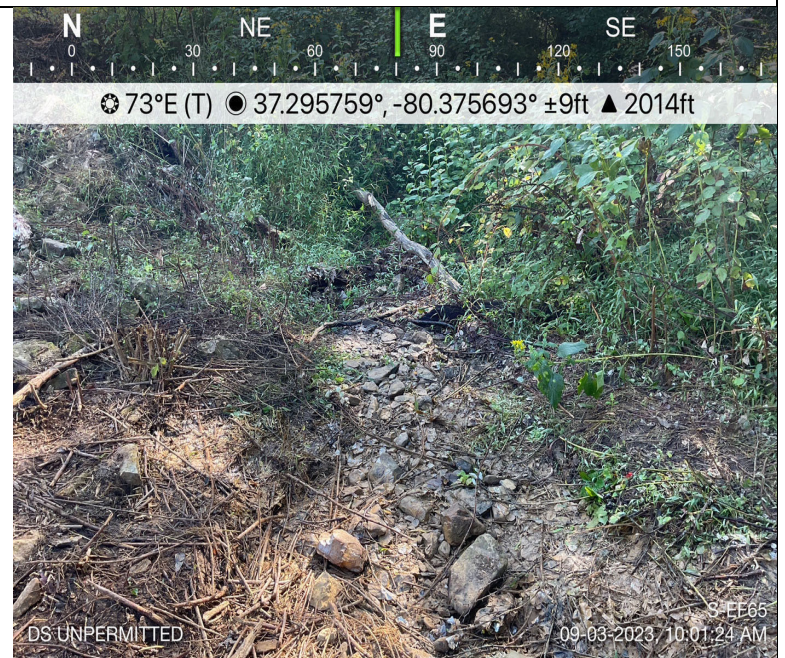
**Photo Description:** Conditions of the downstream area outside the ROW during post-construction assessment.

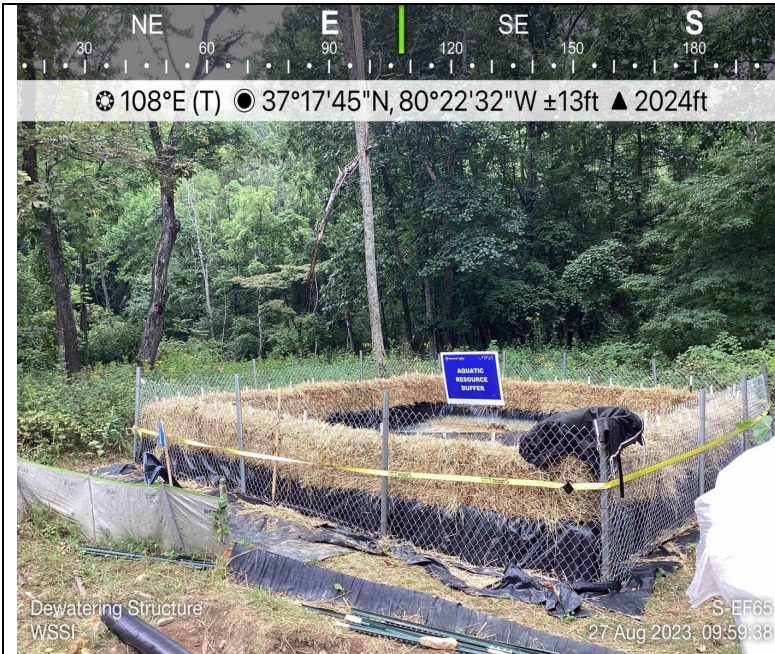
**Photo Description:** Dewatering structure located off ROW with landowner permission.

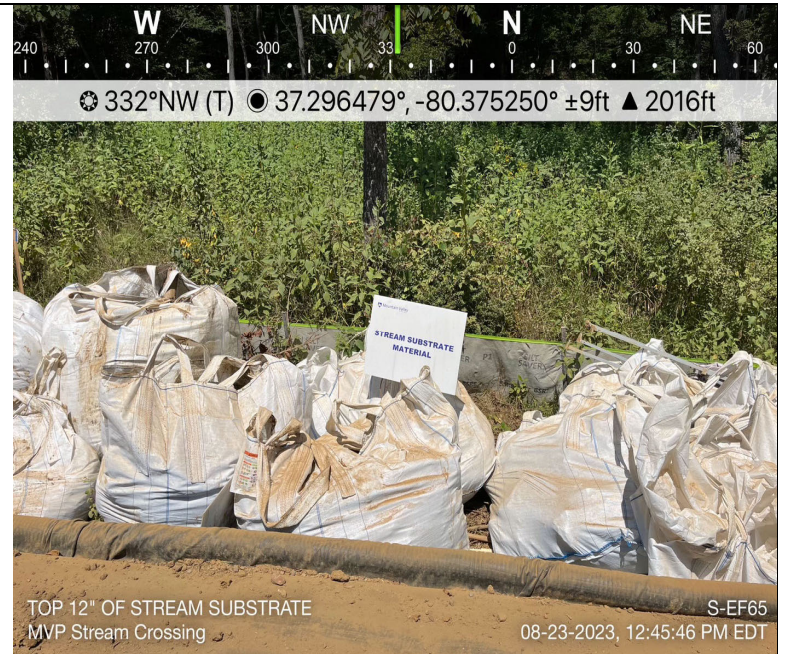
**Photo Description:** Stream substrate stockpile

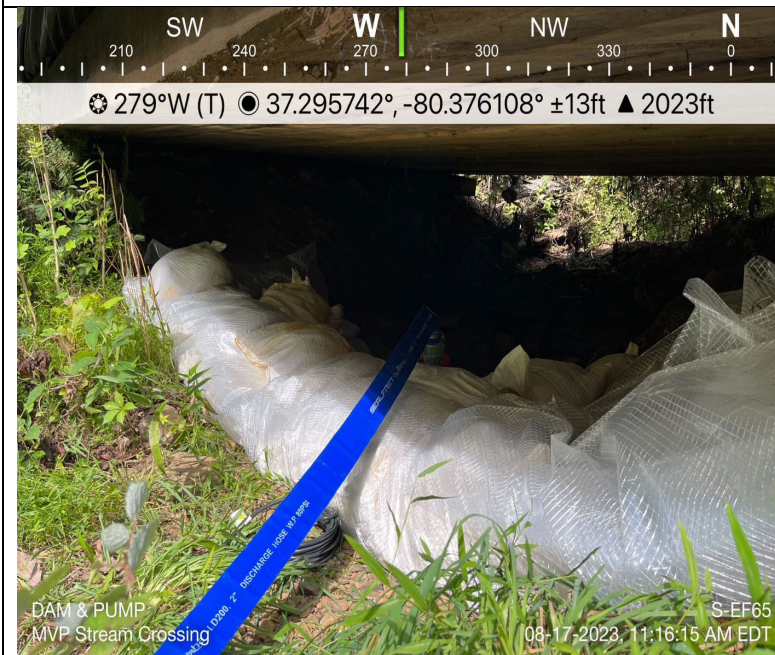
**Photo Description:** Dam & pump

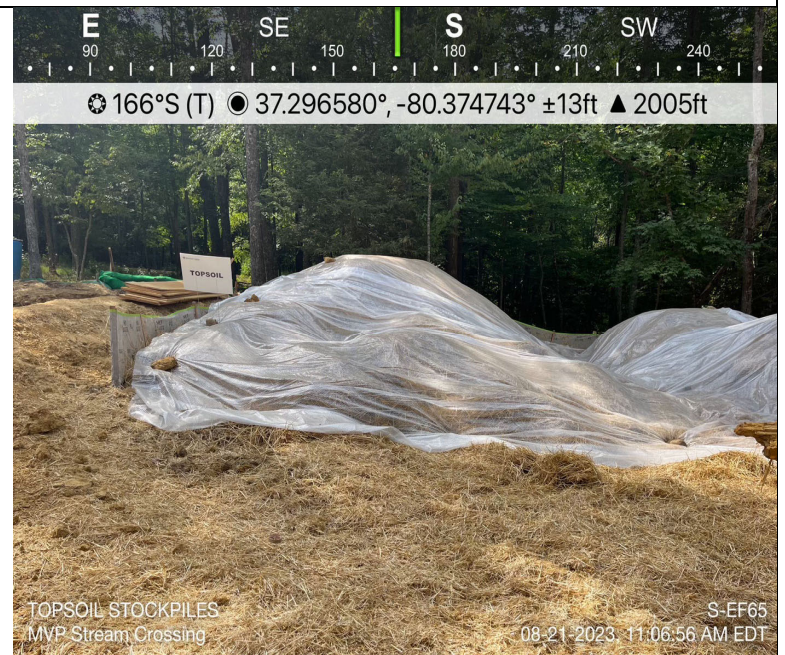
**Photo Description:** Topsoil stockpiles
