STREAM BIOLOGICAL CONDITIONS ENVIRONMENTAL AUDITOR REPORT

Stream ID: S-GH9	Crossing Start Date: 09/01/2023	Crossing Completion Date: 09/07/2023
Milepost: 252.4	Pre-Con Assessment Date: 08/26/2023	Post-Con Assessment Date: 09/12/2023
Station: 13337+13	Stream Classification: Perennial (Perennial, Intermittent, Ephemeral)	Bankfull Width (ft.): 3
County: Franklin	303(d) Impairment Listing: Not Impaired	Riffle:Pool Complexes Present? No

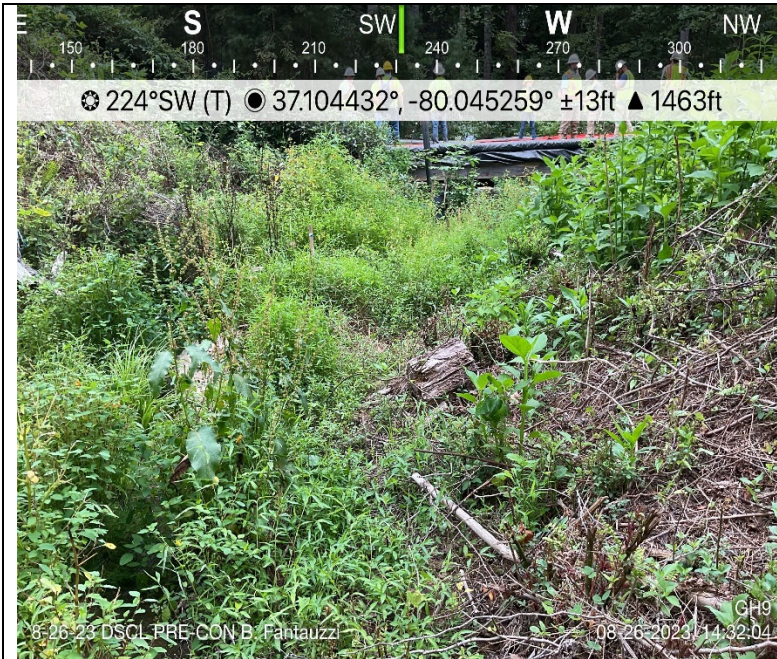
Photo Description: Downstream view of permitted impact area during pre-construction assessment.

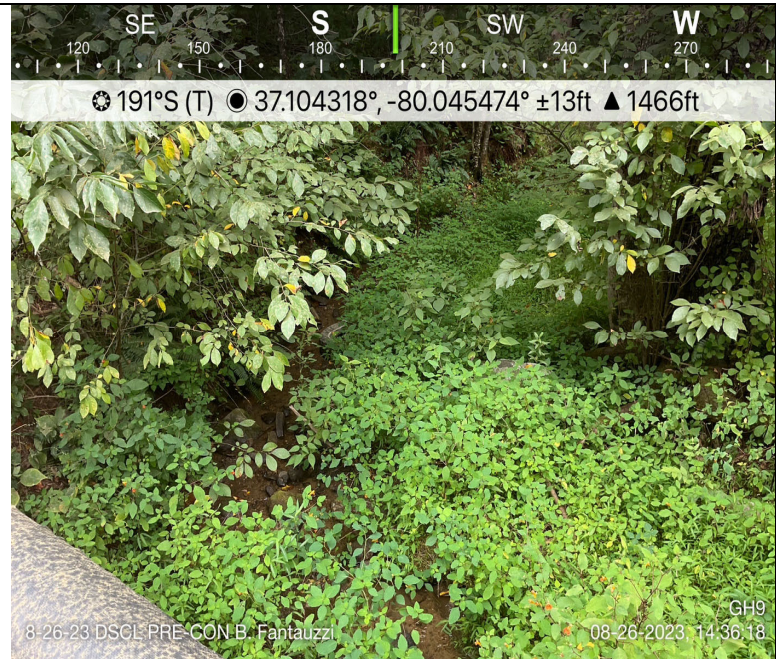
Photo Description: Conditions of the downstream area outside the ROW during pre-construction assessment.

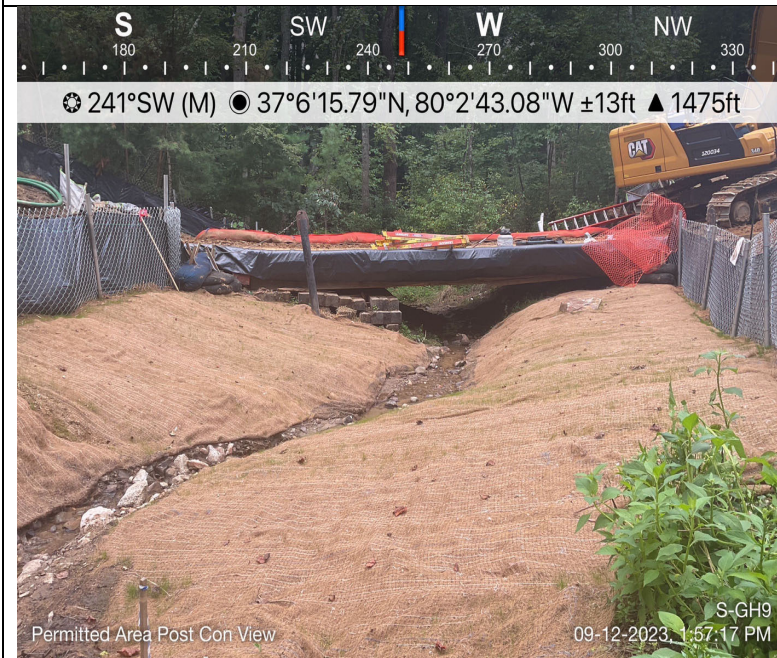
Photo Description: Downstream view of permitted impact area during post-construction assessment.

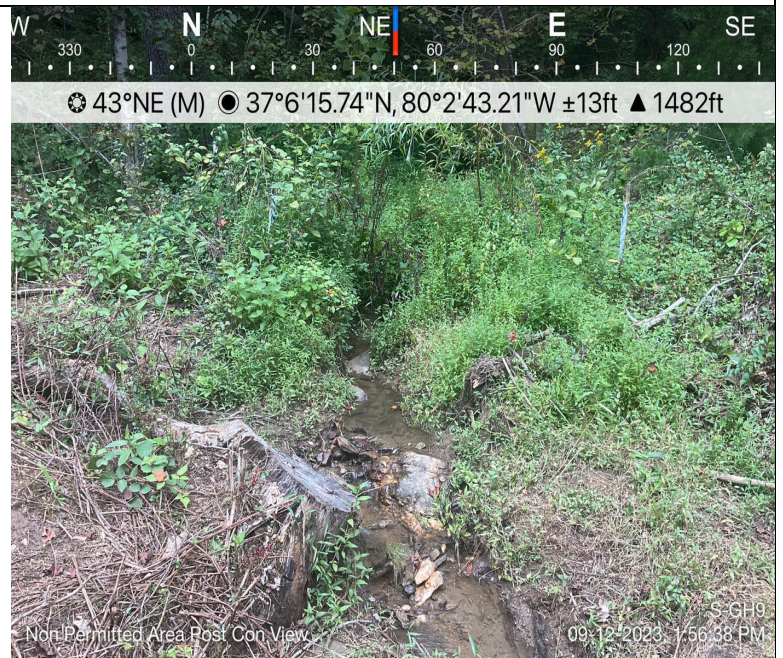
Photo Description: Conditions of the downstream area outside the ROW during post-construction assessment.

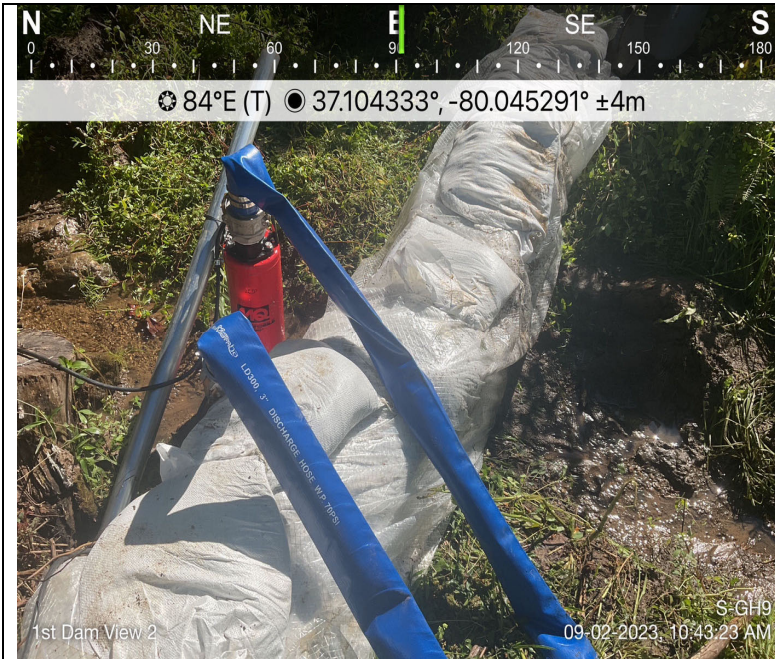
Photo Description: Upstream dam placed in stream.

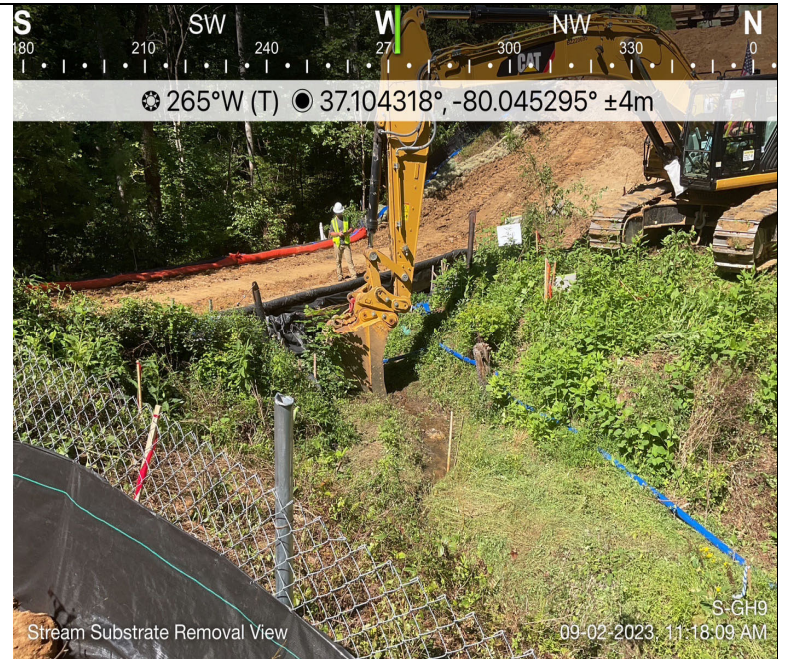
9/2/2023: Stream substrate was removed and contained with separation from trench spoils of GH9. -A. Burge

Photo Description: Stream substrate removal and segregated away from trench materials.

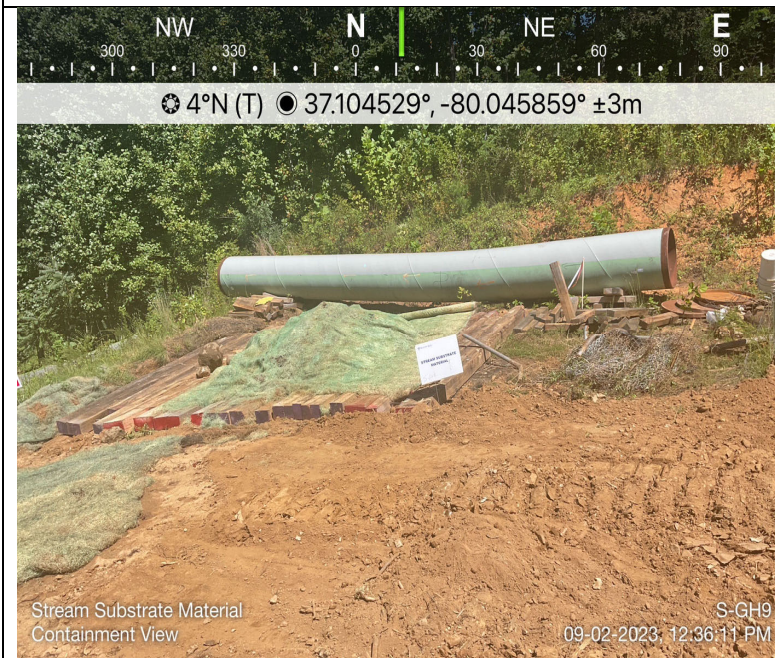
Photo Description: Stream substrate material contained with straw matting to prevent contamination.

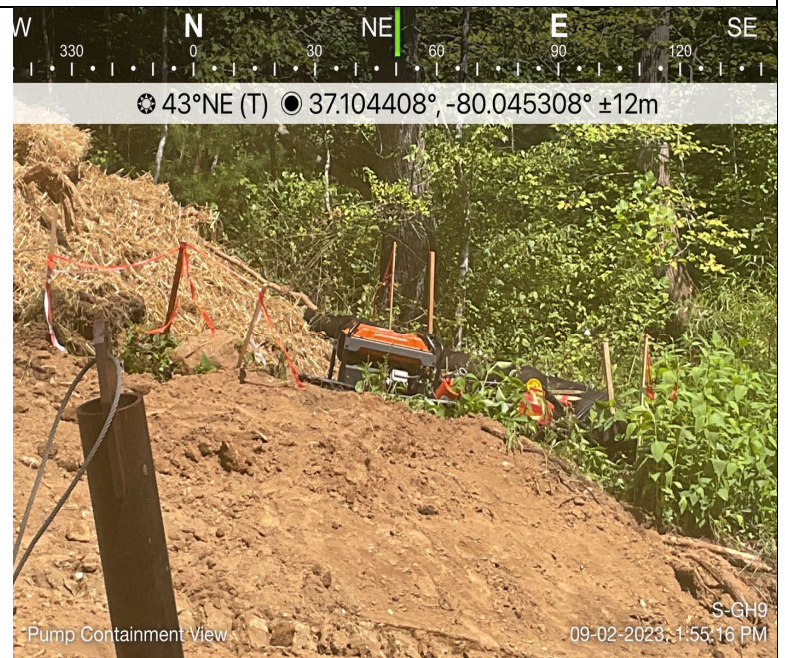
Photo Description: Pump containment structure to contain any potential leaks/spills.
