Stream Biological Conditions EA Report

Project Name	H-600 Pipeline Spread C	AFE	124300131	Spread	H-600 Pipeline Spread C
Contractor	Precision	Report #	45		
Environmental Auditor	Kaitie Wilms	Date/Time	8/14/2023 9:59 AM		
Stream ID	S-H117	Crossing Start Date	8/16/2023	Crossing Completion Date	8/17/2023
Milepost	76.84	Pre-Con Assessment Date	8/14/2023	Post-Con Assessment Date	8/17/2023
Station	4057+15	Bankfull Width (ft.)	17.7	Riffle:Pool Complexes Present?	No
State	WV	Stream Classification	Perennial		
County	Braxton	303(d) Impairment Listing	No

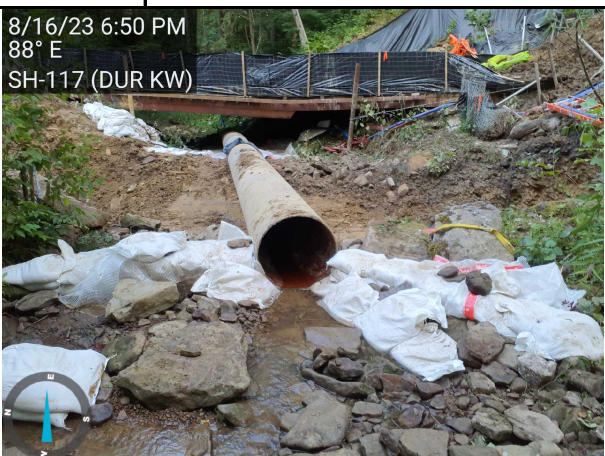
GPS Location	38.731008, -80.506082	GPS Location	38.731136, -80.506412
Description	Downstream view of the impacted area during construction with the flume in place.	Description	Downstream view of the unimpacted area during construction.
<p>8/18/23 8:56 AM 105° E SH-117 (POST KW)</p>

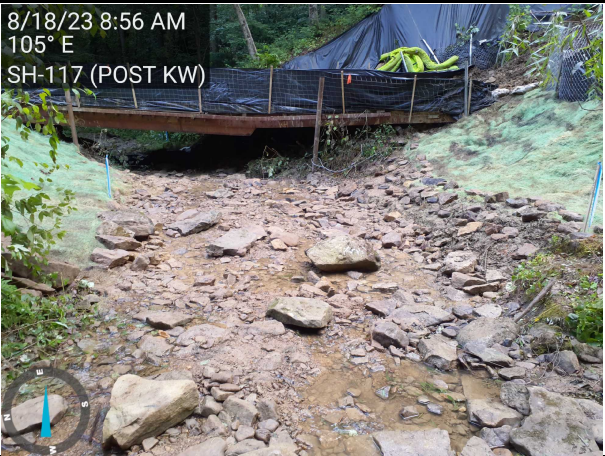
GPS Location	38.731031, -80.506335	GPS Location	38.731114, -80.505684
Description	Downstream view of permitted impact area one day post construction.	Description	Downstream view of unimpacted area one day post construction.
