Stream Biological Conditions EA Report

Project Name	H-600 Pipeline Spread C	AFE	124300131	Spread	H-600 Pipeline Spread C
Contractor	Precision	Report #	188		
Environmental Auditor	Alex Miller	Date/Time	8/15/2023 8:30 AM		
Stream ID	S-H123s	Crossing Start Date	8/15/2023	Crossing Completion Date	8/19/2023
Milepost	74.21	Pre-Con Assessment Date	8/11/2023	Post-Con Assessment Date	8/21/2023
Station	3918+49	Bankfull Width (ft.)	9.1	Riffle:Pool Complexes Present?	No
State	WV	Stream Classification	Perennial		
County	Braxton	303(d) Impairment Listing	No

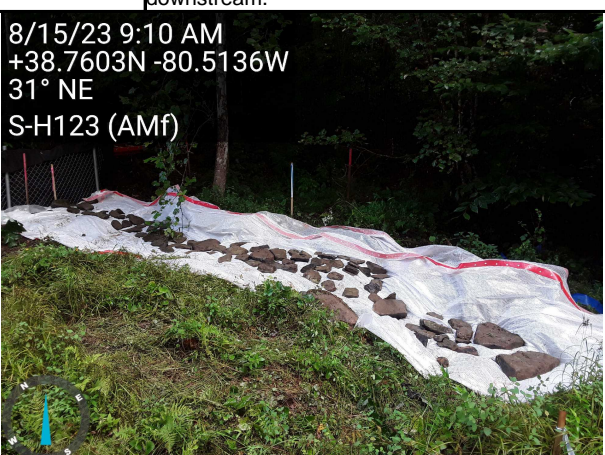
<p>8/15/23 9:10 AM +38.7603N -80.5136W 31° NE S-H123 (AMf)</p>

<p>8/15/23 9:49 AM +38.7605N -80.5137W 285° W S-H123 (AMf)</p>  			
GPS Location See photo		GPS Location See photo			
Description Rocks cobble sized or larger segregated from stream substrate and laid out in order from upstream (left) to downstream (right)		Description View from downstream of streambed after top 12" of substrate were removed and segregated.
