Stream Biological Conditions EA Report

Project Name	H-600 Pipeline Spread B	AFE	124300130	Spread	H-600 Pipeline Spread B
Contractor	Precision	Report #	160		
Environmental Auditor	Devin Jen	Date/Time	8/20/2023 8:54 AM		
Stream ID	S-H145	Crossing Start Date	8/20/2023	Crossing Completion Date	8/26/2023
Milepost	60.06	Pre-Con Assessment Date	8/20/2023	Post-Con Assessment Date	8/26/2023
Station	3171+03.72	Bankfull Width (ft.)	15.0	Riffle:Pool Complexes Present?	No
State	WV	Stream Classification	Perennial		
County	Lewis	303(d) Impairment Listing	No

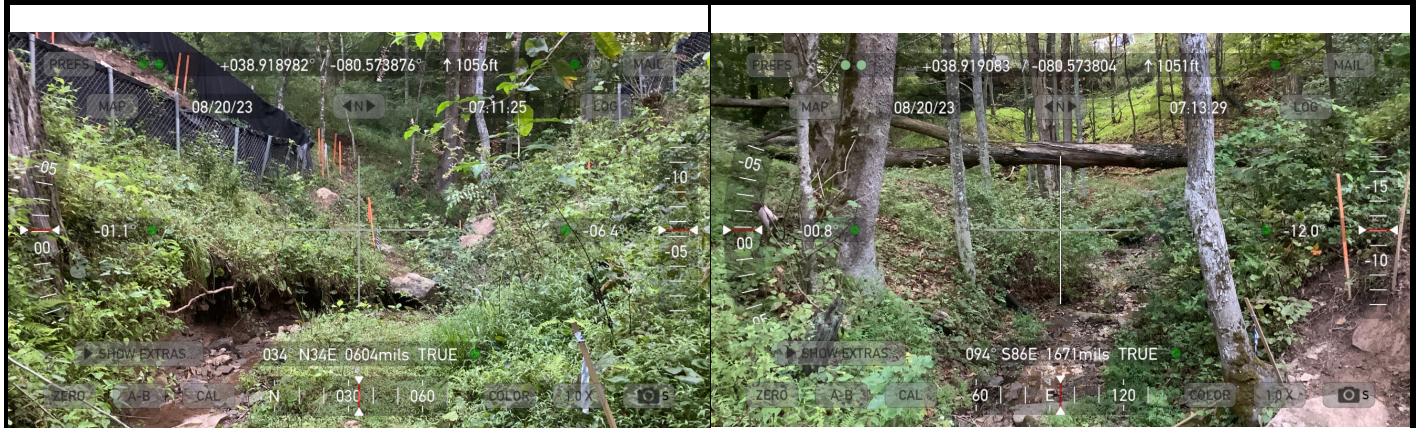
GPS Location	See photograph.	GPS Location	See photograph.
Description	Downstream view of permitted impact area during pre-construction assessment.	Description	Downstream view of unimpacted area during pre-construction assessment.

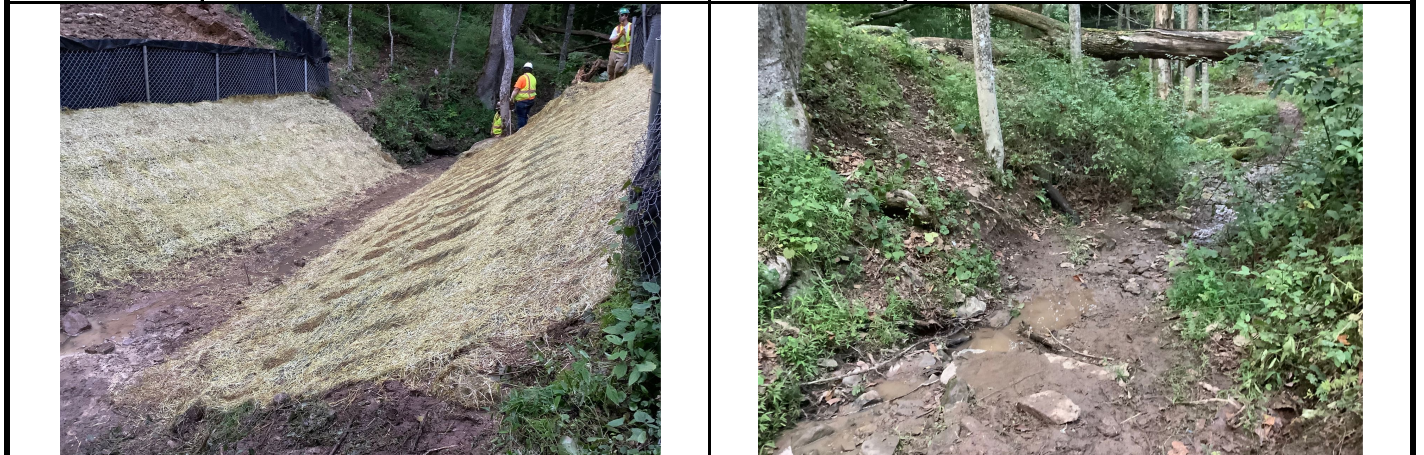
GPS Location	See photograph.	GPS Location	See photograph.
Description	Downstream view of permitted impact area during post-construction assessment.	Description	Downstream view of unimpacted area during post-construction assessment.

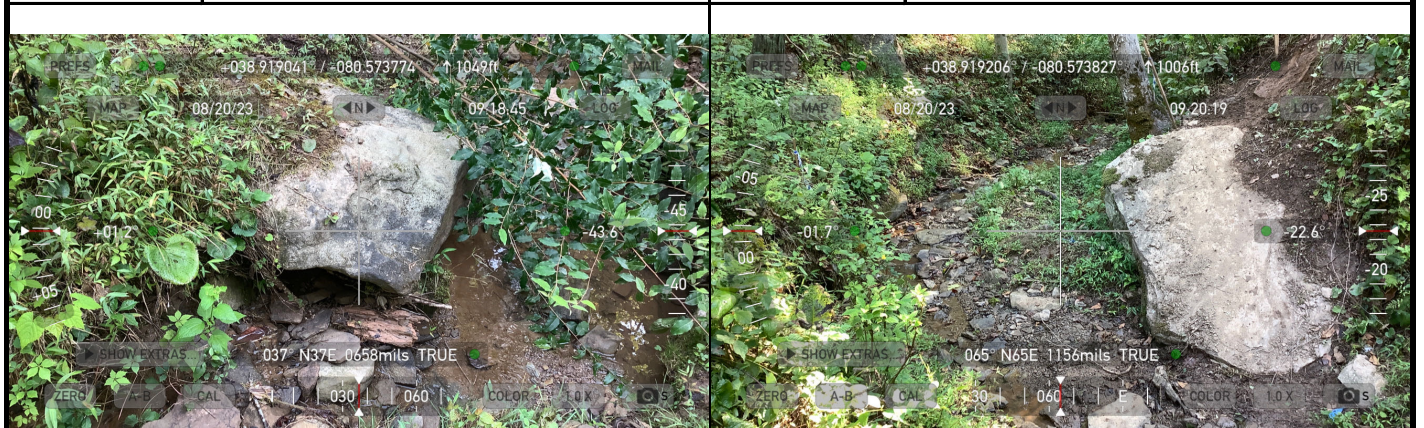
GPS Location	See photograph.	GPS Location	See photograph.
Description	The pictured boulder will not be placed in the exact same spot in order to ensure proper stabilization of slopes and overall restoration efforts.	Description	The photo shows a large feature rock near the edge of the LOD.
