Stream Biological Conditions EA Report

Project Name	H-600 Pipeline Spread E	AFE	124300134	Spread	H-600 Pipeline Spread E
Contractor	Price Gregory	Report #	207		
Environmental Auditor	Dan Miller	Date/Time	8/24/2023 10:22 AM		
Stream ID	S-H64	Crossing Start Date	8/26/2023	Crossing Completion Date	9/9/2023
Milepost	132.28	Pre-Con Assessment Date	8/24/2023	Post-Con Assessment Date	9/9/2023
Station	6984+45	Bankfull Width (ft.)	4.7	Riffle:Pool Complexes Present?	No
State	WV	Stream Classification	Intermittent		
County	Nicholas	303(d) Impairment Listing	No

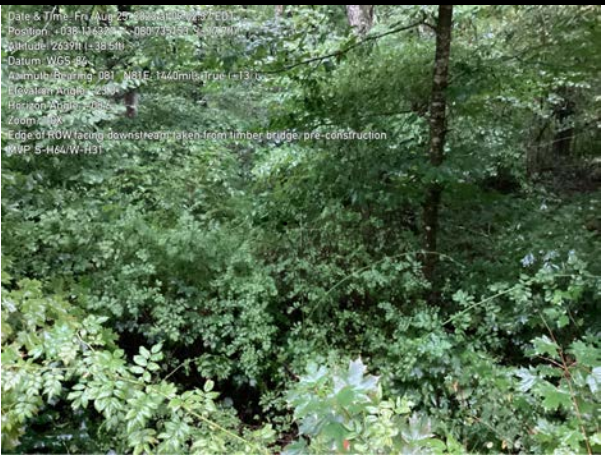
<p>Date & Time: Fri, Aug 25, 2023 at 10:25:07 EDT Position: +038.116271° N / -080.735377° W (-23.3in) Altitude: 2639ft (+38.5ft) Datum: WGS 84 Azimuth/Bearing: 081° N81E 1224mils True (+13) Elevation Angle: +31.0° Horizon Angle: -00.3° Zoom: 1.0X Edge of ROW being downstepped back from timber bridge pre-construction MVP S-H64/W-H31</p>		GPS Location		GPS Location	
Description		Description		Description		Description	
Downstream view of permitted impact area during pre-construction assessment.		Downstream view of unimpacted area during pre-construction assessment.		Downstream view of permitted impact area during post-construction assessment.		Downstream view of unimpacted area during post-construction assessment.

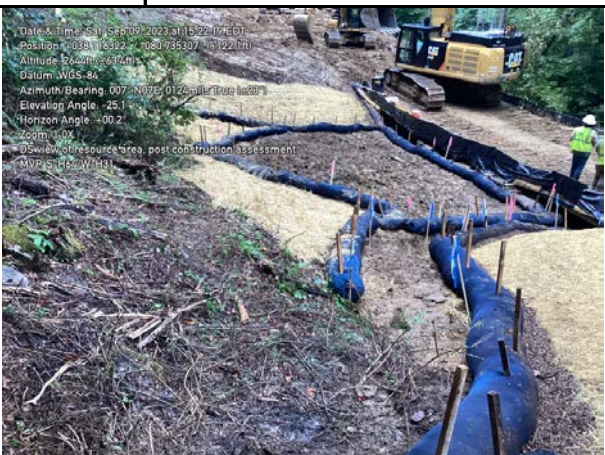
<p>Date & Time: Sat, Sep 09, 2023 at 10:22:07 EDT Position: +038.116316° N / -080.735209° W (-23.3in) Altitude: 2625ft (+38.5ft) Datum: WGS 84 Azimuth/Bearing: 007° N07E 0126mils True (+8) Elevation Angle: -25.1° Horizon Angle: -00.2° Zoom: 1.0X DS view of resource area, post construction assessment MVP S-H64/W-H31</p>

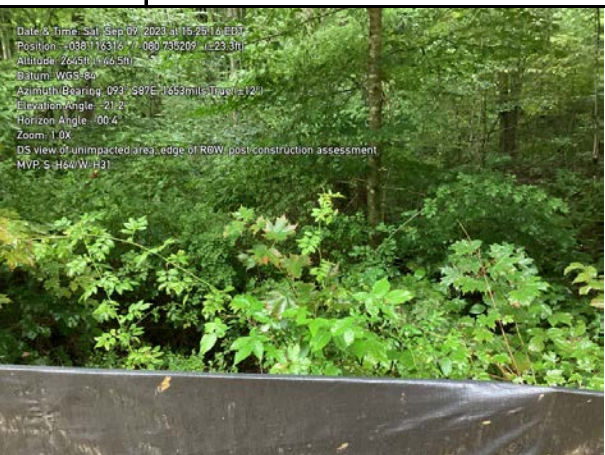
<p>Date & Time: Sat, Sep 09, 2023 at 10:22:07 EDT Position: +038.116316° N / -080.735209° W (-23.3in) Altitude: 2625ft (+38.5ft) Datum: WGS 84 Azimuth/Bearing: 093° S97E 1653mils True (+12) Elevation Angle: -21.2° Horizon Angle: -00.4° Zoom: 1.0X DS view of unimpacted area, edge of ROW post construction assessment MVP S-H64/W-H31</p>		GPS Location		GPS Location	
Description		Description		Description		Description	
Downstream view of permitted impact area during post-construction assessment.		Downstream view of unimpacted area during post-construction assessment.		Downstream view of permitted impact area during post-construction assessment.		Downstream view of unimpacted area during post-construction assessment.

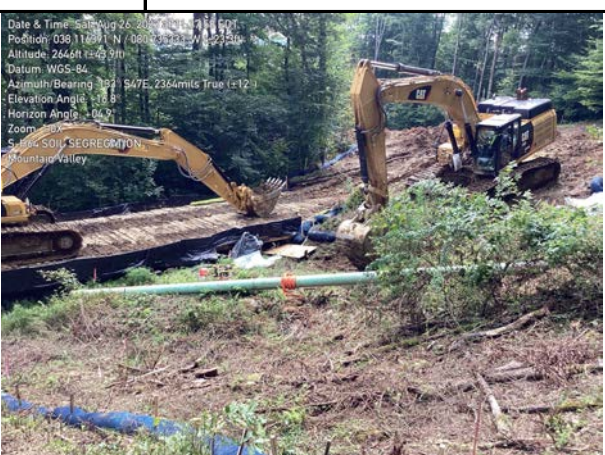
<p>Date & Time: Sat, Aug 26, 2023 at 14:21:07 EDT Position: +038.117071° N / -080.735116° W (-20.4in) Altitude: 2628ft (+67.2ft) Datum: WGS 84 Azimuth/Bearing: 163° S17E 2364mils True (+12) Elevation Angle: +16.8° Horizon Angle: -04.2° Zoom: 1.0X S-H64 TOPSOIL SEGREGATION Mountain Valley</p>

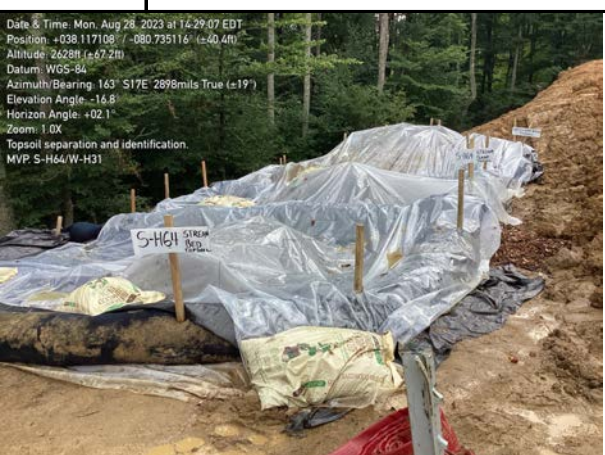
<p>Date & Time: Mon, Aug 28, 2023 at 14:29:07 EDT Position: +038.117108° N / -080.735116° W (-20.4in) Altitude: 2628ft (+67.2ft) Datum: WGS 84 Azimuth/Bearing: 163° S17E 2898mils True (+19) Elevation Angle: -16.8° Horizon Angle: +02.1° Zoom: 1.0X Topsoil separation and identification. MVP S-H64/W-H31</p>		GPS Location		GPS Location	
Description		Description		Description		Description	
Photo 1: Removal of stream substrate in S-H64.		Photo 2: Stream Substrate segregated.		See Photo		See Photo

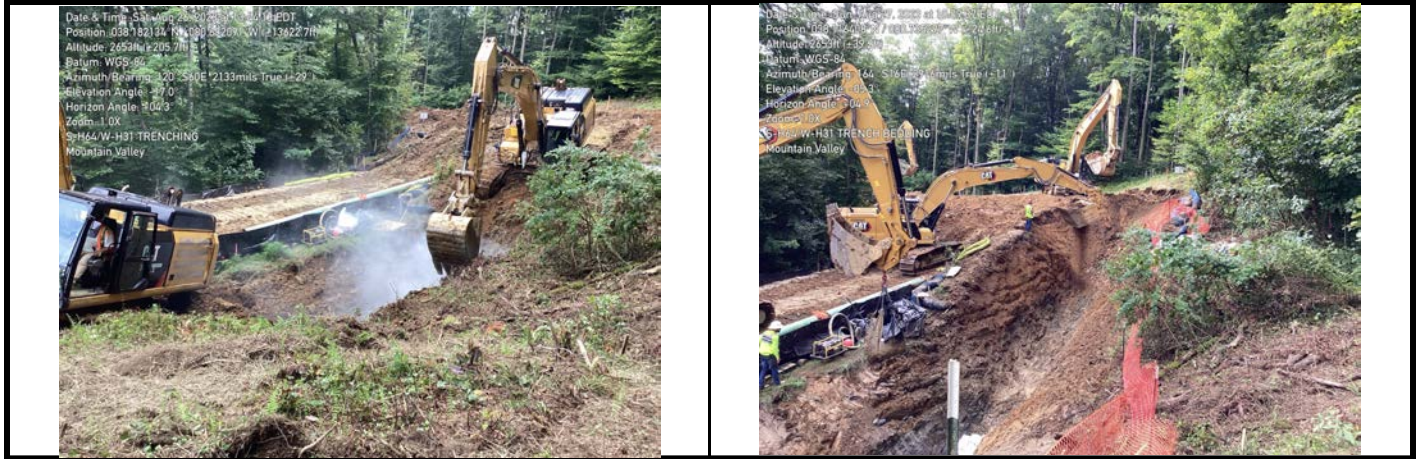
GPS Location See Photo	GPS Location See Photo
Description Photo 3: Trenching through wetland and stream.	Description Photo 4: Lowering bedding into trench to prepare for pipe.

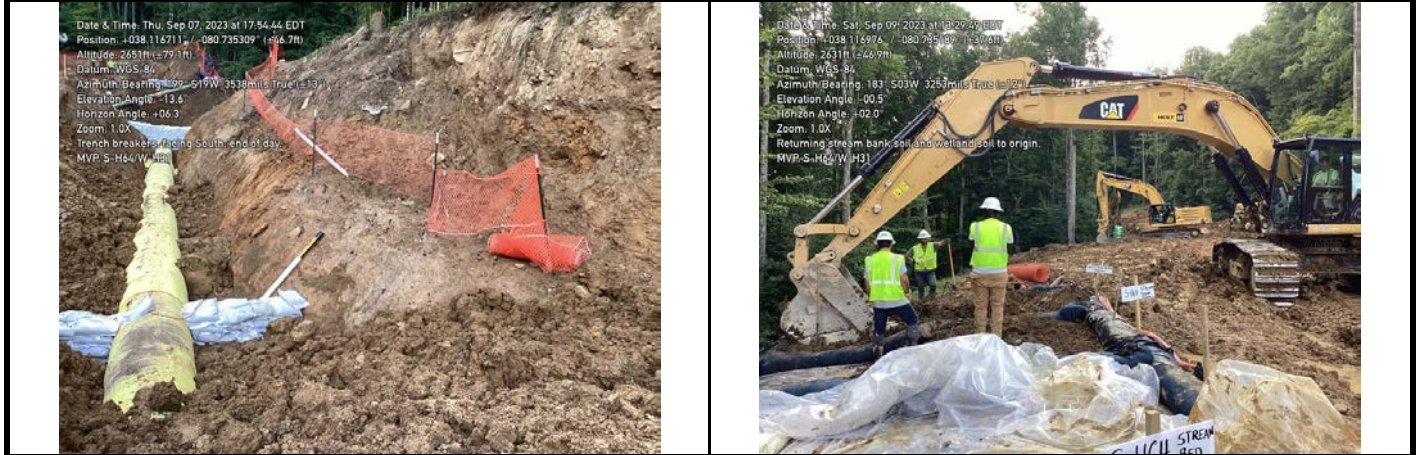
GPS Location See Photo	GPS Location See Photo
Description Photo 5: Trench breaks in place around resource (in background).	Description Photo 6: Remove segregated material.

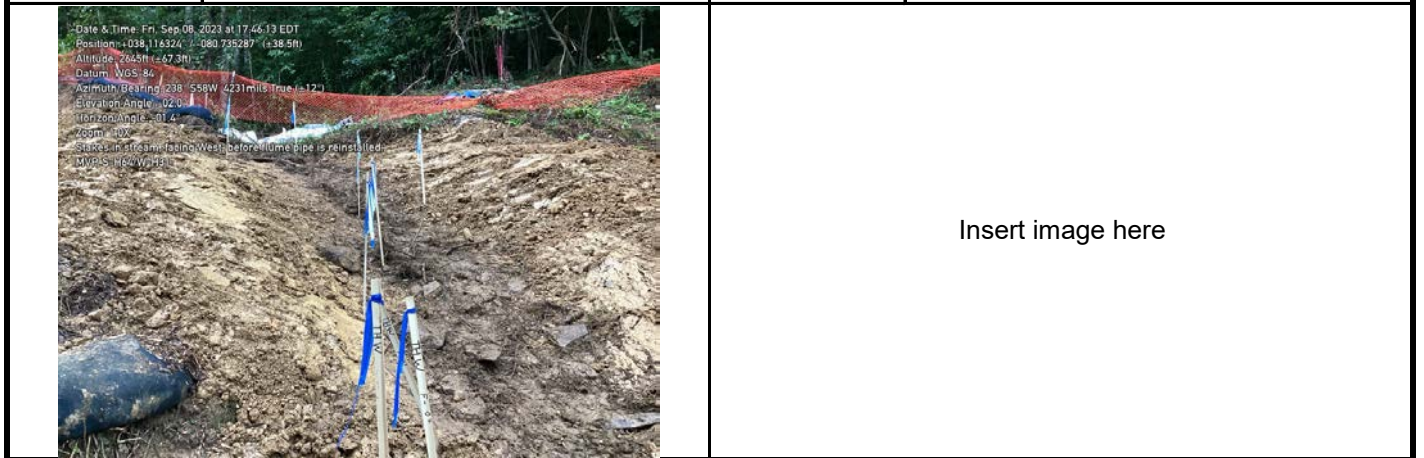
GPS Location See Photo	GPS Location
Description Photo 7: Stream staked by Survey Crew.	Description
