# Stream Biological Conditions EA Report

<b>Project Name</b>	H-600 Pipeline Spread E	<b>AFE</b>	124300134	<b>Spread</b>	H-600 Pipeline Spread E
<b>Contractor</b>	Price Gregory	<b>Report #</b>	39		
<b>Environmental Auditor</b>	Allyson Kincaid	<b>Date/Time</b>	8/15/2023 9:28 AM		
<b>Stream ID</b>	S-H88	<b>Crossing Start Date</b>	8/16/2023	<b>Crossing Completion Date</b>	8/28/2023
<b>Milepost</b>	130.36	<b>Pre-Con Assessment Date</b>	8/15/2023	<b>Post-Con Assessment Date</b>	8/28/2023
<b>Station</b>	6883+01	<b>Bankfull Width (ft.)</b>	17.0	<b>Riffle:Pool Complexes Present?</b>	No
<b>State</b>	WV	<b>Stream Classification</b>	Perennial		
<b>County</b>	Nicholas	<b>303(d) Impairment Listing</b>	None

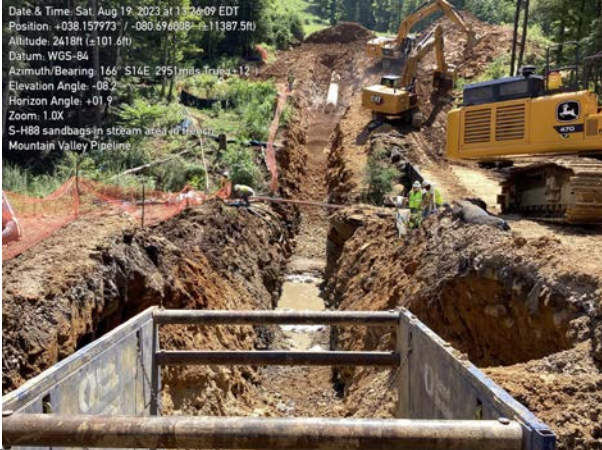
<p><small>Date &amp; Time: Sat, Aug 19, 2023 at 13:26:09 EDT Position: +038.157973 / -080.694988 (-11387.5ft) Altitude: 2418ft (+101.6ft) Datum: WGS-84 Azimuth/Bearing: 166.514E 2951mils True (+12) Elevation Angle: -08.7 Horizon Angle: +01.9 Zoom: 1.0X S-H88 sandbagging stream area of RDB Mountain Valley Pipeline</small></p>

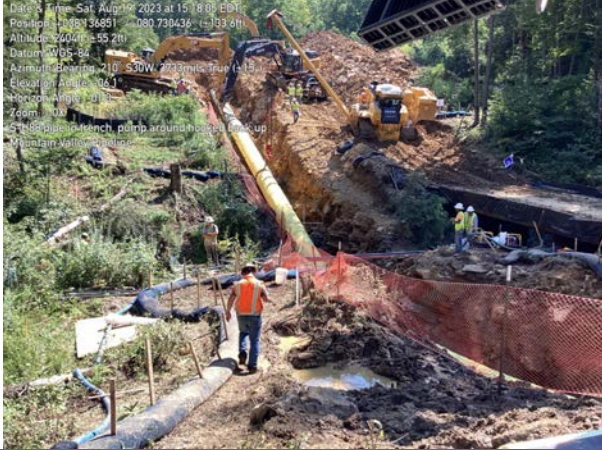
<p><small>Date &amp; Time: Sat, Aug 19, 2023 at 15:18:01 EDT Position: +038.136951 / -080.730436 (-1133.6ft) Altitude: 2204ft (+85.2ft) Datum: WGS-84 Azimuth/Bearing: 210.530W 270mils True (+15) Elevation Angle: -08.1 Horizon Angle: +01.5 Zoom: 1.0X S-H88 sandbagging pump around the pipe to set up Mountain Valley Pipeline</small></p>
<b>GPS Location</b> See Photo	<b>GPS Location</b> See Photo
<b>Description</b> Photo 3. Trench through stream OHRM.	<b>Description</b> Photo 4. Pipe being placed into trench.

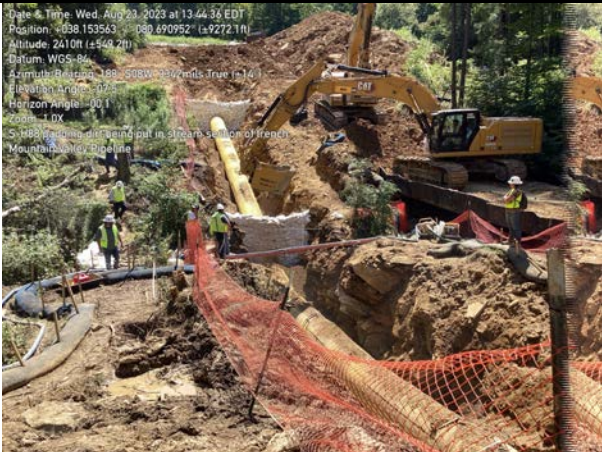
<p><small>Date &amp; Time: Wed, Aug 23, 2023 at 13:44:36 EDT Position: +038.153563 / -080.690752 (+9272.1ft) Altitude: 2410ft (+84.7ft) Datum: WGS-84 Azimuth/Bearing: 166.508W 293mils True (+14) Elevation Angle: -08.2 Horizon Angle: +01.1 Zoom: 1.0X S-H88 trench breaks put in stream section of trench Mountain Valley Pipeline</small></p>

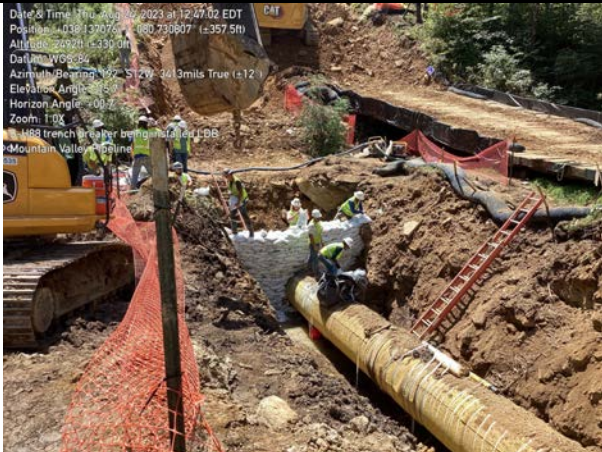
<p><small>Date &amp; Time: Thu, Aug 24, 2023 at 12:27:02 EDT Position: +038.137076 / -080.730507 (-1357.5ft) Altitude: 2252ft (+83.0ft) Datum: WGS-84 Azimuth/Bearing: 172.512W 343mils True (+12) Elevation Angle: -08.3 Horizon Angle: +01.3 Zoom: 1.0X S-H88 trench breaks being installed LDB Mountain Valley Pipeline</small></p>

<b>GPS Location</b> See Photo	<b>GPS Location</b> See Photo
<b>Description</b> Photo 5. Trench breaks installed on RDB.	<b>Description</b> Photo 6. Streambed portion of trench backfilled, trench breakers on LDB.

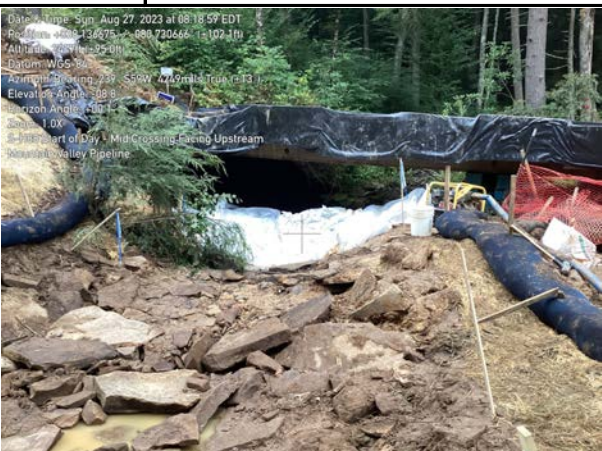
<p><small>Date &amp; Time: Sun, Aug 27, 2023 at 08:18:59 EDT Position: +038.136751 / -080.730566 (-1102.1ft) Altitude: 2295ft (+89.0ft) Datum: WGS-84 Azimuth/Bearing: 236.556W 244mils True (+13) Elevation Angle: -08.8 Horizon Angle: +01.3 Zoom: 1.0X S-H88 part of Day 1 Mid-Crossing Excavation Upstream Mountain Valley Pipeline</small></p>

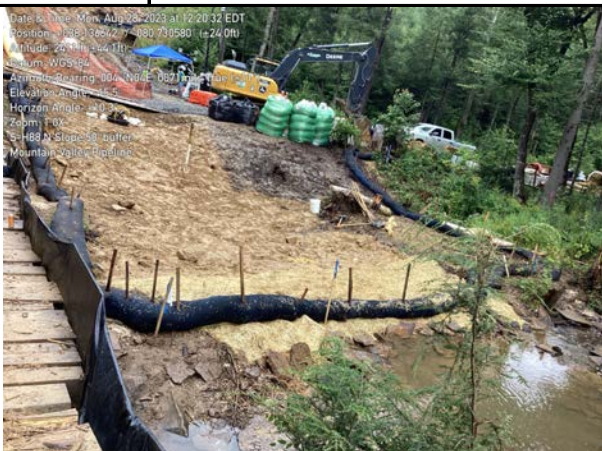
<p><small>Date &amp; Time: Mon, Aug 28, 2023 at 12:20:32 EDT Position: +038.136527 / -080.730580 (-124.0ft) Altitude: 2305ft (+92.1ft) Datum: WGS-84 Azimuth/Bearing: 094.694E 102mils True (+15) Elevation Angle: -8.5 Horizon Angle: +01.3 Zoom: 1.0X S-H88 Slope 36 buffer Mountain Valley Pipeline</small></p>
<b>GPS Location</b> See Photo	<b>GPS Location</b> See Photo

<b>Description</b> Photo 7. Streambed substrate restored.	<b>Description</b> Photo 8. Banks seeded and flow restored.
