Stream Biological Conditions EA Report

Project Name	H-600 Pipeline Spread B	AFE	124300130	Spread	H-600 Pipeline Spread B
Contractor	Precision	Report #	212		
Environmental Auditor	Clayton Biden	Date/Time	8/24/2023 1:16 PM		
Stream ID	S-I63	Crossing Start Date	8/24/2023	Crossing Completion Date	8/31/2023
Milepost	55.28	Pre-Con Assessment Date	8/24/2023	Post-Con Assessment Date	9/1/2023
Station	2918+65	Bankfull Width (ft.)	20.0	Riffle:Pool Complexes Present?	No
State	WV	Stream Classification	Perennial		
County	Lewis	303(d) Impairment Listing	Biological and Iron

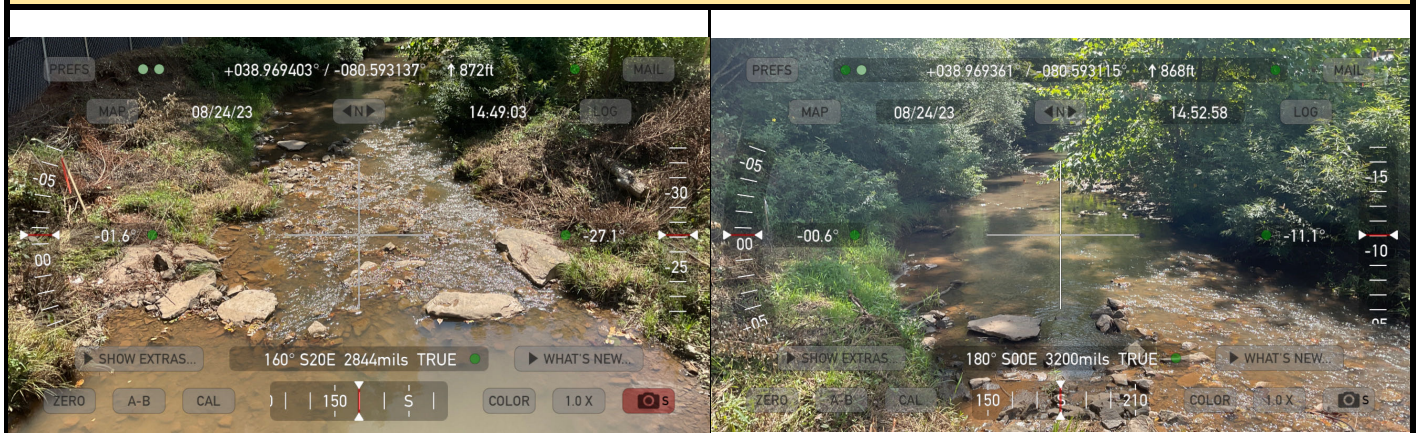
GPS Location	See photo	GPS Location	See photo
Description	Downstream view of permitted impact area during pre-construction assessment.	Description	Downstream view of unimpacted area during pre-construction assessment.

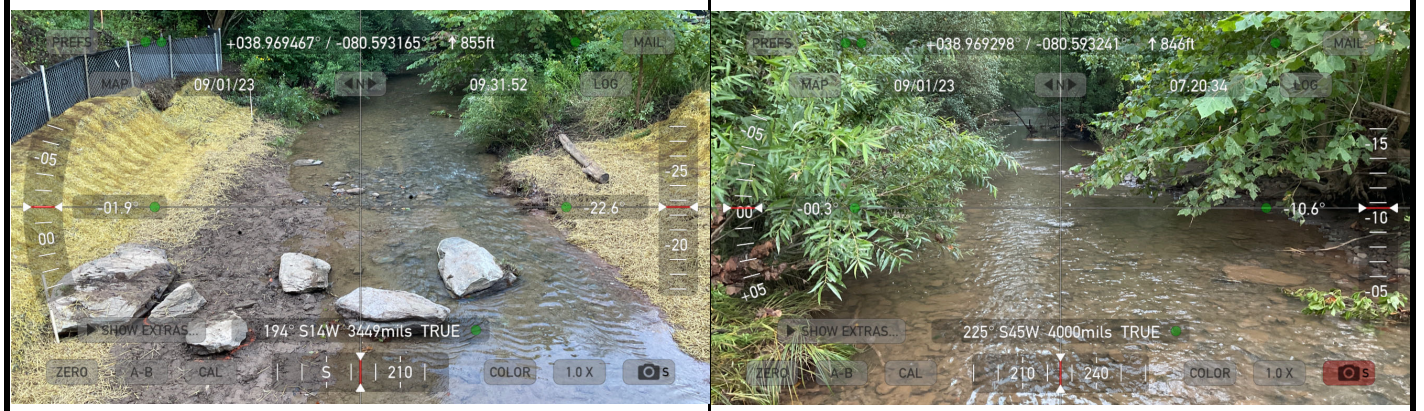
GPS Location	See photo	GPS Location	See photo
Description	Downstream view of permitted impact area during post-construction assessment.	Description	Downstream view of unimpacted area during post-construction assessment.

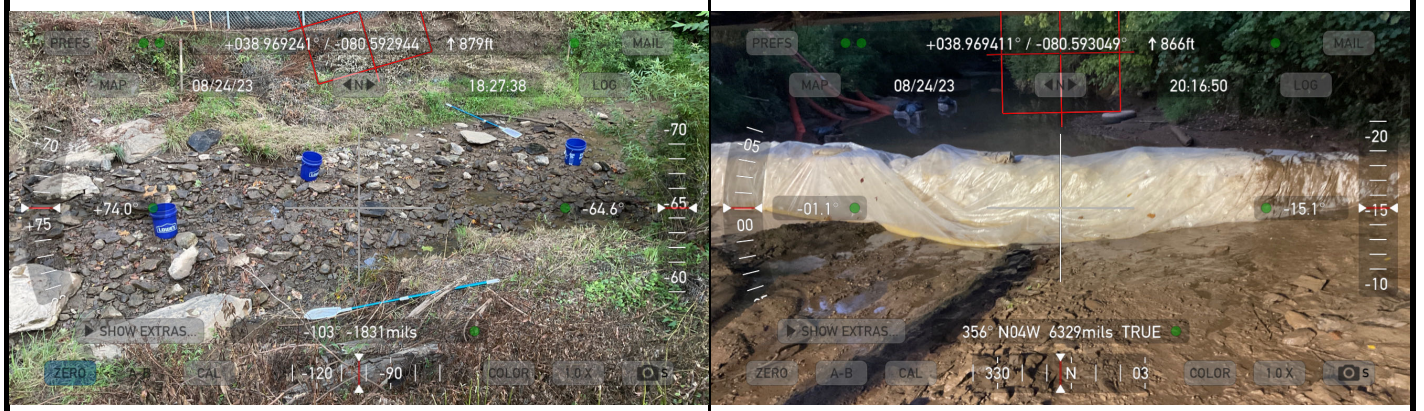
GPS Location	See photo	GPS Location	See photo
Description	In-stream invertebrates and fisheries resources removed from stream crossing area once water was dammed and pumped.	Description	Dam installed upstream using sand bags to prevent flow.

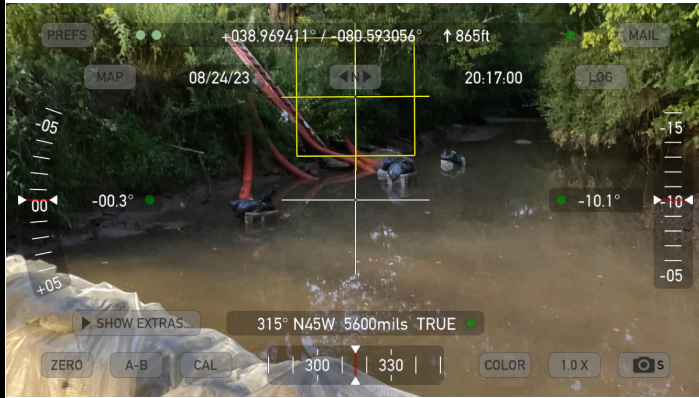
Description Water pumps with protective intake screens at the upstream side of the dam and pump

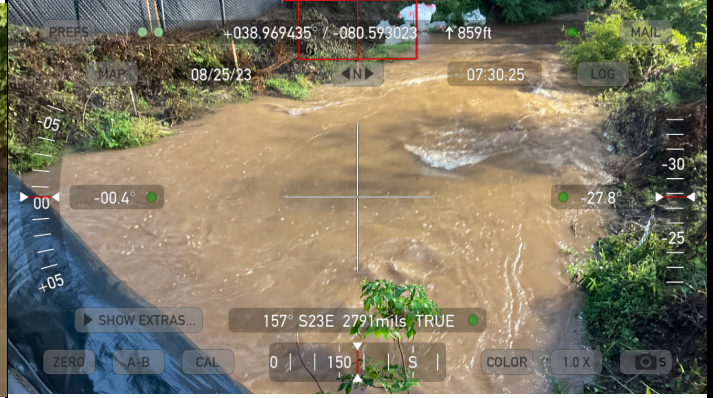
Description First dam overflow occurring on 8/25. Process of pumping out water had to be repeated the following day.

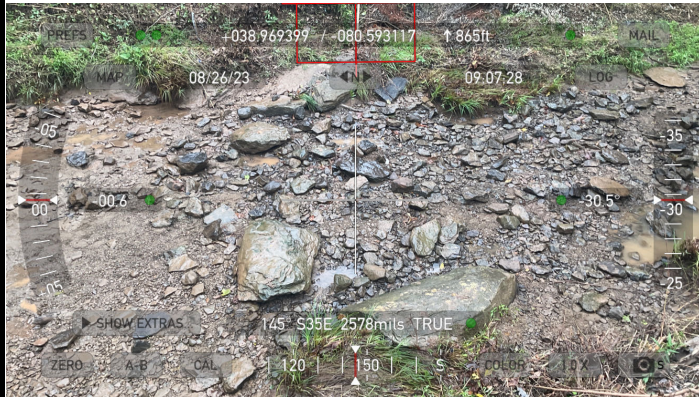
Description This photo shows the dry stream bed prior to substrate removal

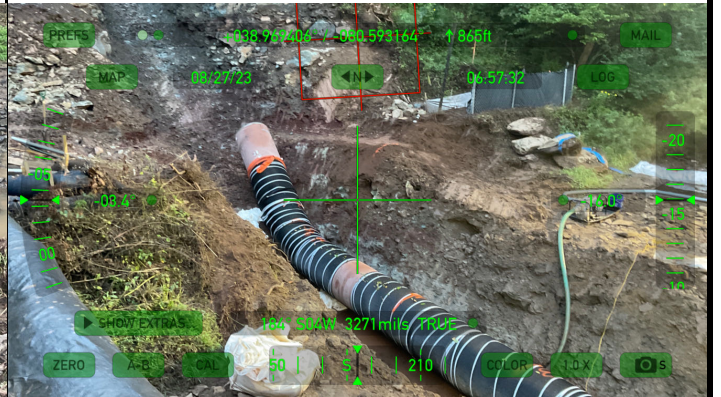
Description This photo shows the pipe installed in the stream crossing

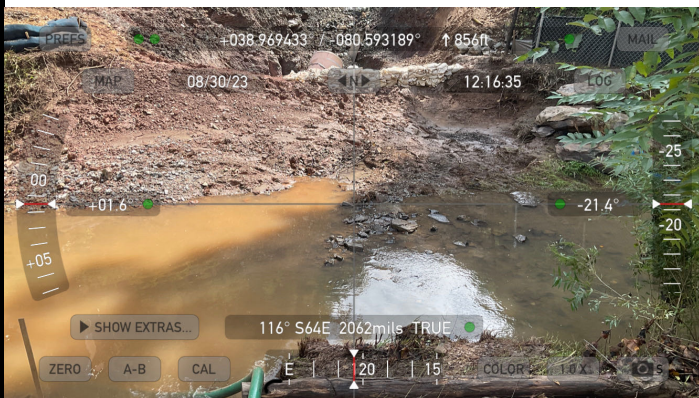
Description isolated trench area on 8/30 after backfill.

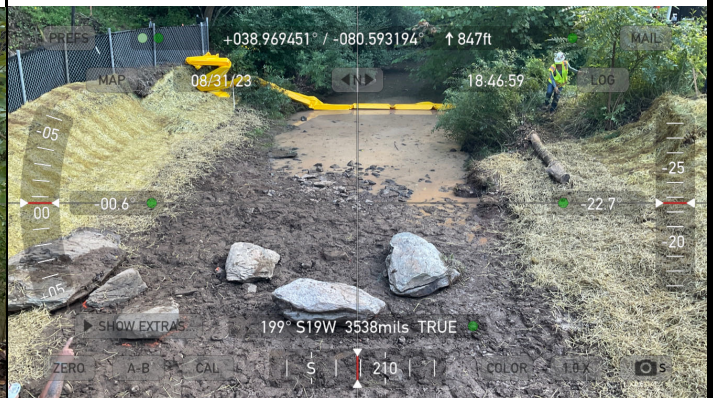
Description Turbidity curtain installed at LOD upon completion of restabilization and restoration on 8/31.
