Stream Biological Conditions EA Report

Project Name	H-600 Pipeline Spread D	AFE	124300132	Spread	H-600 Pipeline Spread D
Contractor	Precision	Report #	216		
Environmental Auditor	Alex Miller	Date/Time	9/6/2023 7:20 AM		
Stream ID	S-IJ57	Crossing Start Date	8/15/2023	Crossing Completion Date	8/27/2023
Milepost	111.59	Pre-Con Assessment Date	8/15/2023	Post-Con Assessment Date	8/27/2023
Station	5891+95	Bankfull Width (ft.)	1.3	Riffle:Pool Complexes Present?	No
State	WV	Stream Classification	Perennial		
County	Nicholas	303(d) Impairment Listing	No

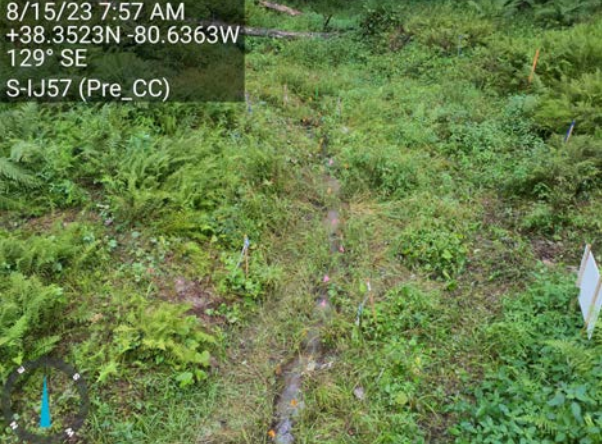
<p>8/15/23 7:57 AM +38.3523N -80.6363W 129° SE S-IJ57 (Pre_CC)</p>

GPS Location	See Photo	GPS Location	38.3519, -80.6360
Description	Downstream view of permitted impact area during pre-construction assessment. Downstream view of S-IJ57 from crossing bridge.	Description	Downstream view of unimpacted area during pre-construction assessment. Downstream view of S-IJ57 (obscured by vegetation) from edge of LOD.
<p>8/27/23 5:09 PM +38.3523N -80.6363W 147° SE S-IJ57 (Post-AMf)</p>

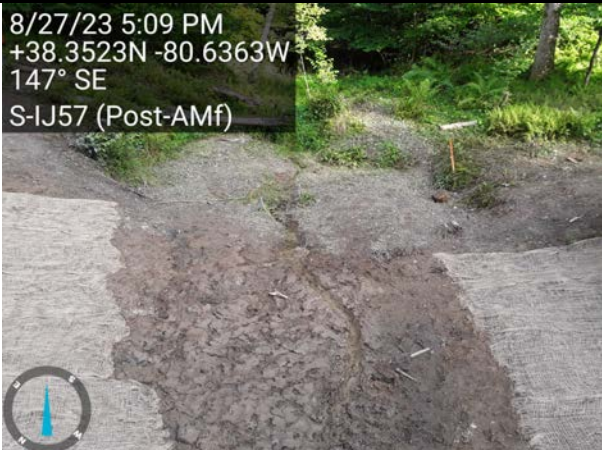
GPS Location	See Photo	GPS Location	See photo
Description	Downstream view of permitted impact area during post-construction assessment. Downstream view of S-IJ57 post construction, taken from crossing bridge.	Description	Downstream view of unimpacted area during post-construction assessment. Downstream view of S-IJ57 (obscured by vegetation) taken from edge of LOD.

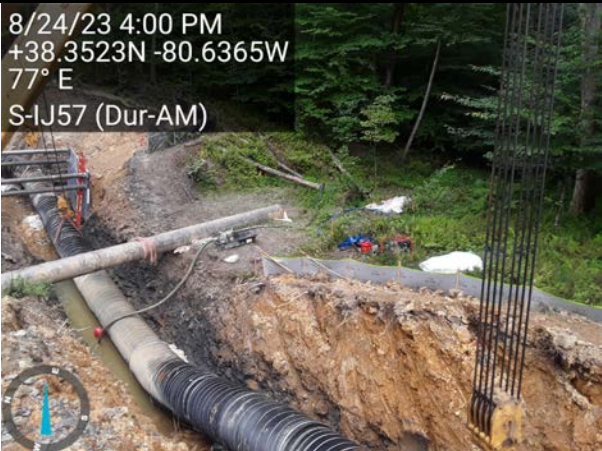
<p>8/24/23 4:00 PM +38.3523N -80.6365W 77° E S-IJ57 (Dur-AM)</p>

GPS Location	See Photo	GPS Location	See Photo
Description	Pipe on 8/24 after welding finished. Trench was being pumped to prepare for padding and stream was running through flume pipe.	Description	Stream and wetland area after grading but prior to replacement of wetland/stream substrate.
