Stream Biological Conditions EA Report

Project Name	H-600 Pipeline Spread A	AFE	124300129	Spread	H-600 Pipeline Spread A
Contractor	Precision	Report #	236		
Environmental Auditor	Devin Jen	Date/Time	9/11/2023 8:54 AM		
Stream ID	S-K77	Crossing Start Date	9/11/2023	Crossing Completion Date	9/16/2023
Milepost	32.41	Pre-Con Assessment Date	9/11/2023	Post-Con Assessment Date	9/16/2023
Station	1711+25	Bankfull Width (ft.)	4.0	Riffle:Pool Complexes Present?	No
State	WV	Stream Classification	Intermittent		
County	Doddridge	303(d) Impairment Listing	No

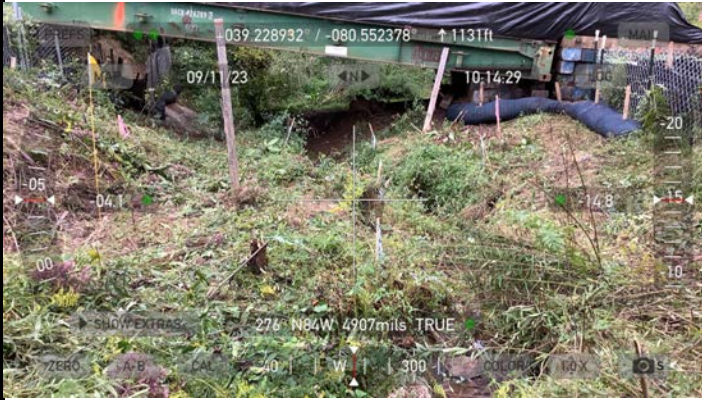
GPS Location	See photograph.		GPS Location	See photograph.	
Description	Downstream view of permitted impact area during pre-construction assessment.		Description	Downstream view of unimpacted area during pre-construction assessment.

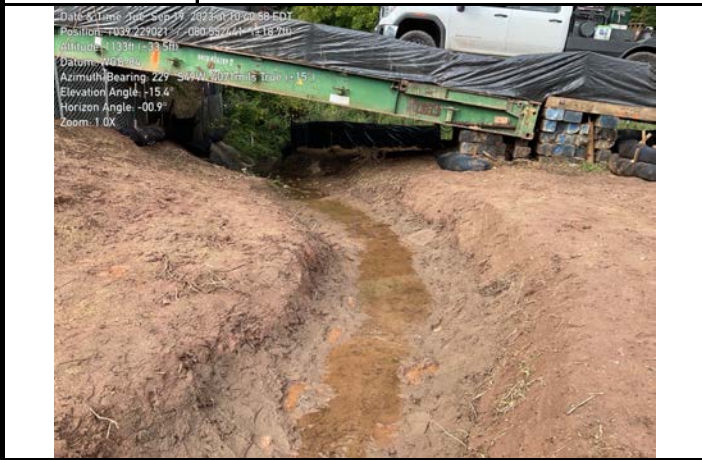
GPS Location	See photograph.		GPS Location	See photograph.	
Description	Downstream view of permitted impact area during post-construction assessment.		Description	Downstream view of unimpacted area during post-construction assessment.

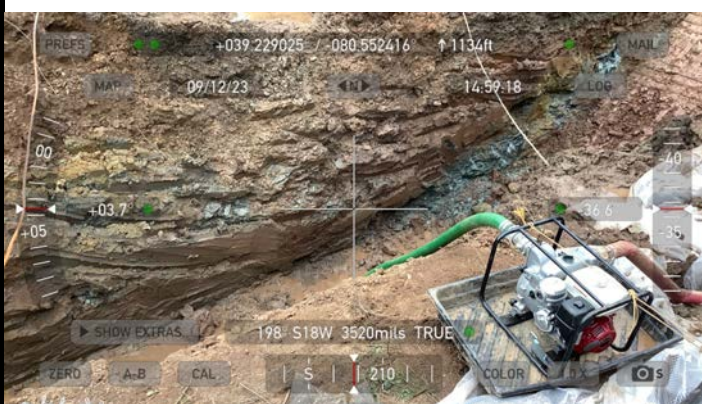
GPS Location	See photograph.		GPS Location	See photograph.	
Description	The photo taken on 9/12/2023 shows the progress of the trench excavation.		Description	The photo shows the pipe and sandbags placed in the area of the stream crossing at the end of the workday on 9/13/2023.

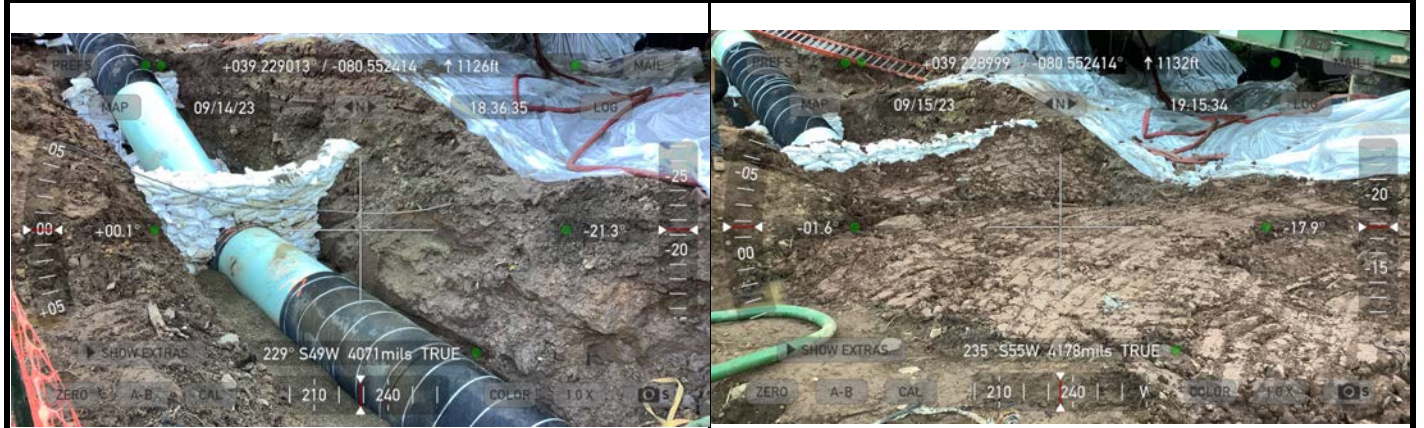
GPS Location	See photograph.	GPS Location	
Description	The photo shows the addition of the trench breaker and pea gravel that were placed on 9/14/2023 in the area of the stream crossing.	Description	The photo shows the progress of backfilling on 9/15/2023.
Insert image here		Insert image here	
GPS Location		GPS Location	
Description		Description	
Insert image here		Insert image here	
GPS Location		GPS Location	
Description		Description
