STREAM BIOLOGICAL CONDITIONS ENVIRONMENTAL AUDITOR REPORT

Stream ID: S-KL38	Crossing Start Date: 09/05/2023	Crossing Completion Date: 09/09/2023
Milepost: 265.1	Pre-Con Assessment Date: 09/01/2023	Post-Con Assessment Date: 09/16/2023
Station: 14009+40	Stream Classification: Perennial (Perennial, Intermittent, Ephemeral)	Bankfull Width (ft.): 7
County: Franklin	303(d) Impairment Listing: Not Impaired	Riffle:Pool Complexes Present? No

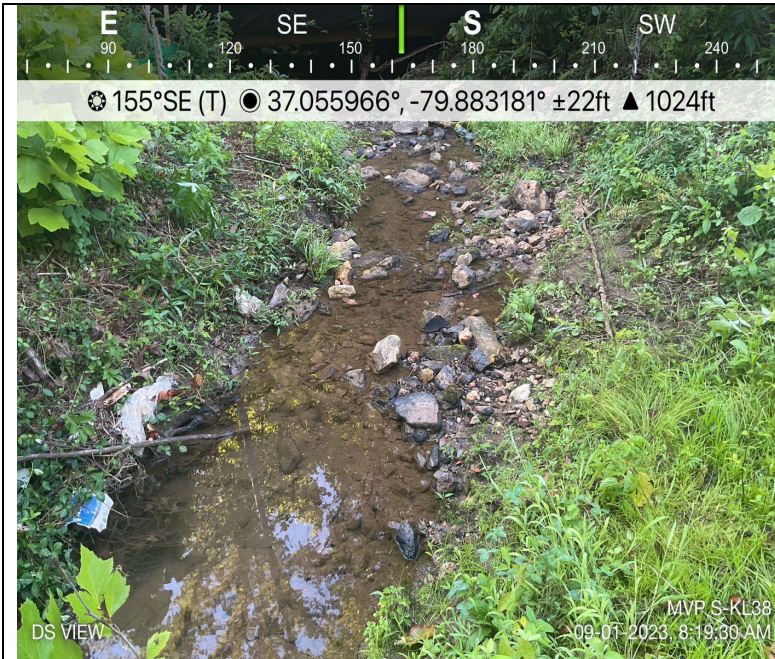
Photo Description: Downstream view of permitted impact area during pre-construction assessment.

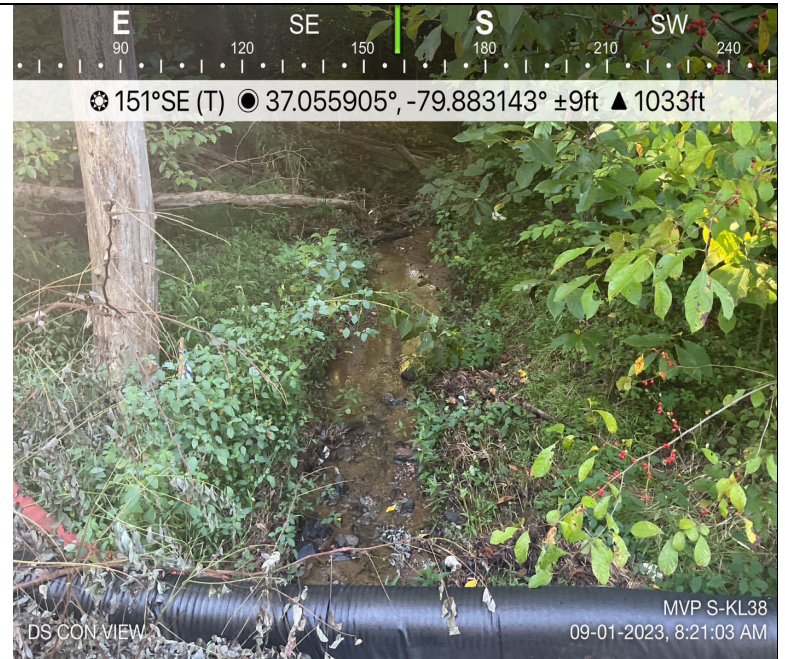
Photo Description: Conditions of the downstream area outside the ROW during pre-construction assessment.

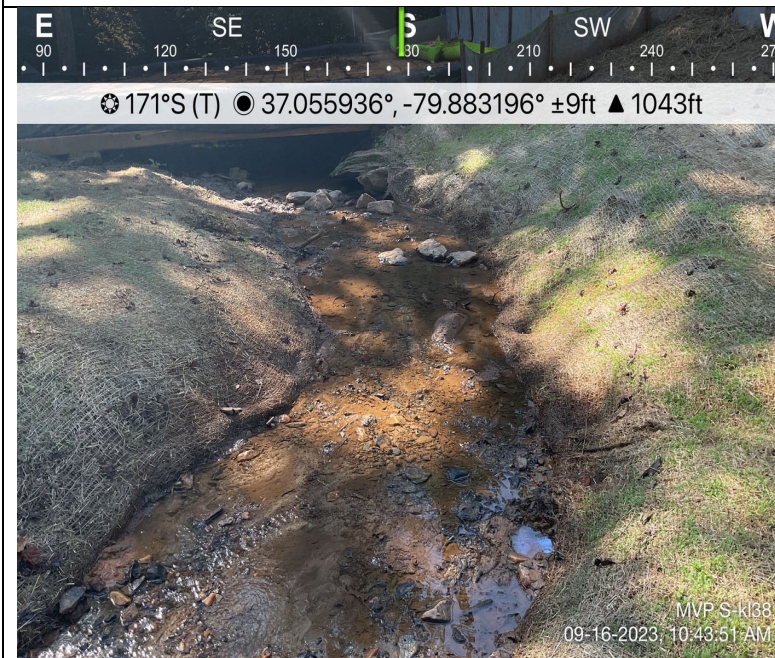
Photo Description: Downstream view of permitted impact area during post-construction assessment.

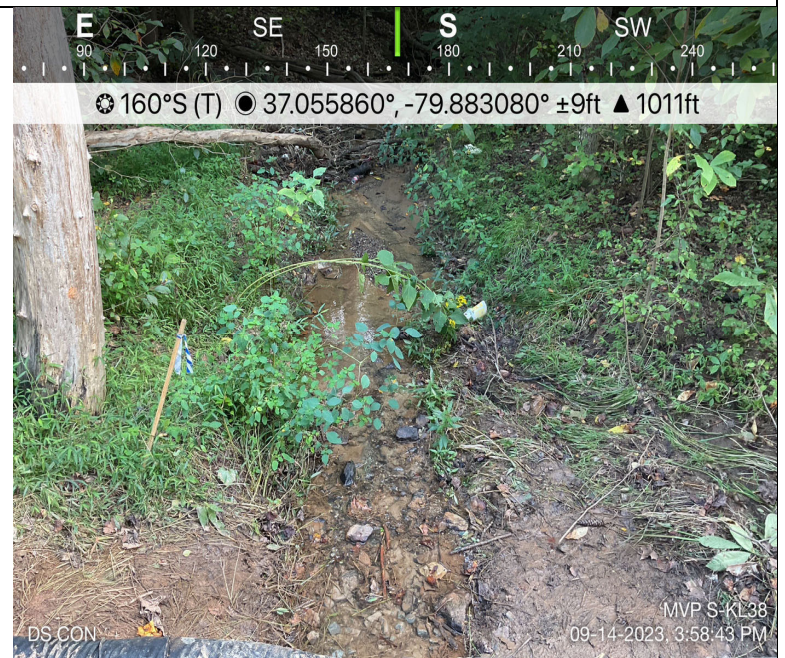
Photo Description: Conditions of the downstream area outside the ROW during post-construction assessment.

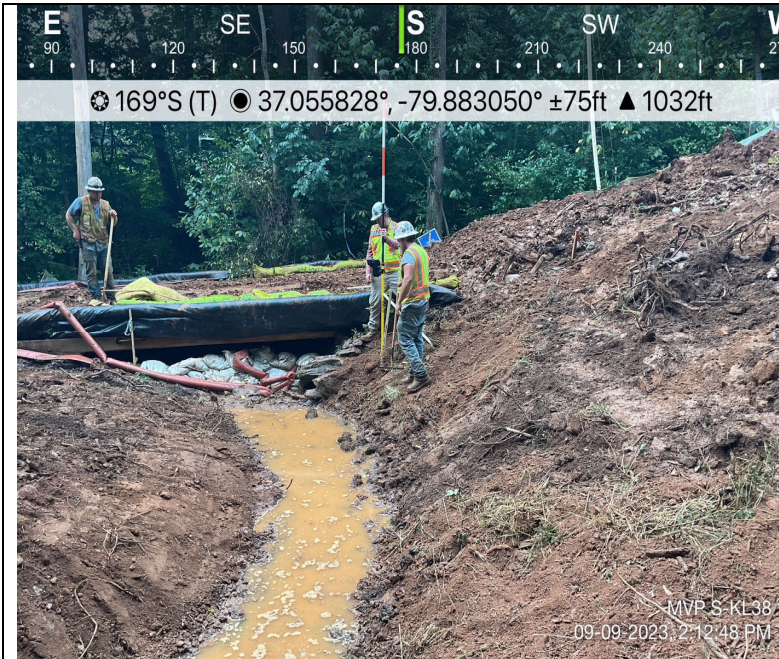
Photo Description: Surveying for reconstruction.

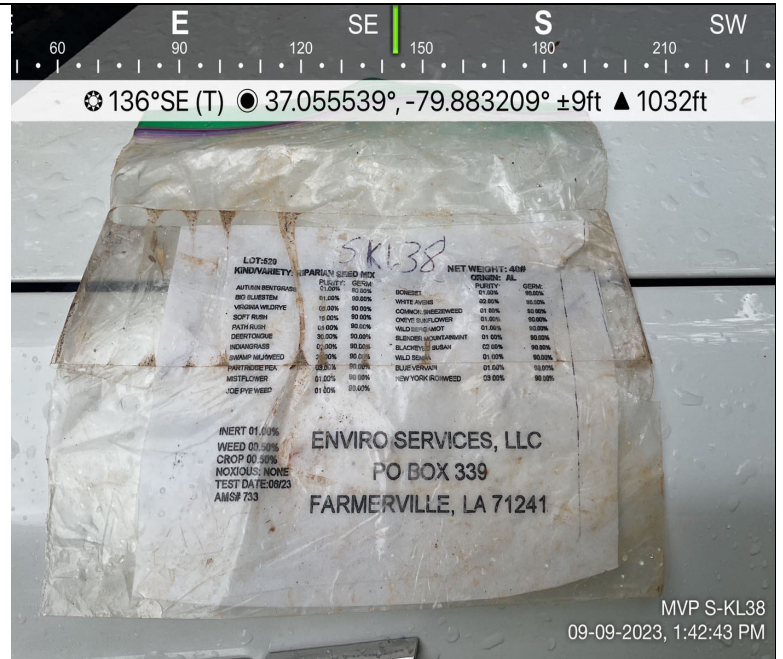
Photo Description: Seeding list.

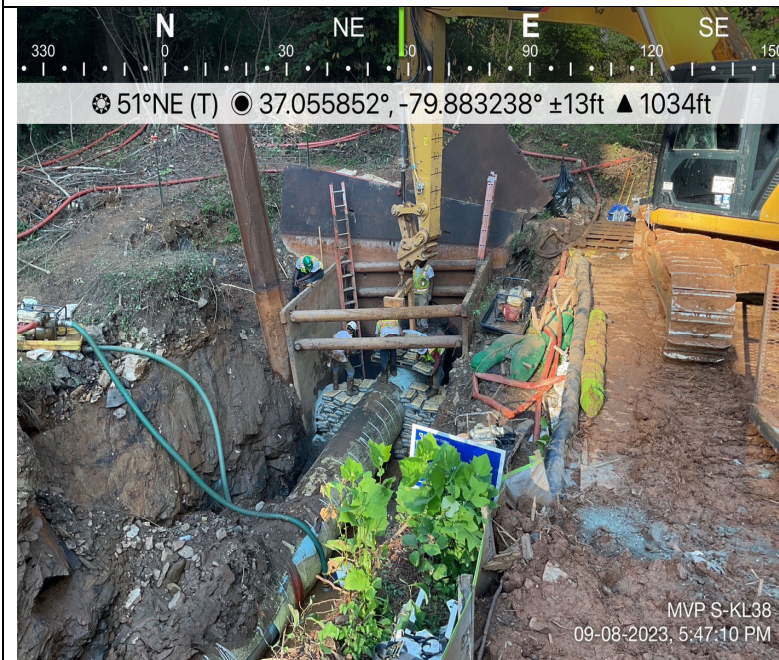
Photo Description: Trench breakers being installed.

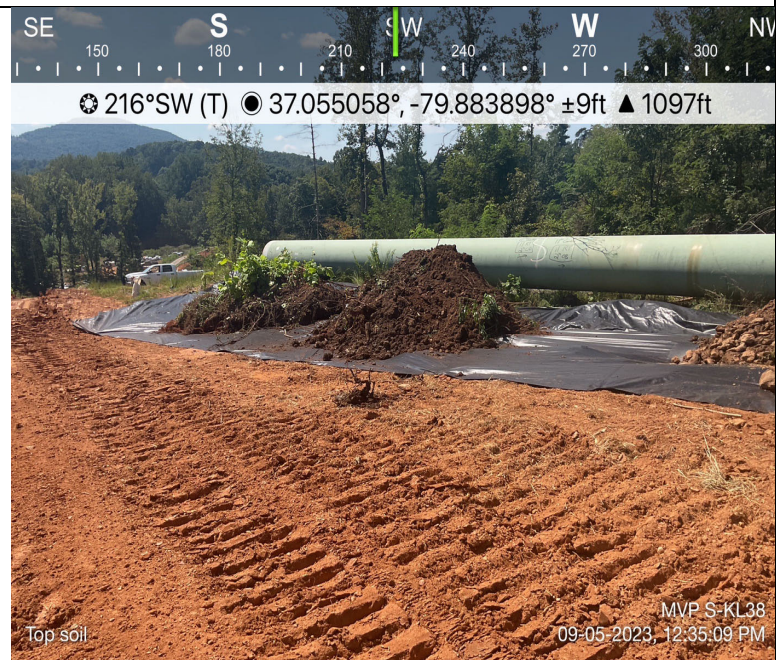
Photo Description: Top soil stockpiled separately.
