STREAM BIOLOGICAL CONDITIONS ENVIRONMENTAL AUDITOR REPORT

Stream ID: S-KL39	Crossing Start Date: 08/18/2023	Crossing Completion Date: 08/22/2023
Milepost: 265.6	Pre-Con Assessment Date: 08/15/2023	Post-Con Assessment Date: 08/23/2023
Station: 14038+69	Stream Classification: Perennial (Perennial, Intermittent, Ephemeral)	Bankfull Width (ft.): 6.5
County: Franklin	303(d) Impairment Listing: Not Impaired	Riffle:Pool Complexes Present? No

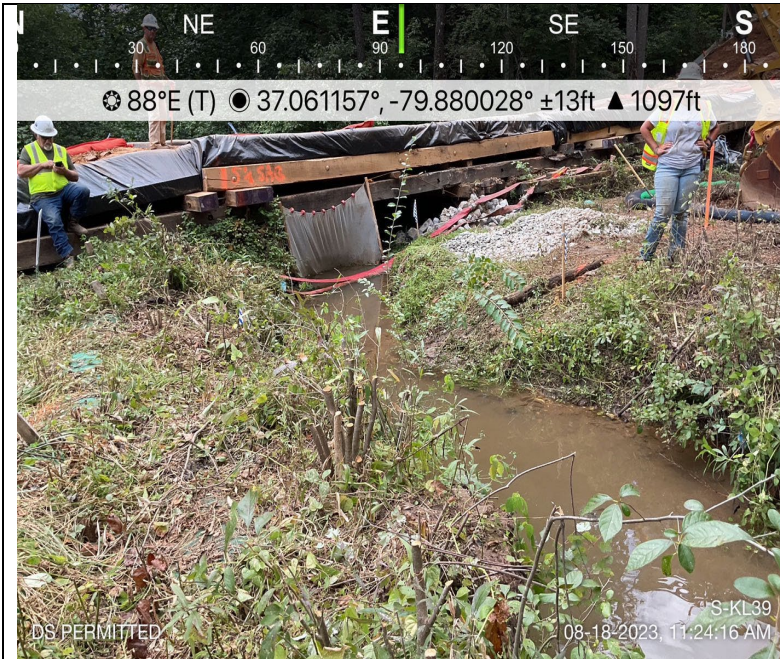
Photo Description: Downstream view of permitted impact area during pre-construction assessment.

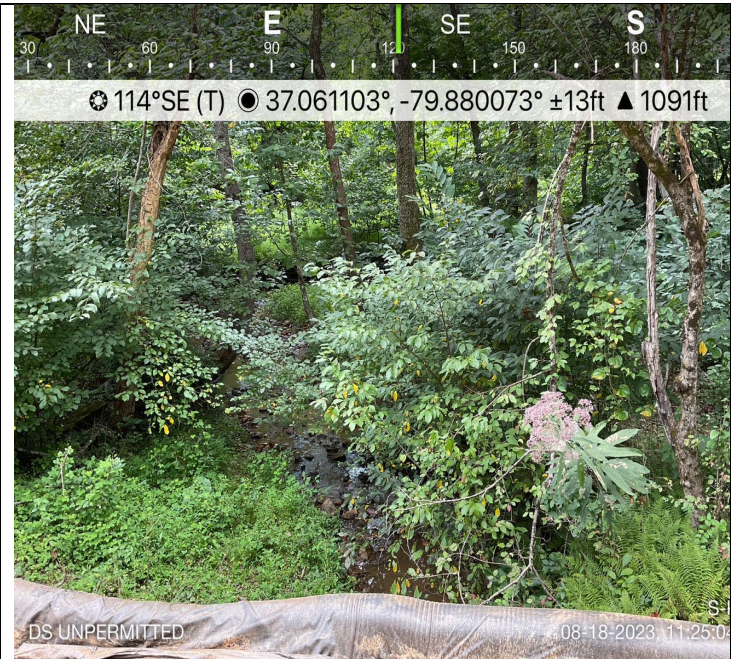
Photo Description: Downstream view of unpermitted area during pre-construction assessment.

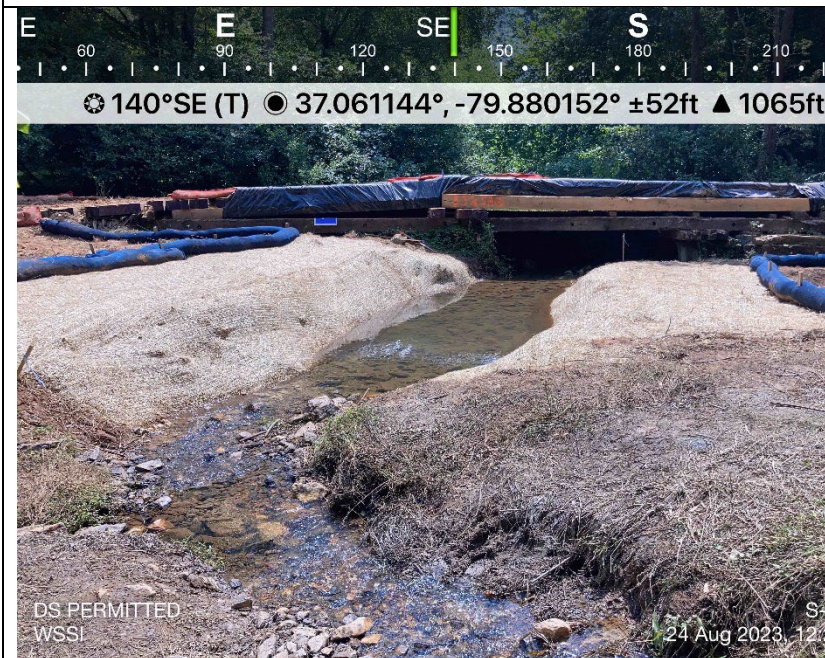
Photo Description: Downstream view of permitted impact area during post-construction assessment.

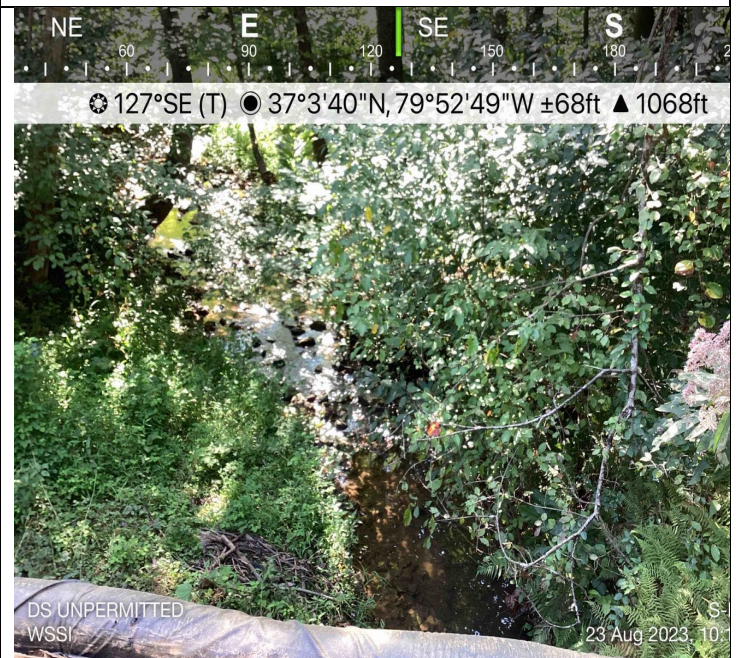
Photo Description: Downstream view of unpermitted area during post-construction assessment.

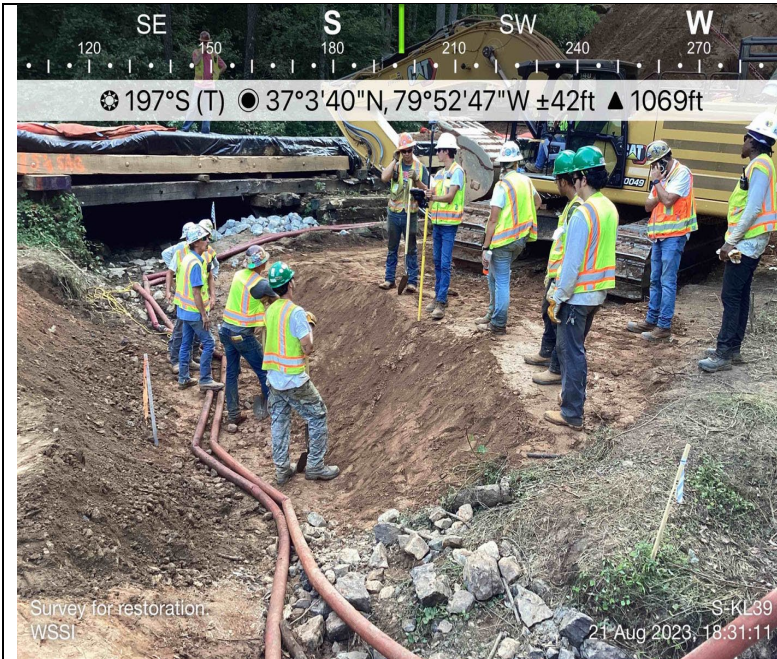
Photo Description: Survey for restoration.

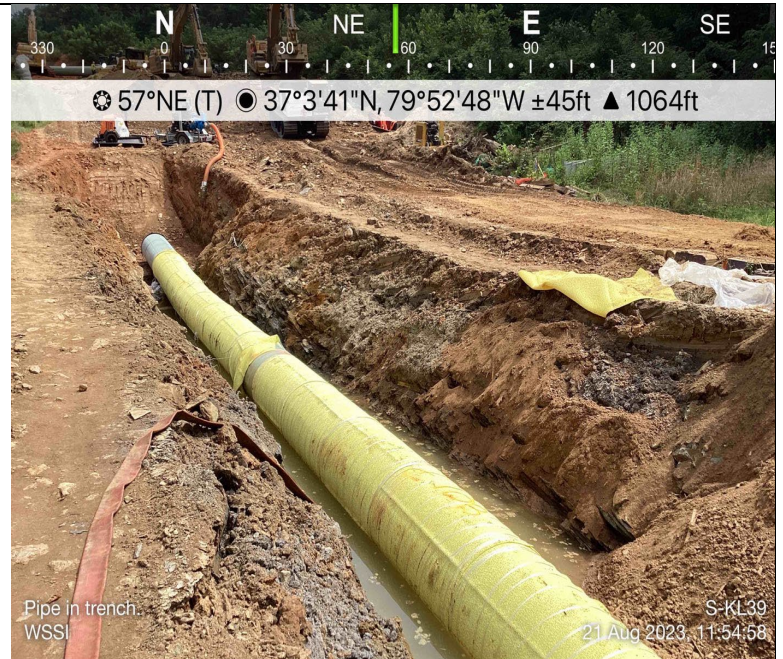
Photo Description: Pipe in trench.

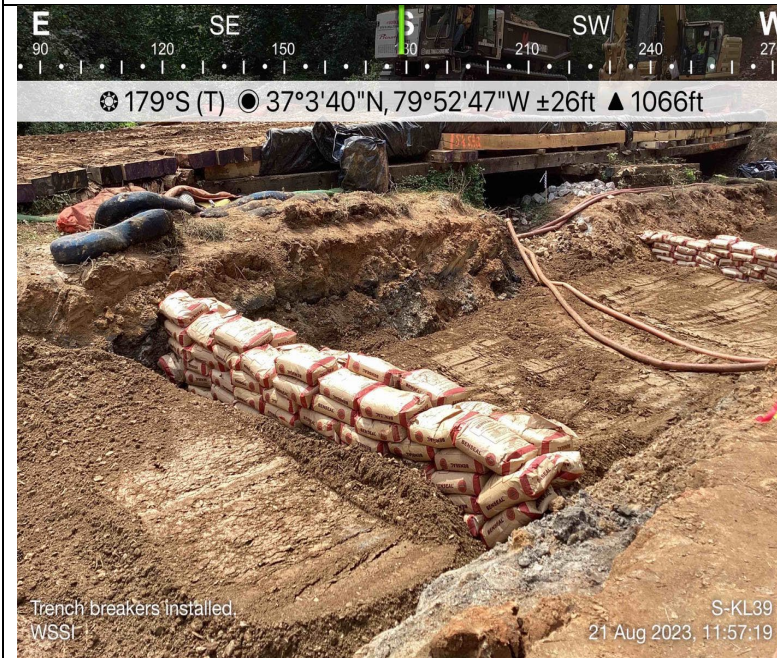
Photo Description: Trench breakers installed.

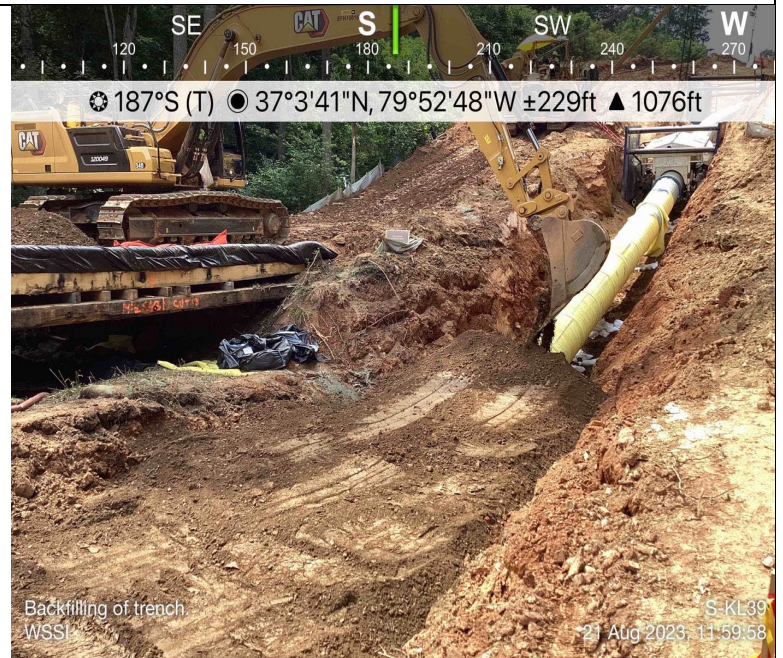
Photo Description: Backfilling of trench.
