## Stream Biological Conditions EA Report

<b>Project Name</b>	H-600 Pipeline Spread F	<b>AFE</b>	124300135	<b>Spread</b>	H-600 Pipeline Spread F
<b>Contractor</b>	Price Gregory	<b>Report #</b>	31		
<b>Environmental Auditor</b>	Allyson Kincaid	<b>Date/Time</b>	8/9/2023 2:27 PM		
<b>Stream ID</b>	S-L2	<b>Crossing Start Date</b>	8/15/2023	<b>Crossing Completion Date</b>	8/17/2023
<b>Milepost</b>	172.17	<b>Pre-Con Assessment Date</b>	8/9/2023	<b>Post-Con Assessment Date</b>	8/17/2023
<b>Station</b>	9090+58	<b>Bankfull Width (ft.)</b>	6.3	<b>Riffle:Pool Complexes Present?</b>	No
<b>State</b>	WV	<b>Stream Classification</b>	Intermittent		
<b>County</b>	Summers	<b>303(d) Impairment Listing</b>	No

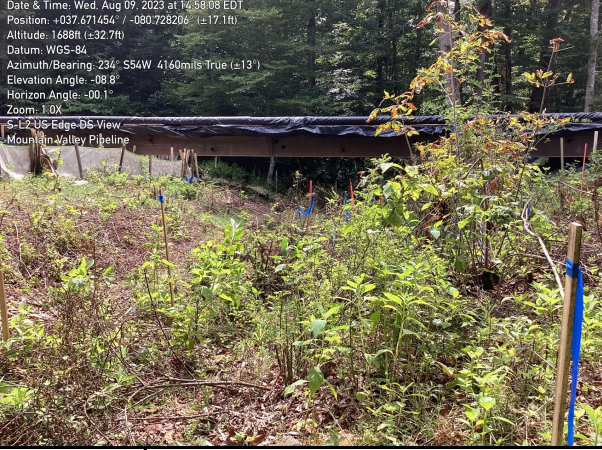
<b>GPS Location</b> Refer to Photo	<b>GPS Location</b> Refer to Photo
<b>Description</b> Downstream view of permitted impact area during pre-construction assessment. DS View from US edge of ROW Pre-Construction	<b>Description</b> Downstream view of unimpacted area during pre-construction assessment. DS View from DS edge of ROW Pre-Construction

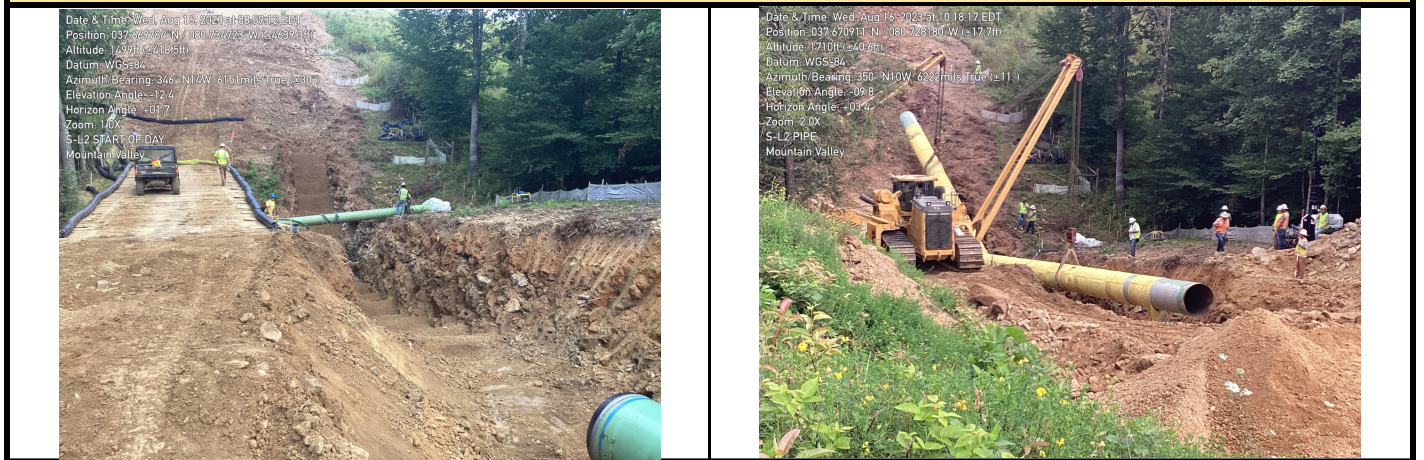
<b>GPS Location</b>	Refer to Photo	<b>GPS Location</b>	Refer to Photo
<b>Description</b>	Photo 3. Trench through resource.	<b>Description</b>	Photo 4. Pipe lowered into resource.

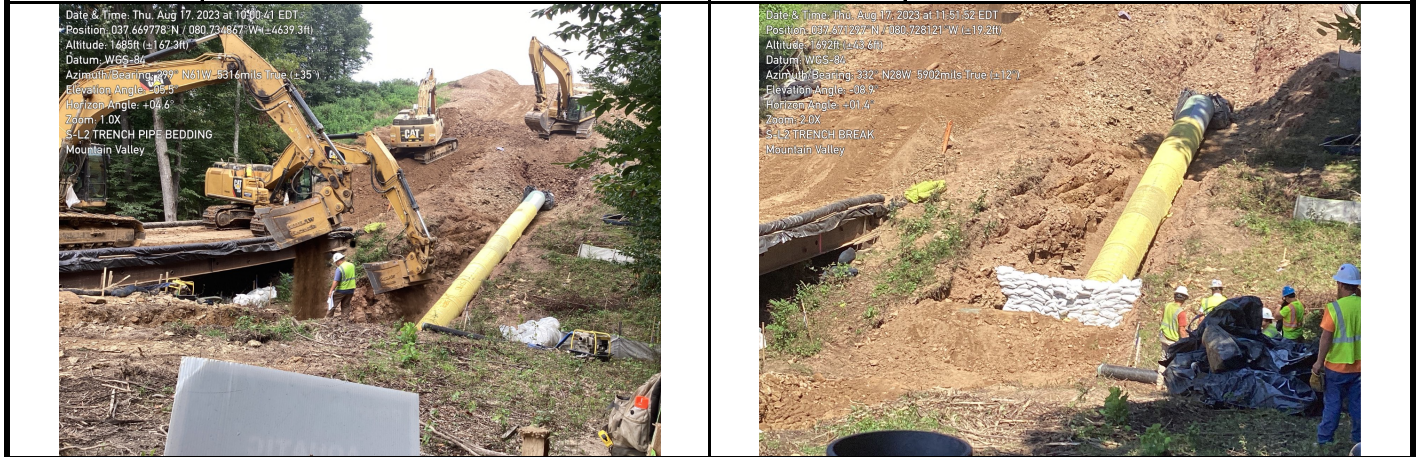
<b>GPS Location</b>	Refer to Photo	<b>GPS Location</b>	Refer to Photo
<b>Description</b>	Photo 5. Placing bedding and backfilling.	<b>Description</b>	Photo 6. Trench breakers

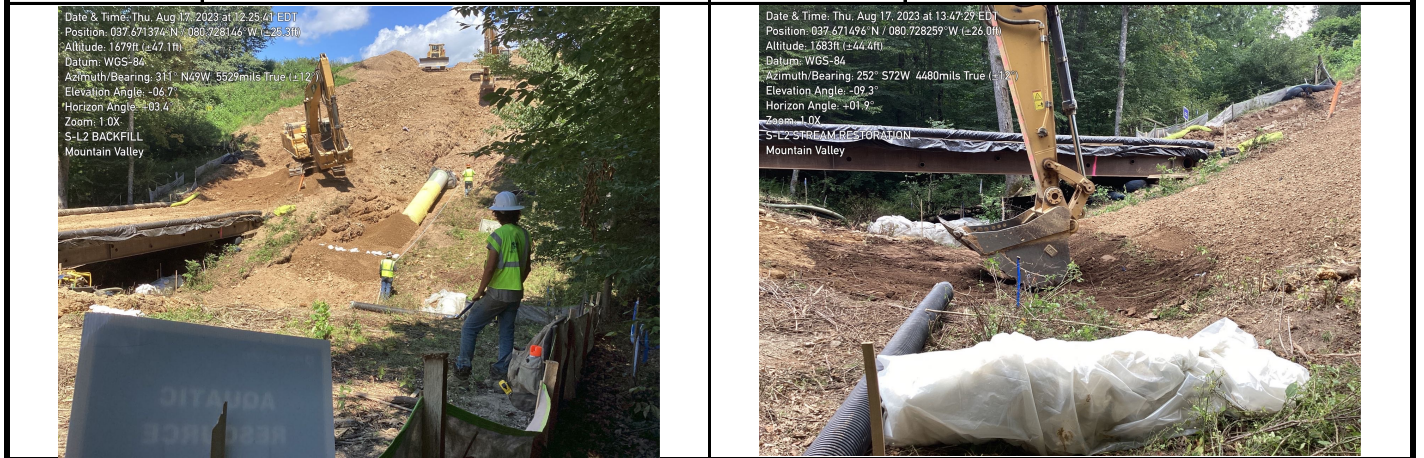
<b>GPS Location</b>	Refer to Photo	<b>GPS Location</b>	Refer to Photo
<b>Description</b>	Photo 7. Trench backfill.	<b>Description</b>	Photo 8. Restoring stream topsoil.
