# Stream Biological Conditions EA Report

<b>Project Name</b>	H-600 Pipeline Spread E	<b>AFE</b>	124300134	<b>Spread</b>	H-600 Pipeline Spread E
<b>Contractor</b>	Price Gregory	<b>Report #</b>	191		
<b>Environmental Auditor</b>	Tim Ferguson	<b>Date/Time</b>	8/22/2023 8:41 AM		
<b>Stream ID</b>	S-L26	<b>Crossing Start Date</b>	8/24/2023	<b>Crossing Completion Date</b>	9/13/2023
<b>Milepost</b>	144.36	<b>Pre-Con Assessment Date</b>	8/22/2023	<b>Post-Con Assessment Date</b>	9/13/2023
<b>Station</b>	7622+21	<b>Bankfull Width (ft.)</b>	5.0	<b>Riffle:Pool Complexes Present?</b>	No
<b>State</b>	WV	<b>Stream Classification</b>	Perennial		
<b>County</b>	Greenbrier	<b>303(d) Impairment Listing</b>	No

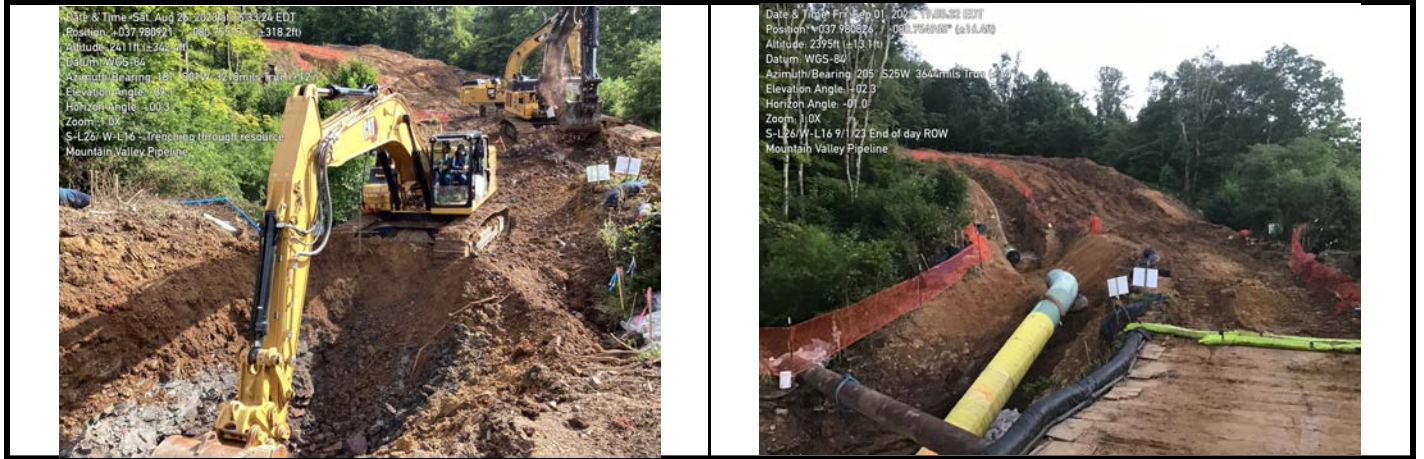
<b>GPS Location</b> See Photo	<b>GPS Location</b> See Photo
<b>Description</b> Photo 3: Trenching through aquatic resources.	<b>Description</b> Photo 4: Pipe lowered into aquatic resources

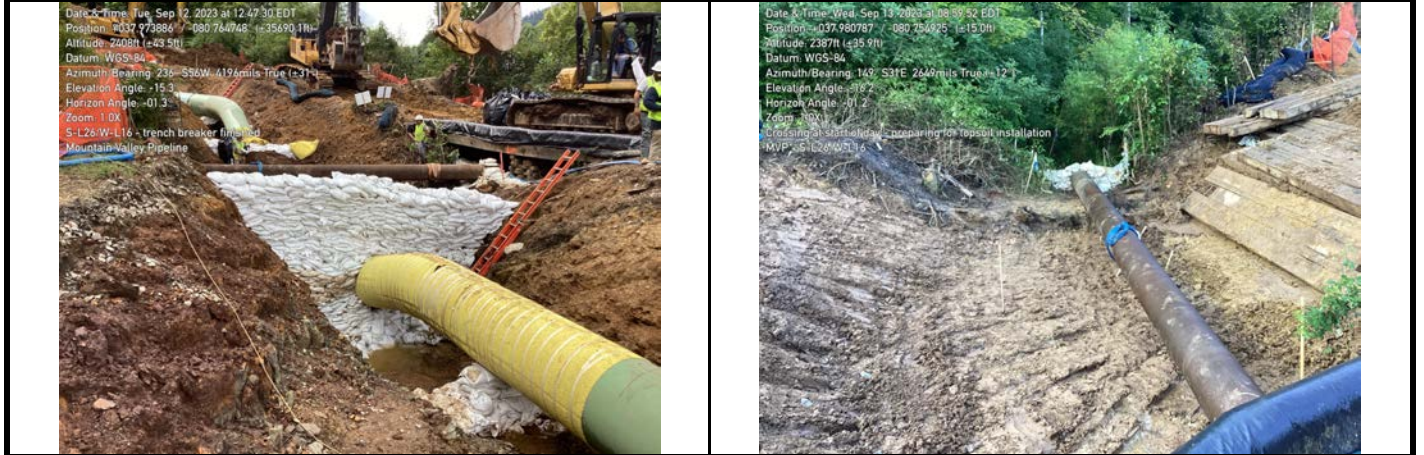
<b>GPS Location</b> See Photo	<b>GPS Location</b> See Photo
<b>Description</b> Photo 5: Trench breakers at aquatic resources.	<b>Description</b> Photo 6: Contouring the stream channel.

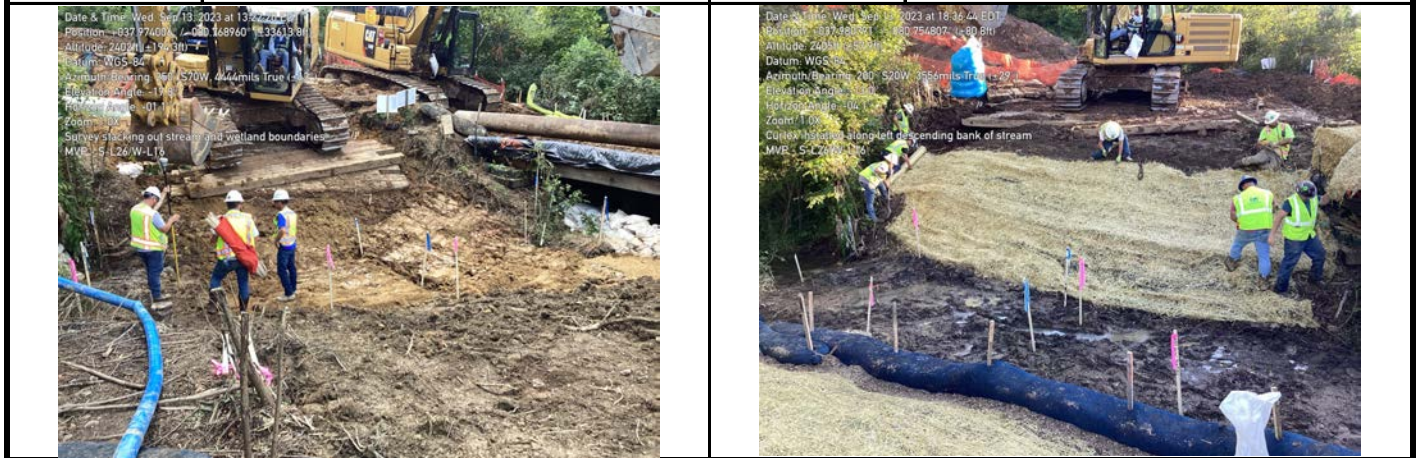
<b>GPS Location</b> See Photo	<b>GPS Location</b> See Photo
<b>Description</b> Photo 7: Survey staking out aquatic resources.	<b>Description</b> Photo 8: Installing Curlex.
