# Stream Biological Conditions EA Report

<b>Project Name</b>	H-600 Pipeline Spread C	<b>AFE</b>	124300131	<b>Spread</b>	H-600 Pipeline Spread C
<b>Contractor</b>	Precision	<b>Report #</b>	206		
<b>Environmental Auditor</b>	Jeffrey Arbogast	<b>Date/Time</b>	8/21/2023 1:48 PM		
<b>Stream ID</b>	S-L60	<b>Crossing Start Date</b>	8/15/2023	<b>Crossing Completion Date</b>	8/23/2023
<b>Milepost</b>	68.83	<b>Pre-Con Assessment Date</b>	8/12/2023	<b>Post-Con Assessment Date</b>	8/26/2023
<b>Station</b>	3634+29	<b>Bankfull Width (ft.)</b>	9.6	<b>Riffle:Pool Complexes Present?</b>	No
<b>State</b>	WV	<b>Stream Classification</b>	Perennial		
<b>County</b>	Braxton	<b>303(d) Impairment Listing</b>	No

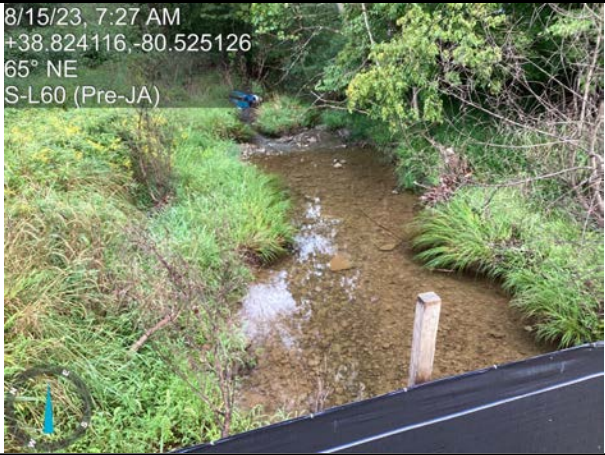
AFE 124300131		Date/Time 8/21/2023 1:48 PM		Report # 206	
Required Photos					
<p>8/15/23, 7:29 AM +38.824052,-80.524933 340° N S-L60 (Pre-JA)</p>  		<p>8/15/23, 7:27 AM +38.824116,-80.525126 65° NE S-L60 (Pre-JA)</p>

<b>GPS Location</b> See caption in photo		<b>GPS Location</b> See caption in photo			
<b>Description</b> Downstream view of permitted impact area during pre-construction assessment. Pre-construction view looking downstream from upstream LOD.		<b>Description</b> Downstream view of unimpacted area during pre-construction assessment. Pre-construction view looking downstream from downstream LOD on top of bridge.			
<p>8/26/23, 6:04 PM +38.824160,-80.525034 285° W S-L60 (Post-JA)</p>

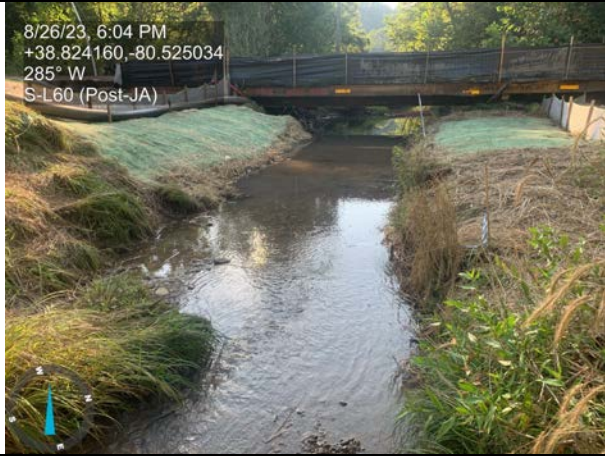
<p>8/26/23, 6:03 PM +38.824043,-80.525167 49° NE S-L60 (Post-JA)</p>  			
<b>GPS Location</b> See caption in photo		<b>GPS Location</b> See caption in photo			
<b>Description</b> Downstream view of permitted impact area during post-construction assessment. Post-construction view looking downstream from upstream LOD.		<b>Description</b> Downstream view of unimpacted area during post-construction assessment. Post-construction view looking downstream from downstream LOD on top of bridge.

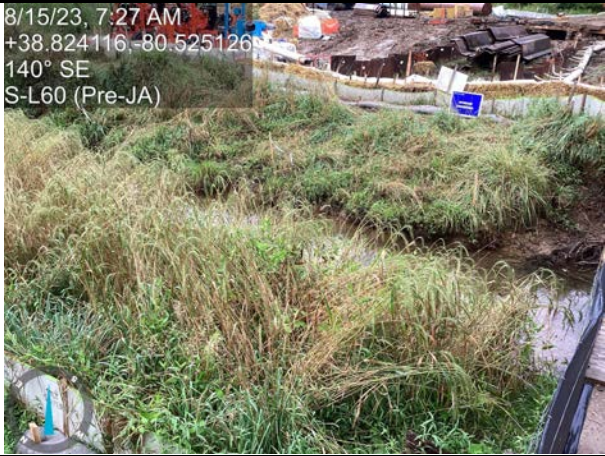
<p>8/15/23, 7:27 AM +38.824116,-80.525126 140° SE S-L60 (Pre-JA)</p>

<b>GPS Location</b> See caption in photo		<b>GPS Location</b> See caption in photo			
<b>Description</b> Pre-construction view from the coming in side of the stream crossing. Sheet piling has been installed up to the 10' buffer.		<b>Description</b> Pre-construction view from going away side of crossing.

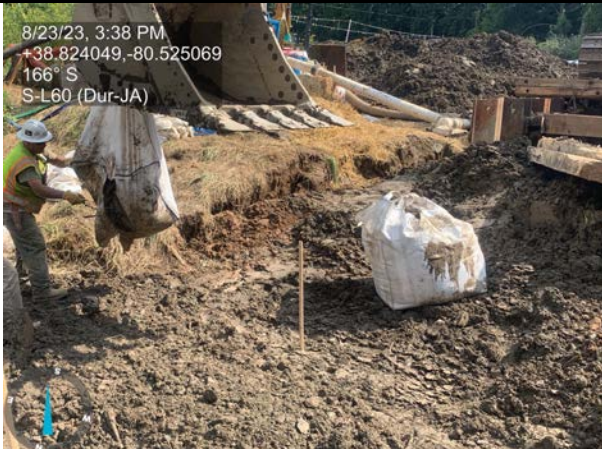
<b>GPS Location</b> See caption in photo	<b>GPS Location</b> See caption in photo
<b>Description</b> Stream with flume pipe, sheet piling and well points installed.	<b>Description</b> Stream substrate stored in super sacks.
