Stream Biological Conditions EA Report

Project Name	H-600 Pipeline Spread C	AFE	124300131	Spread	H-600 Pipeline Spread C
Contractor	Precision	Report #	211		
Environmental Auditor	Jeffrey Arbogast	Date/Time	8/24/2023 10:01 AM		
Stream ID	S-LL1	Crossing Start Date	8/24/2023	Crossing Completion Date	9/2/2023
Milepost	68.87	Pre-Con Assessment Date	8/12/2023	Post-Con Assessment Date	9/5/2023
Station	3636+29	Bankfull Width (ft.)	21.5	Riffle:Pool Complexes Present?	Yes
State	WV	Stream Classification	Perennial		
County	Braxton	303(d) Impairment Listing	No

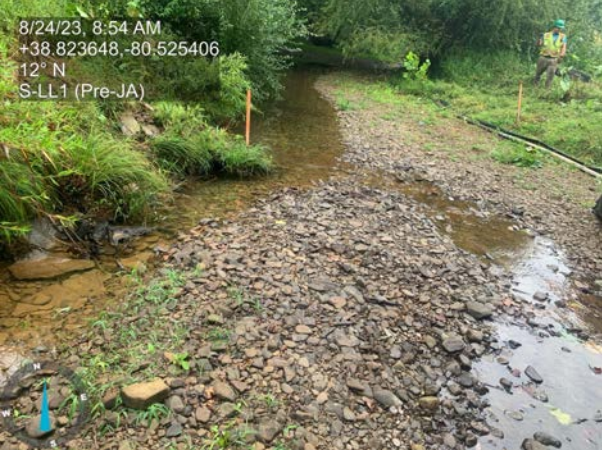
GPS Location	See caption in photo	GPS Location	See caption in photo
Description	Downstream view of permitted impact area during pre-construction assessment.	Description	Downstream view of unimpacted area during pre-construction assessment.

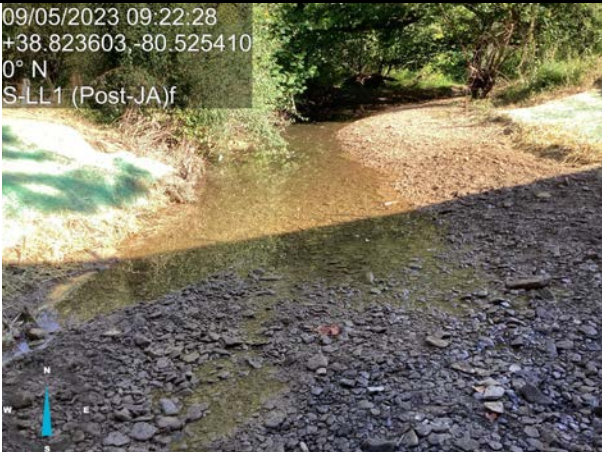
GPS Location	See caption in photo	GPS Location	See caption in photo
Description	Downstream view of permitted impact area during post-construction assessment.	Description	Downstream view of unimpacted area during post-construction assessment.

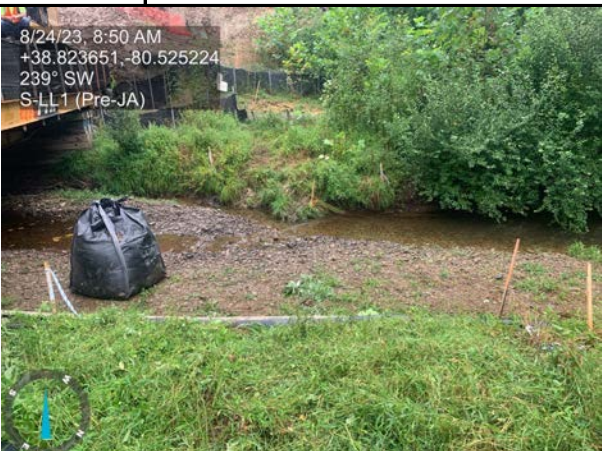
GPS Location	See caption in photo	GPS Location	See caption in photo
Description	Pre-construction view from coming in side of crossing.	Description	Pre-construction view from going away side of crossing.
