# STREAM BIOLOGICAL CONDITIONS ENVIRONMENTAL AUDITOR REPORT

<b>Stream ID:</b> S-MN22	<b>Crossing Start Date:</b> 09/05/2023	<b>Crossing Completion Date:</b> 09/09/2023
<b>Milepost:</b> 221.5	<b>Pre-Con Assessment Date:</b> 09/01/2023	<b>Post-Con Assessment Date:</b> 09/13/2023
<b>Station:</b> 11704+10	<b>Stream Classification:</b> Ephemeral (Perennial, Intermittent, Ephemeral)	<b>Bankfull Width (ft.):</b> 2
<b>County:</b> Montgomery	<b>303(d) Impairment Listing:</b> Not Impaired	<b>Riffle:Pool Complexes Present?</b> No

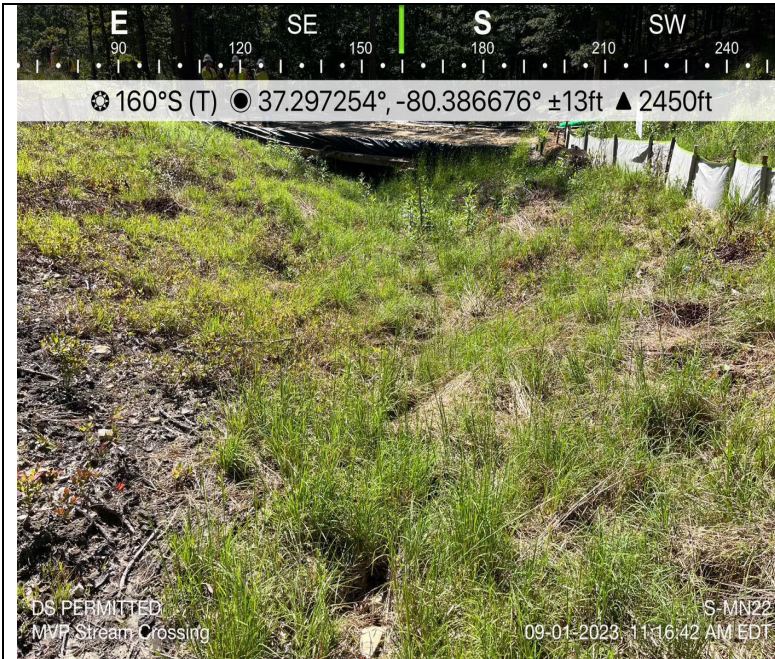
**Photo Description:** Downstream view of permitted impact area during pre-construction assessment.

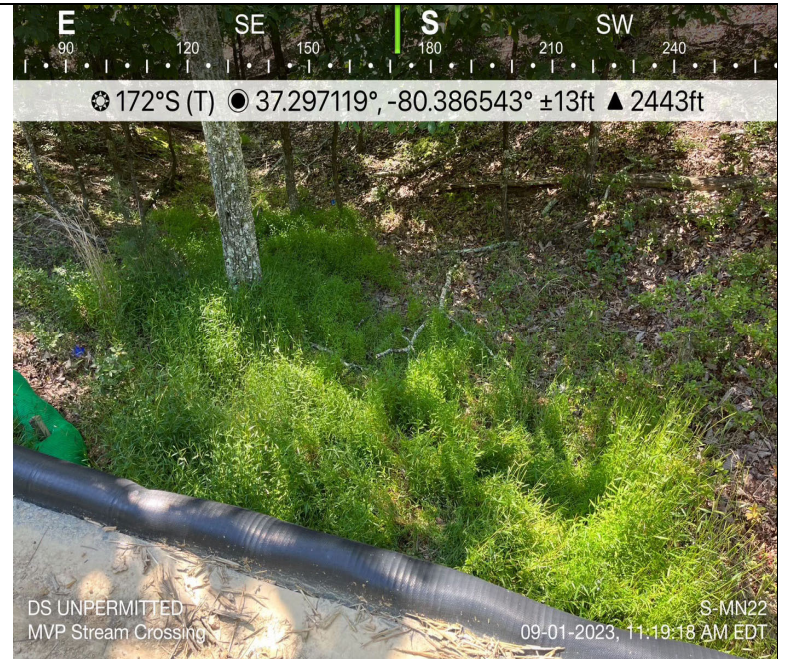
**Photo Description:** Conditions of the downstream area outside the ROW during pre-construction assessment.

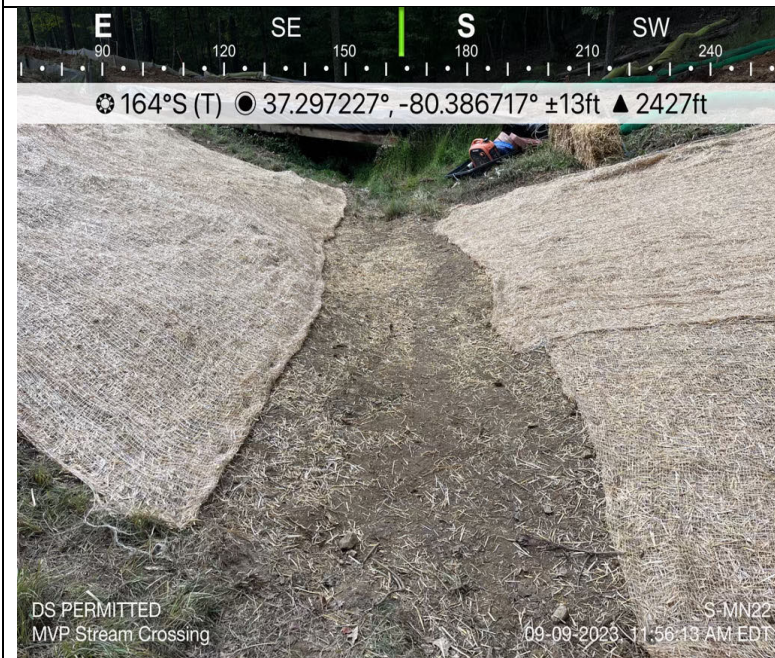
**Photo Description:** Downstream view of permitted impact area during post-construction assessment.

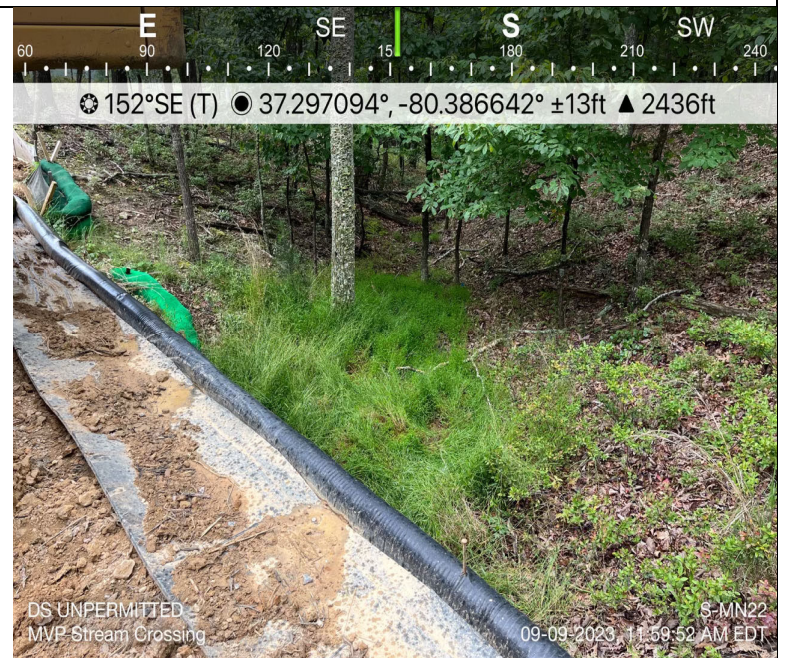
**Photo Description:** Conditions of the downstream area outside the ROW during post-construction assessment.

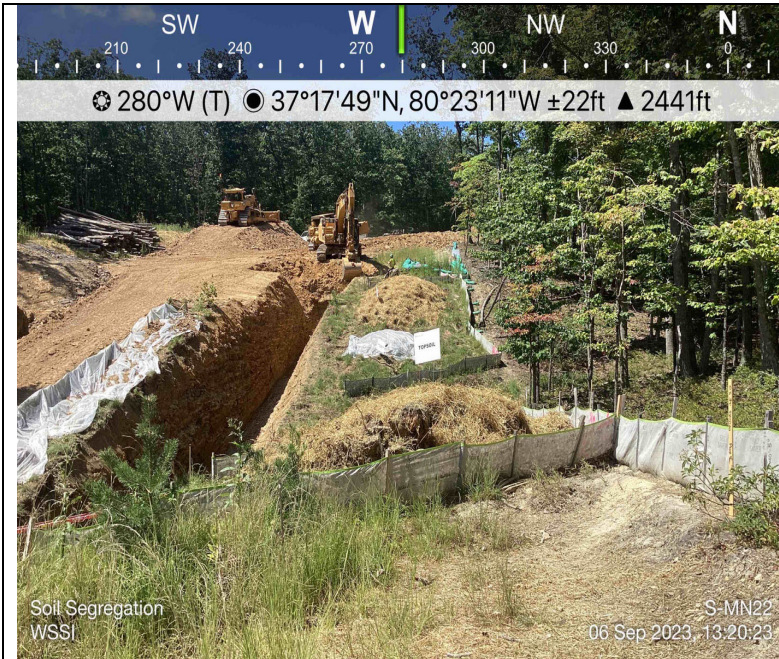
**Photo Description:** Soil segregation in buffer areas.

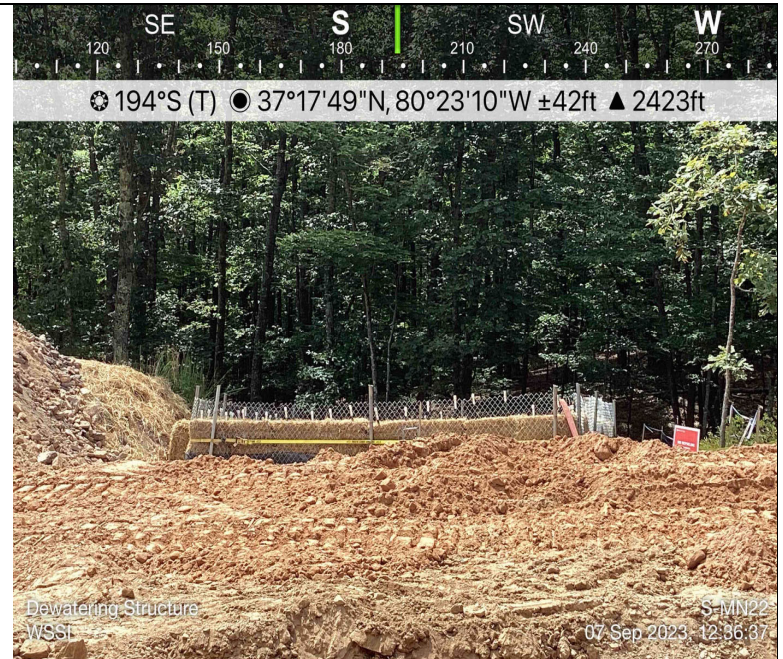
**Photo Description:** Dewatering Structure built on ROW.

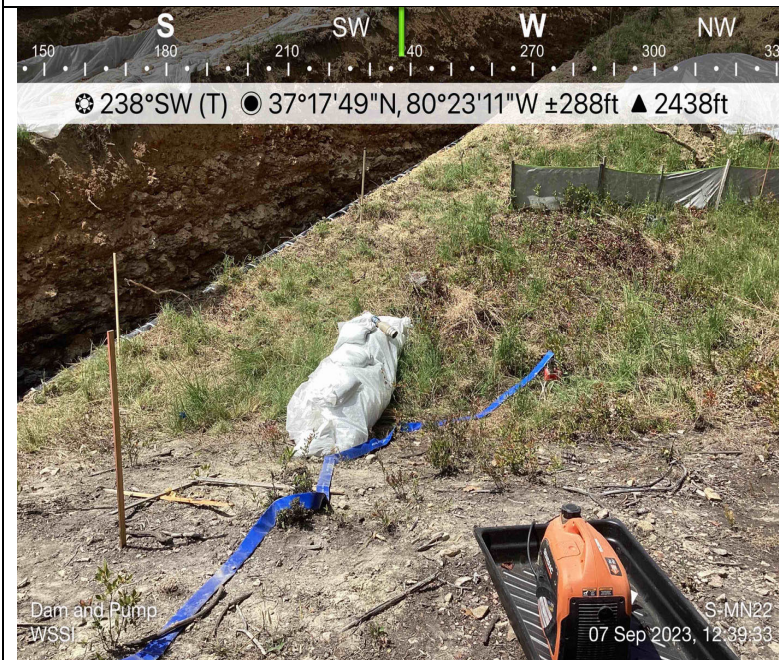
**Photo Description:** Dam and pump in dry stream.

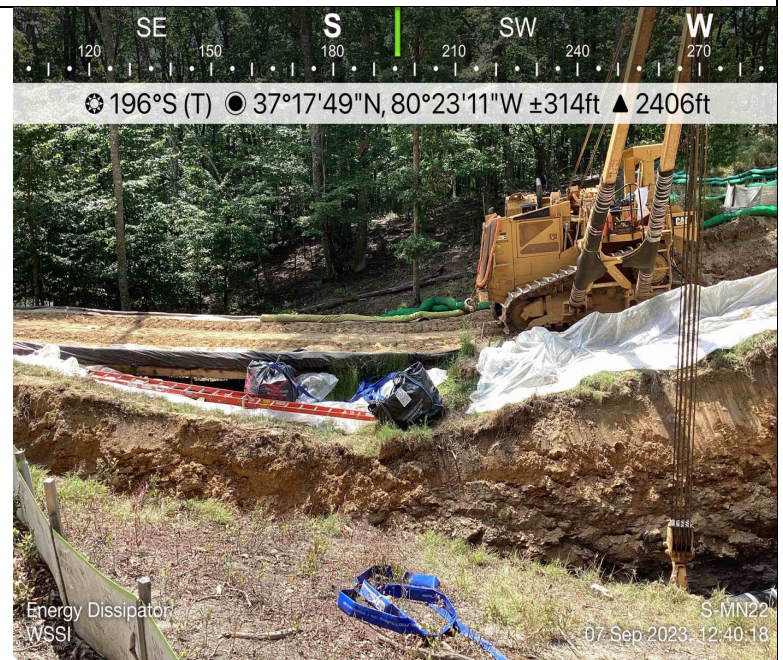
**Photo Description:** Energy Dissipator.
