STREAM BIOLOGICAL CONDITIONS ENVIRONMENTAL AUDITOR REPORT

Stream ID: S-NN12	Crossing Start Date: 08/09/2023	Crossing Completion Date: 09/01/2023
Milepost: 214.4	Pre-Con Assessment Date: 08/08/2023	Post-Con Assessment Date: 09/01/2023
Station: 11327+85	Stream Classification: Ephemeral (Perennial, Intermittent, Ephemeral)	Bankfull Width (ft.): 2
County: Giles	303(d) Impairment Listing: Not Impaired	Riffle: Pool Complexes Present? No

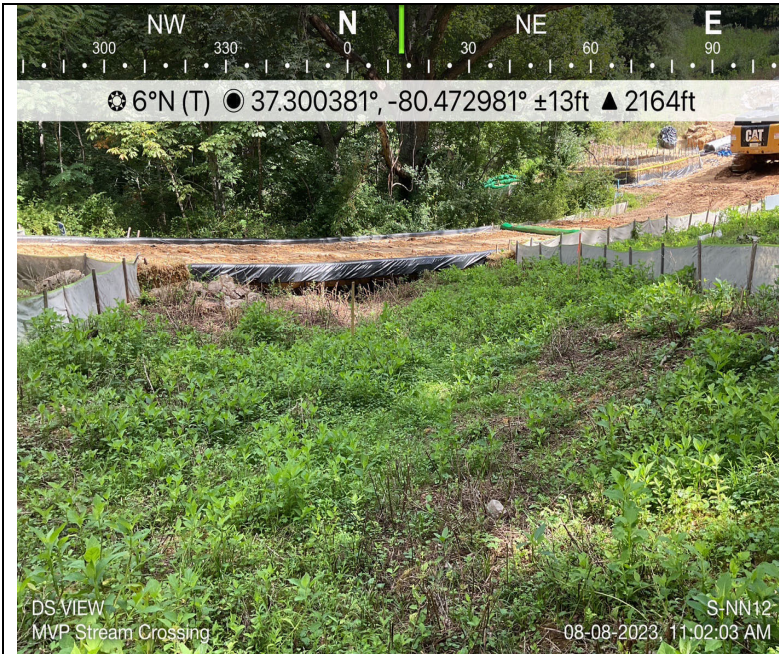
Photo Description: Downstream view of permitted impact area during pre-construction assessment.

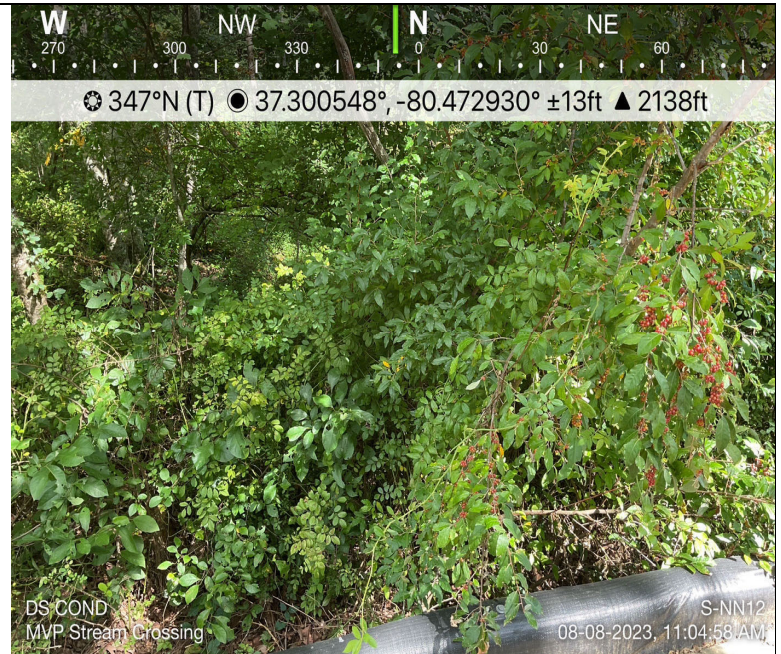
Photo Description: Conditions of the downstream area outside the ROW during pre-construction assessment.

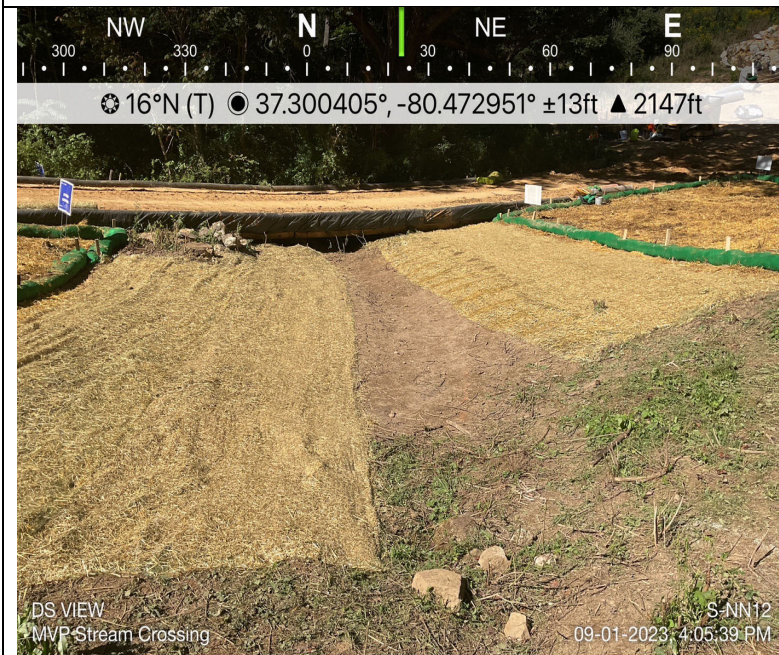
Photo Description: Downstream view of permitted impact area during post-construction assessment.

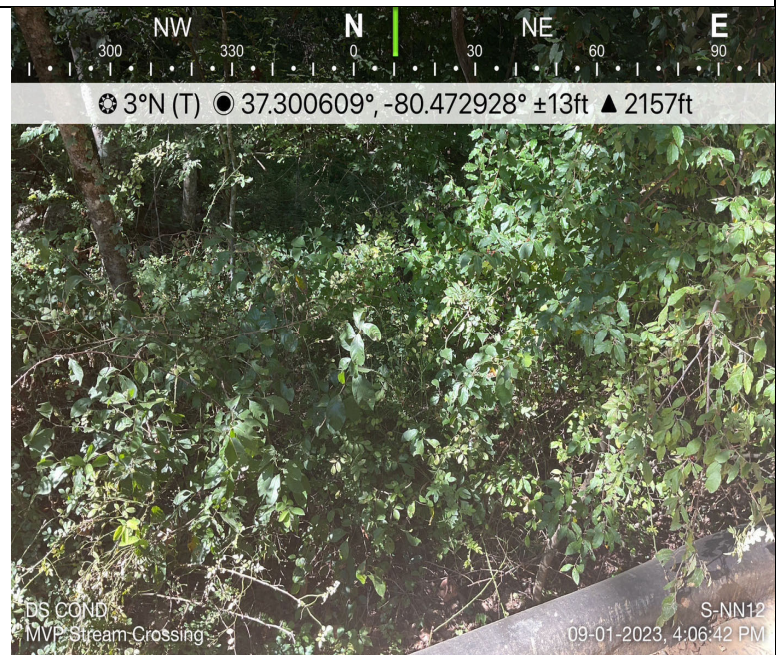
Photo Description: Conditions of the downstream area outside the ROW during post-construction assessment.

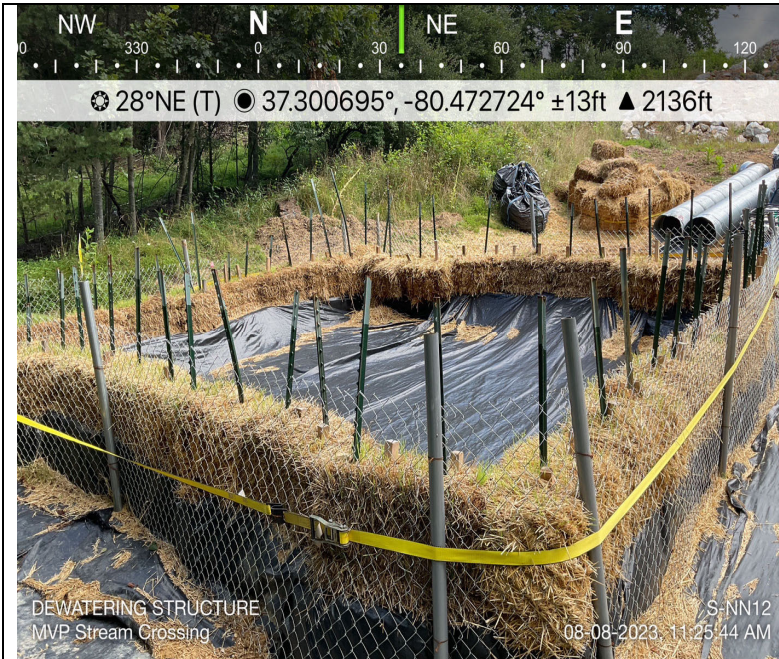
Photo Description: Dewatering structure.

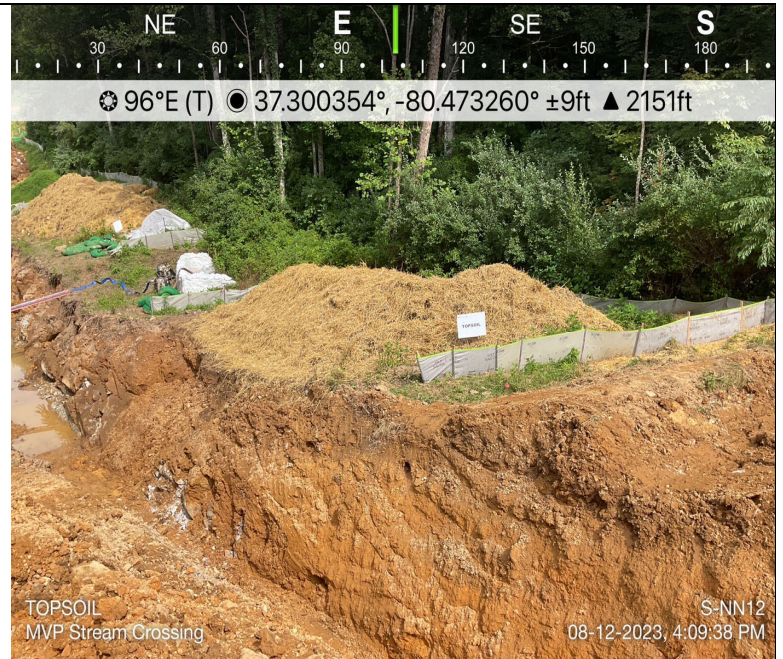
Photo Description: Segregation of soil.

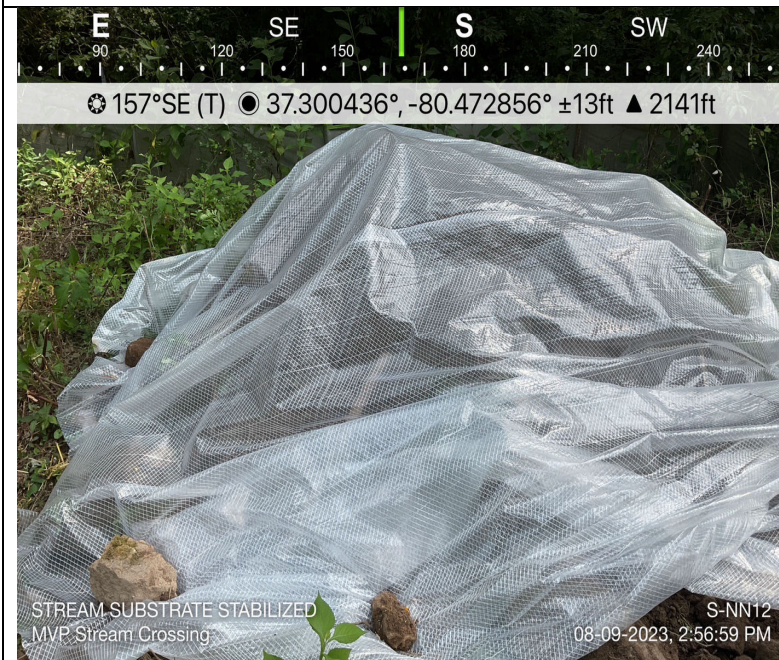
Photo Description: Stream substrate segregation.

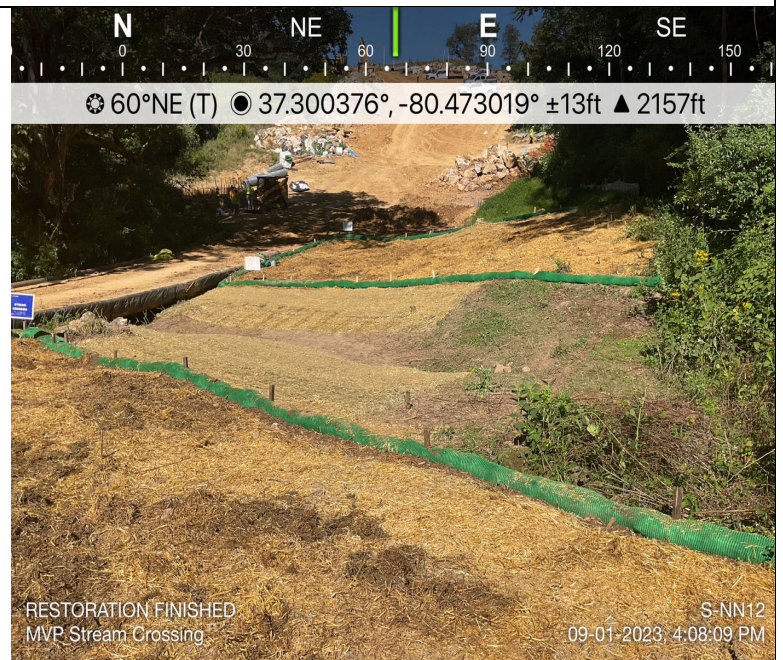
Photo Description: Stream restoration finished.
