STREAM BIOLOGICAL CONDITIONS ENVIRONMENTAL AUDITOR REPORT

| Stream ID: S-PP1 | Crossing Start Date: 08/17/2023 | Crossing Completion Date: 08/23/2023 |
| Milepost: 217.4 | Pre-Con Assessment Date: 08/15/2023 | Post-Con Assessment Date: 08/24/2023 |
| Station: 11489+58 | Stream Classification: Intermittent (Perennial, Intermittent, Ephemeral) | Bankfull Width (ft.): 3 |

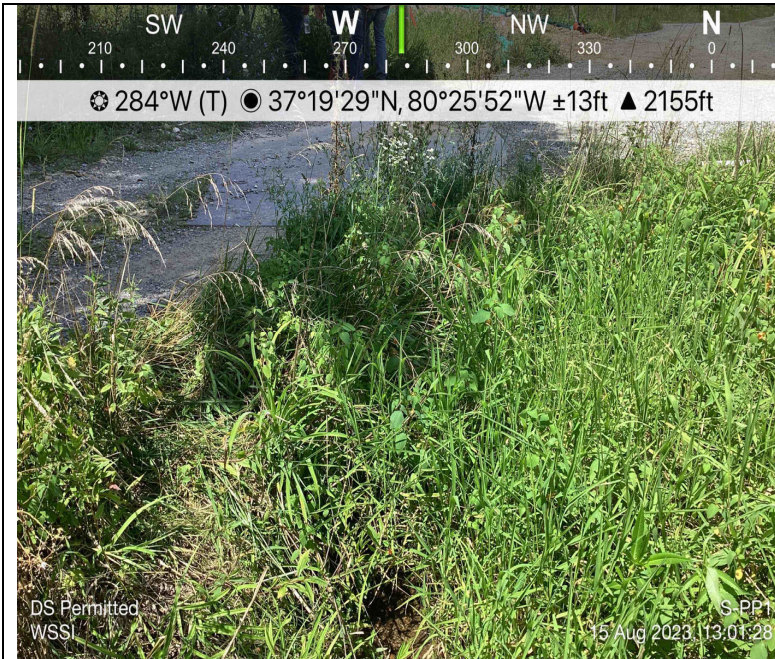
Photo Description: Downstream view of permitted impact area during pre-construction assessment.

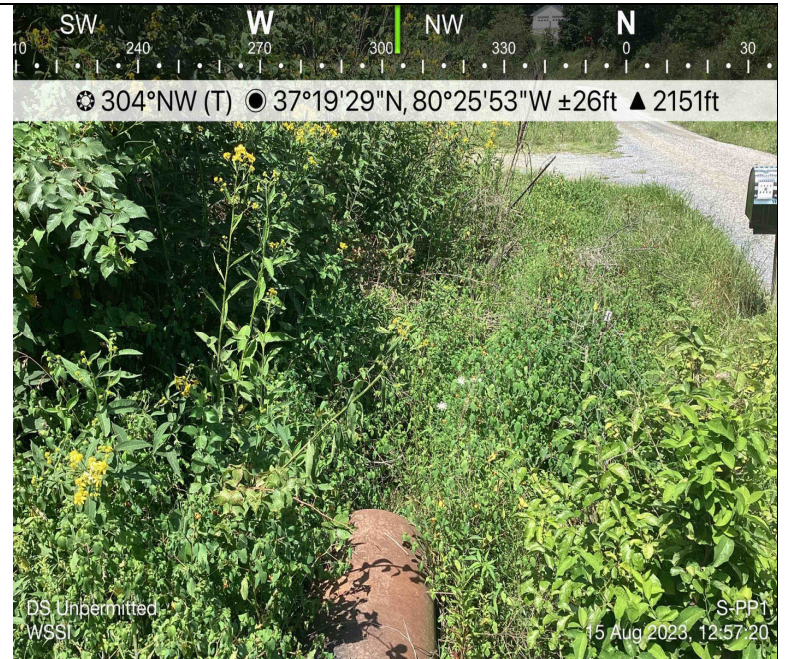
Photo Description: Downstream view of unpermitted area during pre-construction assessment.

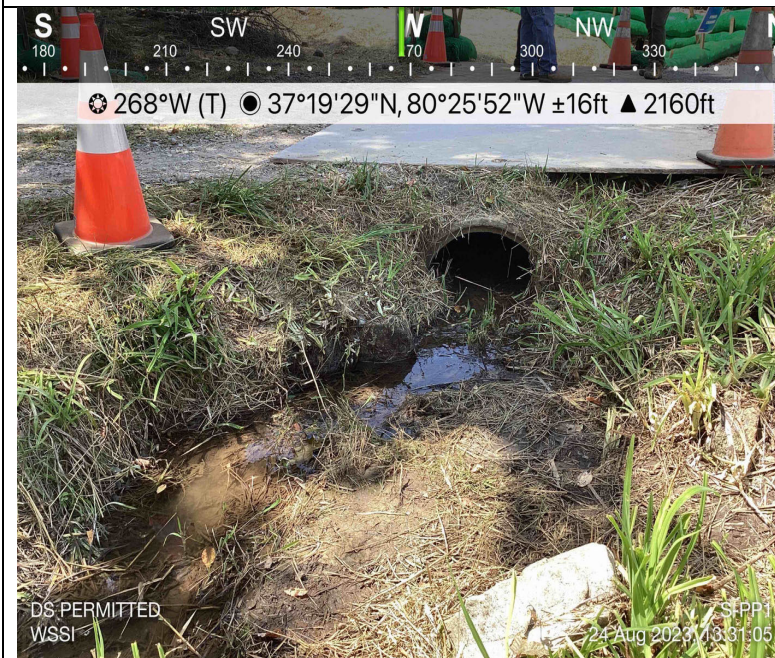
Photo Description: Downstream view of permitted impact area during post-construction assessment.

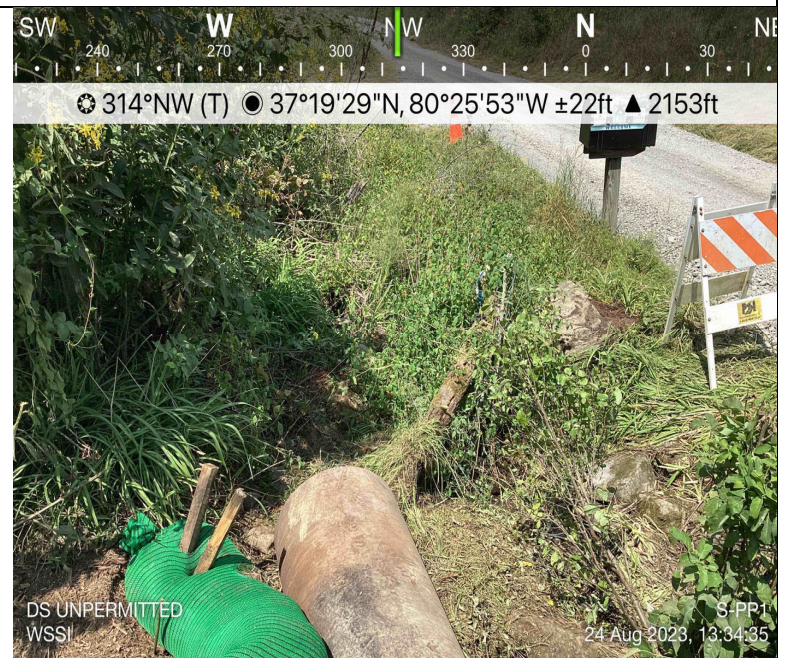
Photo Description: Downstream view of unpermitted area during post-construction assessment.

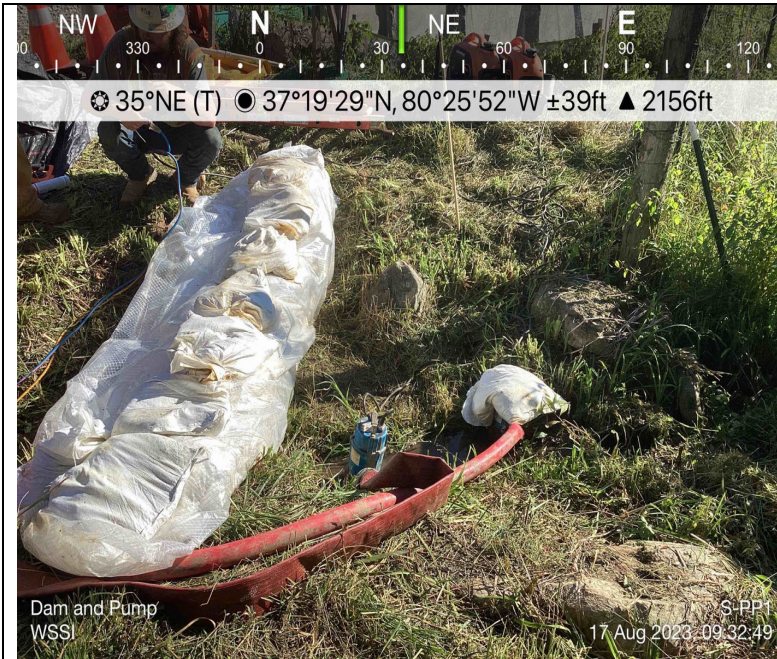
Photo Description: Dam and Pump installed and functioning.

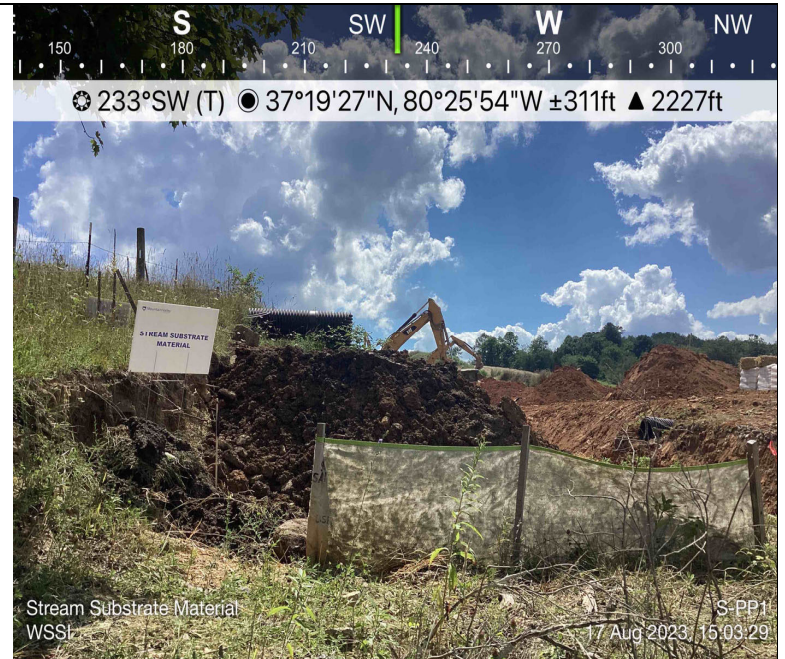
Photo Description: Stream substrate material with subsoil stockpiles in background.

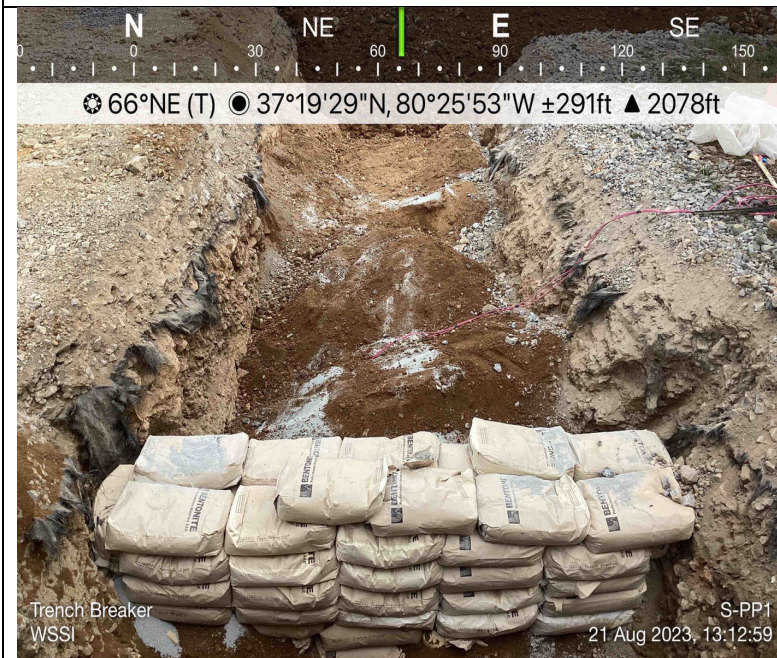
Photo Description: Trench Breakers installed appropriately.

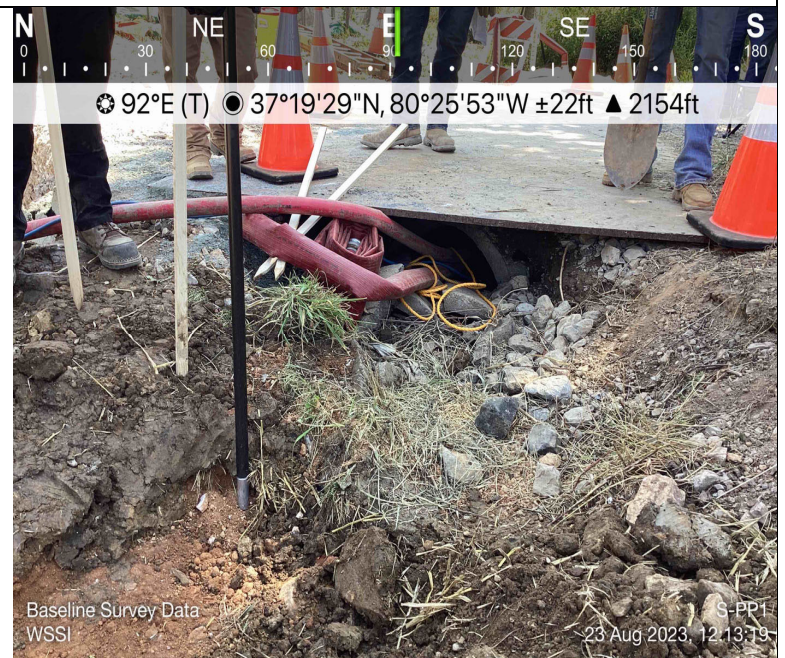
Item #8: Survey data was utilized to restore stream to pre-construction conditions, however, stable tie out to existing grade was prioritized over one point in cross section A. It should be noted that stones larger than 4" outside of stream banks were not put back.

Photo Description: Baseline data survey did not match up to current field conditions. Therefore, a modification was made to only one point, the toe of bank in cross section A. All other data points held constant.

8/23/2023: Road fill was brought in, controlled density fill. Modification to toe of bank point in cross section A to hold existing ground and prevent erosion. Existing grade was prioritized over survey stake out for one point in XS A, the rest of data points were shot to match the pre-construction survey conditions. Stream contouring was completed, and ECM was installed appropriately. Stream flow was restored successfully, and the crossing was completed. -A. Breeding
