# Stream Biological Conditions EA Report

<b>Project Name</b>	H-600 Pipeline Spread C	<b>AFE</b>	124300131	<b>Spread</b>	H-600 Pipeline Spread C
<b>Contractor</b>	Precision	<b>Report #</b>	38		
<b>Environmental Auditor</b>	Roderick Grills	<b>Date/Time</b>	8/16/2023 8:09 AM		
<b>Stream ID</b>	S-QR30	<b>Crossing Start Date</b>	8/16/2023	<b>Crossing Completion Date</b>	8/21/2023
<b>Milepost</b>	70.18	<b>Pre-Con Assessment Date</b>	8/15/2023	<b>Post-Con Assessment Date</b>	8/25/2023
<b>Station</b>	3705+27	<b>Bankfull Width (ft.)</b>	4.8	<b>Riffle:Pool Complexes Present?</b>	No
<b>State</b>	WV	<b>Stream Classification</b>	Perennial		
<b>County</b>	Braxton	<b>303(d) Impairment Listing</b>	No

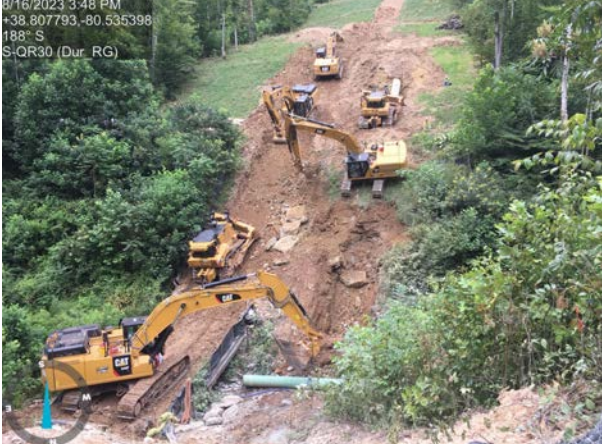
<b>GPS Location</b>	Location in the upper left corner of photo.	<b>GPS Location</b>	Location in the upper left corner of photo.
<b>Description</b>	Looking form the going away side to S-QR30, flume being installed for over night stream water flow.	<b>Description</b>	Looking form the going away side of S-QR30, welding a section of pipe on the coming in side.

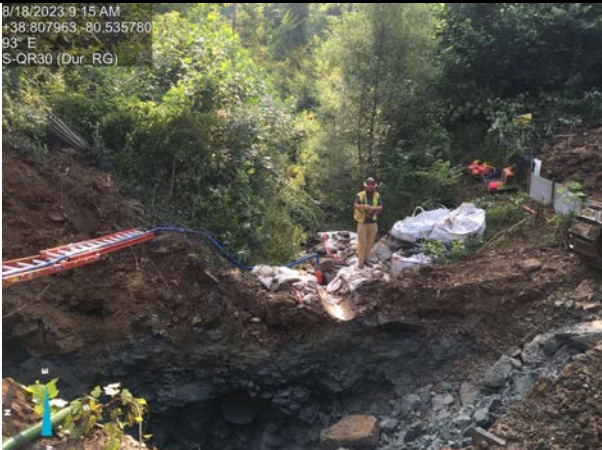
<b>GPS Location</b>	Location in the upper left corner of photo.	<b>GPS Location</b>	Location in the upper left corner of photo.
<b>Description</b>	Looking from bridge at the left side of the LOD at the dam and pump around setup of S-QR30.	<b>Description</b>	Looking form the coming side of S-QR30, sifting excavator putting in clean fill around the pipe.

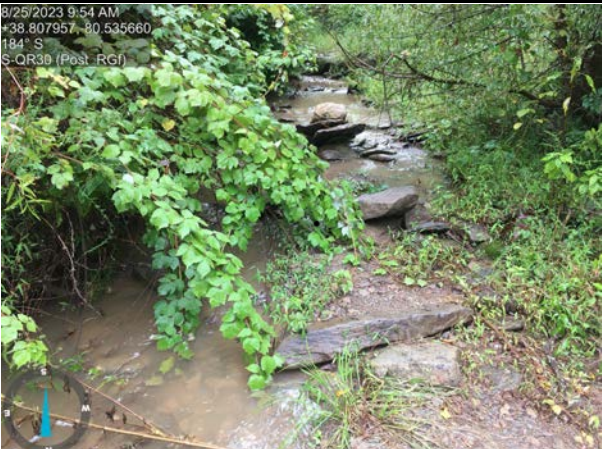
<b>GPS Location</b>	Location in the upper left corner of photo.	<b>GPS Location</b>	Location in the upper left corner of photo.
<b>Description</b>	Looking up stream from the left edge of LOD of turbid water entering the LOD	<b>Description</b>	Looking from the bridge at trench breaker on the going away side of S-QR30.
