Stream Biological Conditions EA Report

Project Name	H-600 Pipeline Spread B	AFE	124300130	Spread	H-600 Pipeline Spread B
Contractor	Precision	Report #	231		
Environmental Auditor	Elyse Johnston	Date/Time	9/13/2023 11:40 AM		
Stream ID	S-UV11	Crossing Start Date	9/13/2023	Crossing Completion Date	9/16/2023
Milepost	62.35	Pre-Con Assessment Date	9/13/2023	Post-Con Assessment Date	9/18/2023
Station	3291+89	Bankfull Width (ft.)	15.0	Riffle:Pool Complexes Present?	Yes
State	WV	Stream Classification	Perennial		
County	Lewis	303(d) Impairment Listing	No

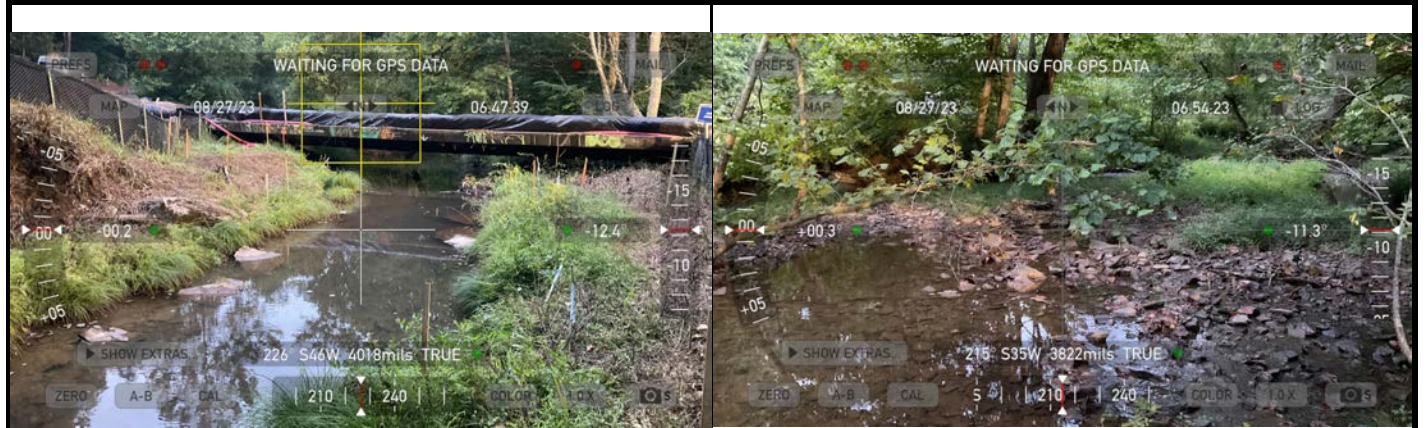
GPS Location	See photo.	GPS Location	See photo.
Description	Downstream view of permitted impact area during pre-construction assessment.	Description	Downstream view of unimpacted area during pre-construction assessment.

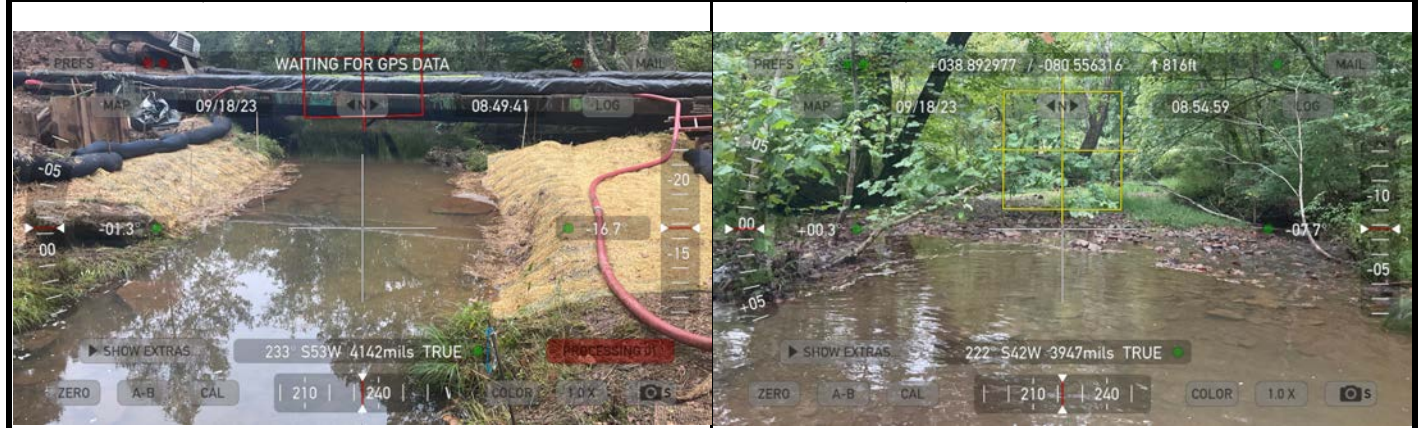
GPS Location	See photo.	GPS Location	See photo.
Description	Downstream view of permitted impact area during post-construction assessment.	Description	Downstream view of unimpacted area during post-construction assessment.

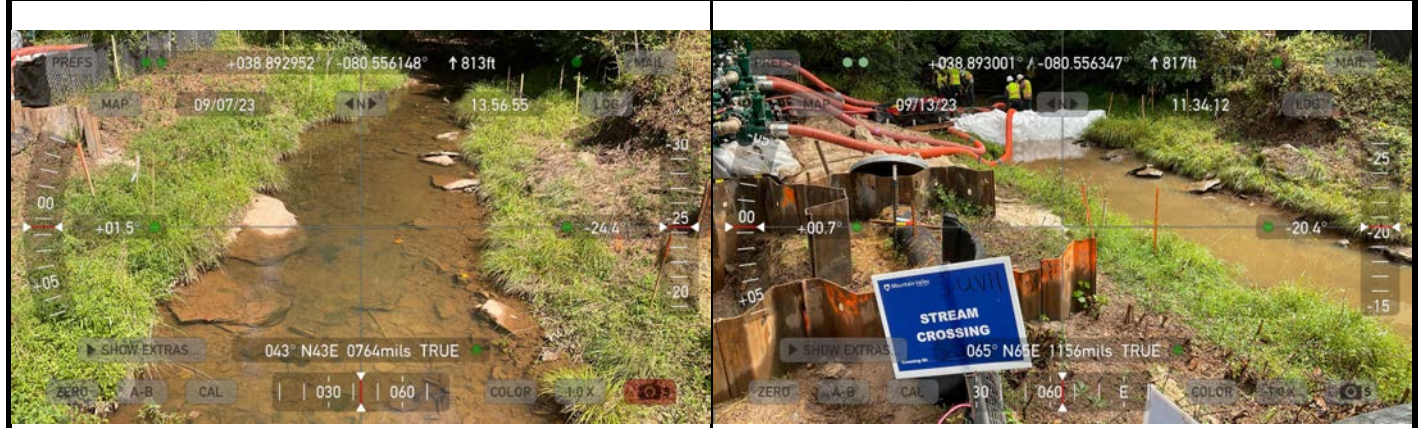
GPS Location	See photo.	GPS Location	See photo.
Description	Alternate view of stream, facing upstream from the equipment crossing	Description	View of dam and pump installation
