# Stream Biological Conditions EA Report

<b>Project Name</b>	H-600 Pipeline Spread C	<b>AFE</b>	124300130	<b>Spread</b>	H-600 Pipeline Spread C
<b>Contractor</b>	Precision	<b>Report #</b>	193		
<b>Environmental Auditor</b>	Mathew Huber	<b>Date/Time</b>	8/20/2023 8:17 AM		
<b>Stream ID</b>	S-VV2	<b>Crossing Start Date</b>	8/20/2023	<b>Crossing Completion Date</b>	8/26/2023
<b>Milepost</b>	65.62	<b>Pre-Con Assessment Date</b>	8/20/2023	<b>Post-Con Assessment Date</b>	8/26/2023
<b>Station</b>	3464+68	<b>Bankfull Width (ft.)</b>	20.0	<b>Riffle:Pool Complexes Present?</b>	No
<b>State</b>	WV	<b>Stream Classification</b>	Perennial		
<b>County</b>	Braxton	<b>303(d) Impairment Listing</b>	No

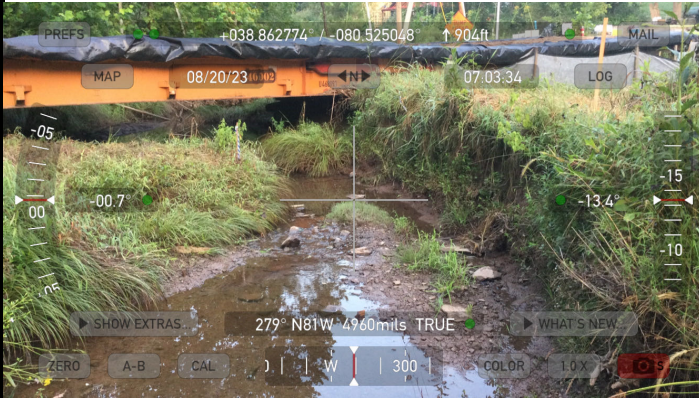
<b>GPS Location</b>	See Photo
<b>Description</b>	Downstream view of permitted impact area during pre-construction assessment.

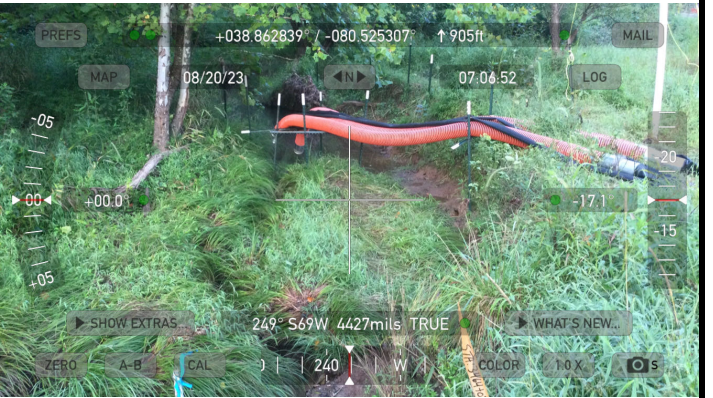
<b>GPS Location</b>	See Photo
<b>Description</b>	Downstream view of unimpacted area during pre-construction assessment.

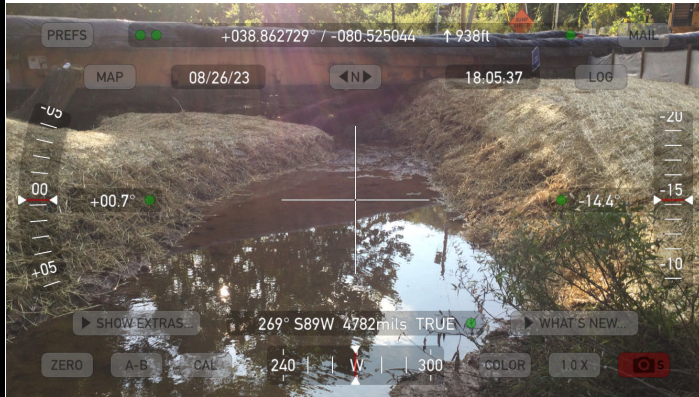
<b>GPS Location</b>	See Photo
<b>Description</b>	Downstream view of permitted impact area during post-construction assessment.

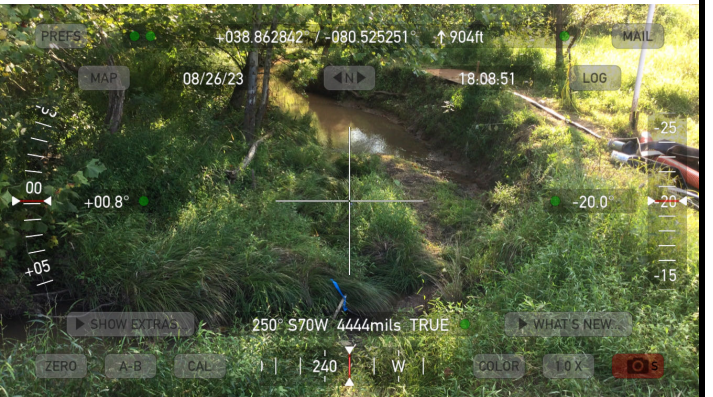
<b>GPS Location</b>	See Photo
<b>Description</b>	Downstream view of unimpacted area during post-construction assessment.

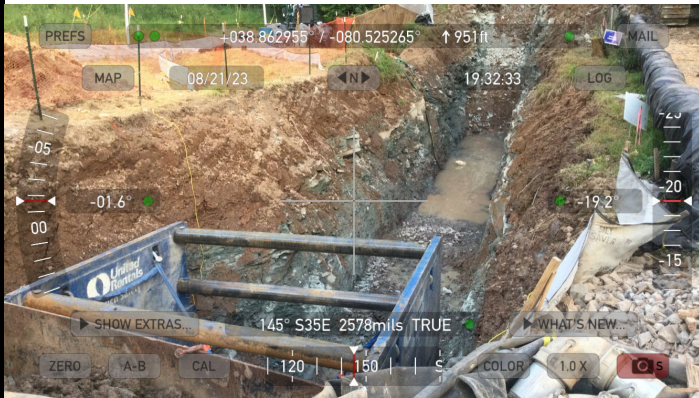
<b>GPS Location</b>	See Photo
<b>Description</b>	Stream crossing at end of workday 08/21/2023

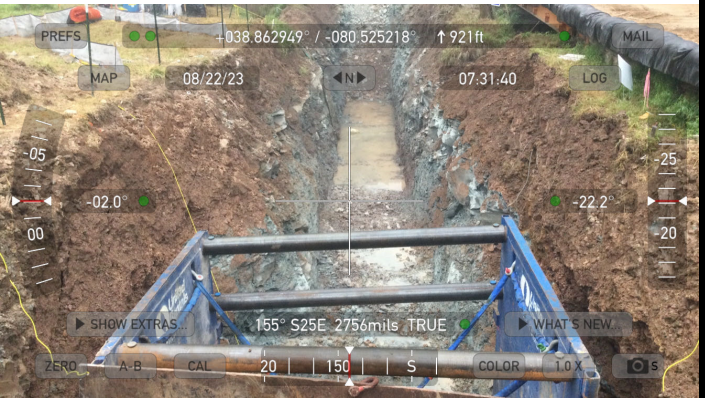
<b>GPS Location</b>	See Photo
<b>Description</b>	Stream crossing at start of workday 08/22/2023

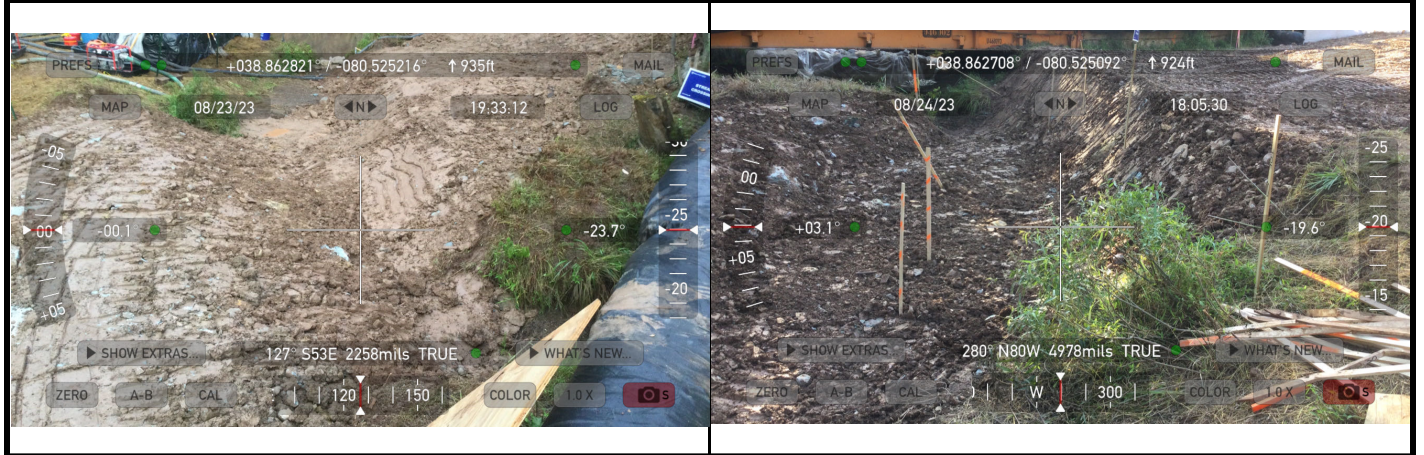
<b>Description</b>	Stream crossing at end of workday 08/23/2023	<b>Description</b>	Stream crossing at end of workday 08/24/2023
--------------------	--	--------------------	--
