STREAM BIOLOGICAL CONDITIONS ENVIRONMENTAL AUDITOR REPORT

Stream ID: S-Y13	Crossing Start Date: 08/24/2023	Crossing Completion Date: 09/13/2023
Milepost: 240.6	Pre-Con Assessment Date: 08/21/2023	Post-Con Assessment Date: 09/13/2023
Station: 12715+79	Stream Classification: Intermittent (Perennial, Intermittent, Ephemeral)	Bankfull Width (ft.): 8
County: Roanoke	303(d) Impairment Listing: Not Impaired	Riffle:Pool Complexes Present? No

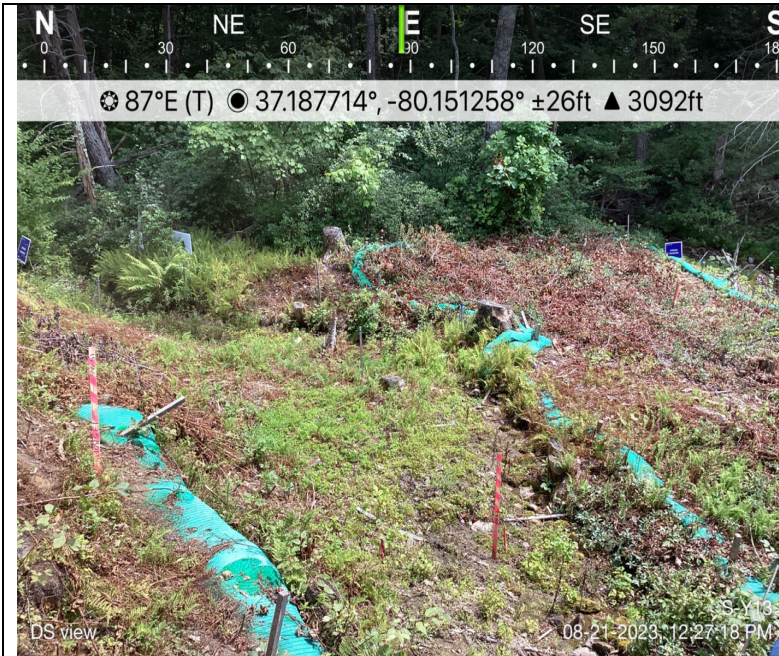
Photo Description: Downstream view of permitted impact area during pre-construction assessment.

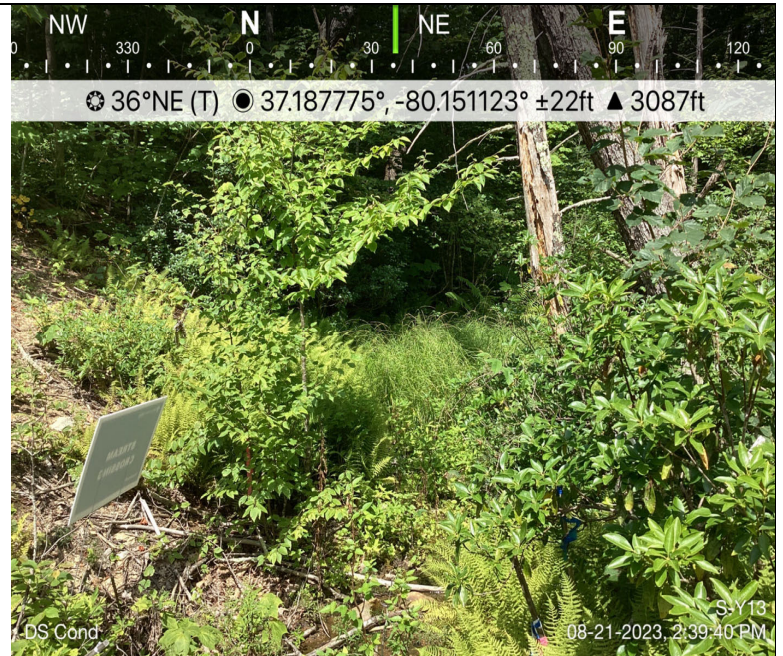
Photo Description: Conditions of the downstream area outside the ROW during pre-construction assessment.

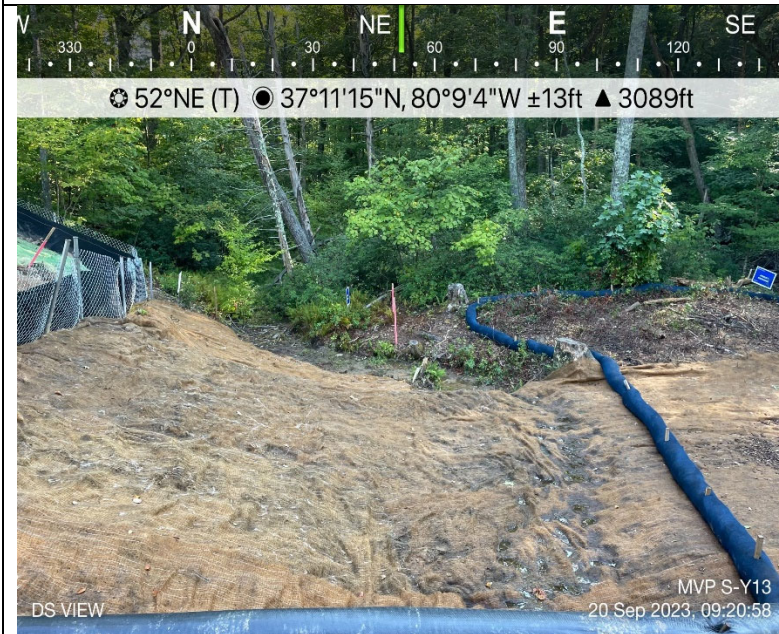
No unauthorized discharges or impacts to biological conditions were observed during the crossing activities.

Photo Description: Downstream view of permitted impact area during post-construction assessment.

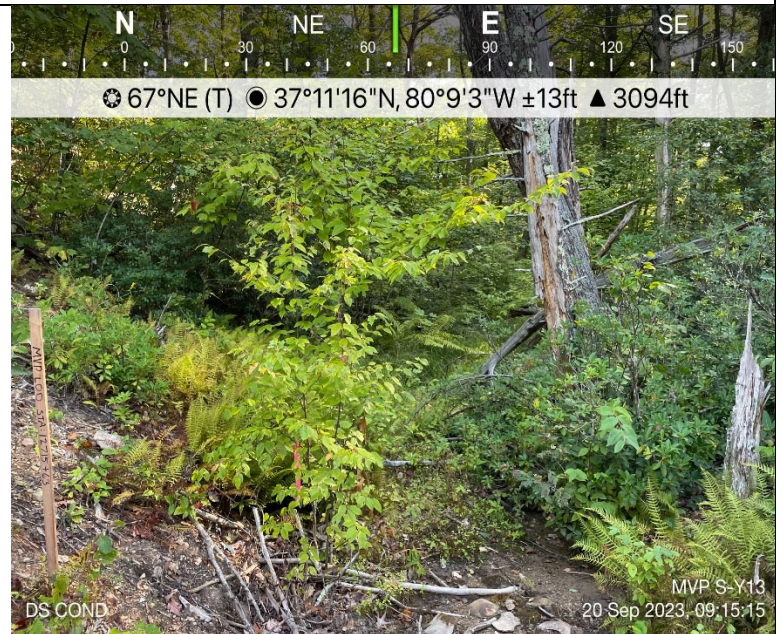
Photo Description: Conditions of the downstream area outside the ROW during post-construction assessment.

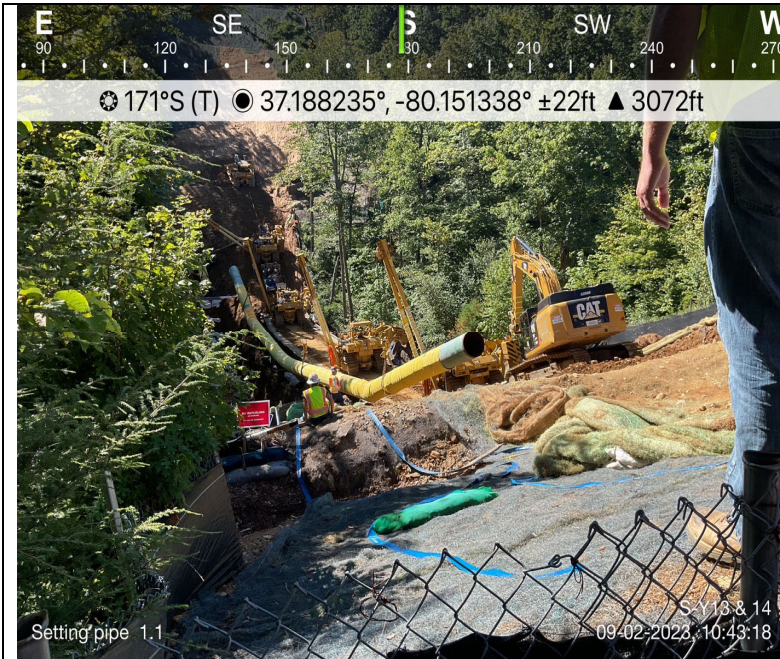
Photo Description: Setting Pipe

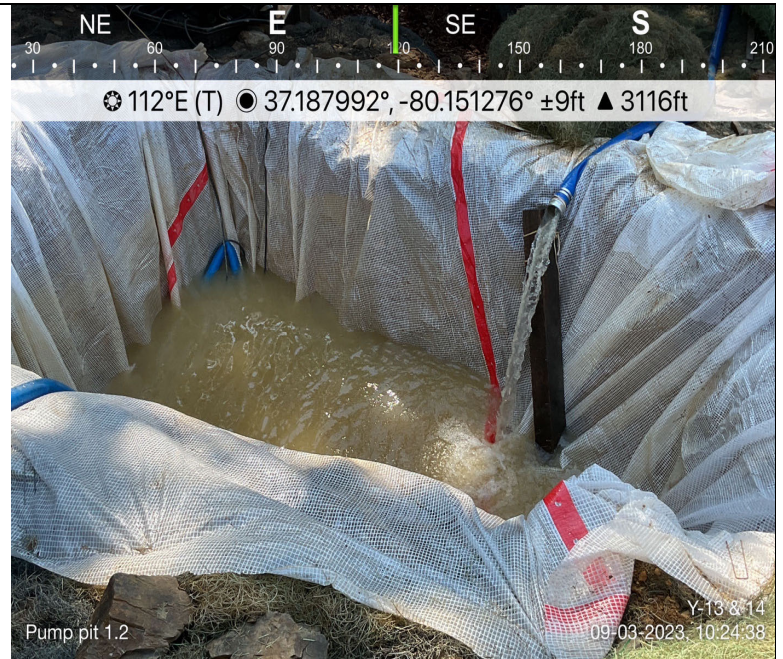
Photo Description: Dewatering pit

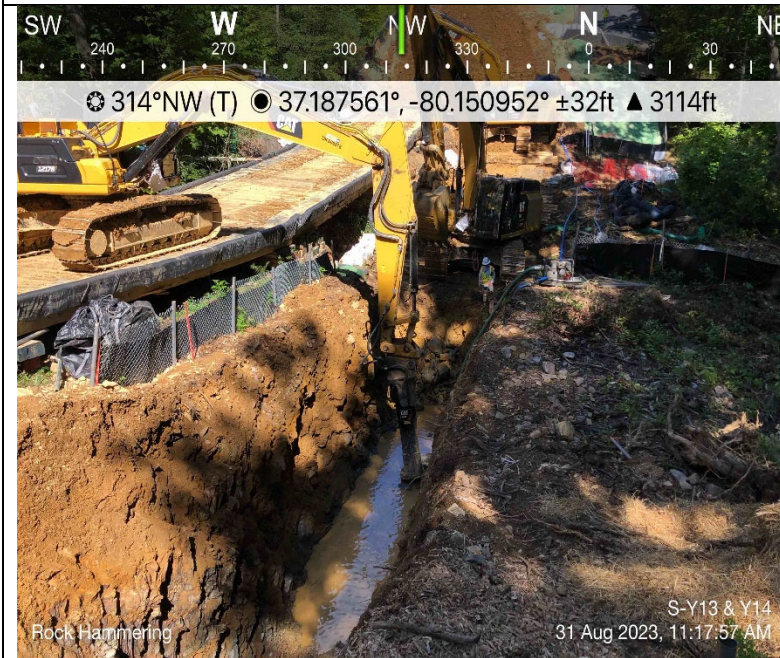
Photo Description: Trench excavation and rock hammer.

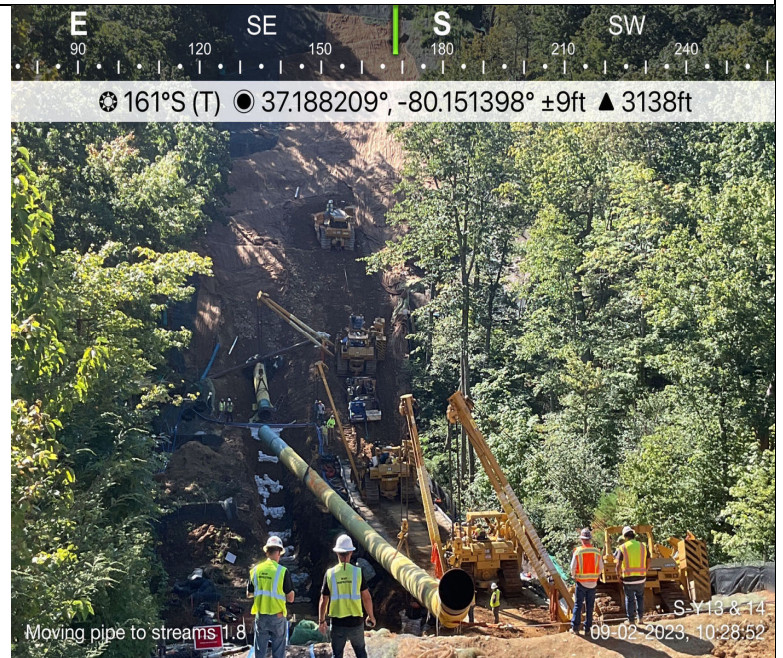
Photo Description: Moving pipe to crossing.
