STREAM BIOLOGICAL CONDITIONS ENVIRONMENTAL AUDITOR REPORT

Stream ID: S-Y14	Crossing Start Date: 08/24/2023	Crossing Completion Date: 09/06/2023
Milepost: 240.7	Pre-Con Assessment Date: 08/21/2023	Post-Con Assessment Date: 09/06/2023
Station: 12716+23	Stream Classification: Perennial (Perennial, Intermittent, Ephemeral)	Bankfull Width (ft.): 14
County: Roanoke	303(d) Impairment Listing: Not Impaired	Riffle:Pool Complexes Present? No

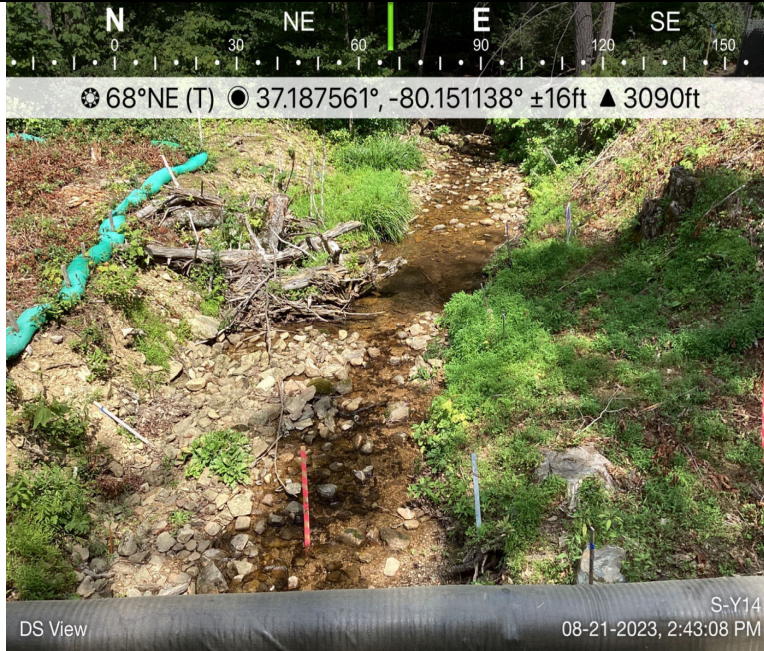
Photo Description: Downstream view of permitted impact area during pre-construction assessment.

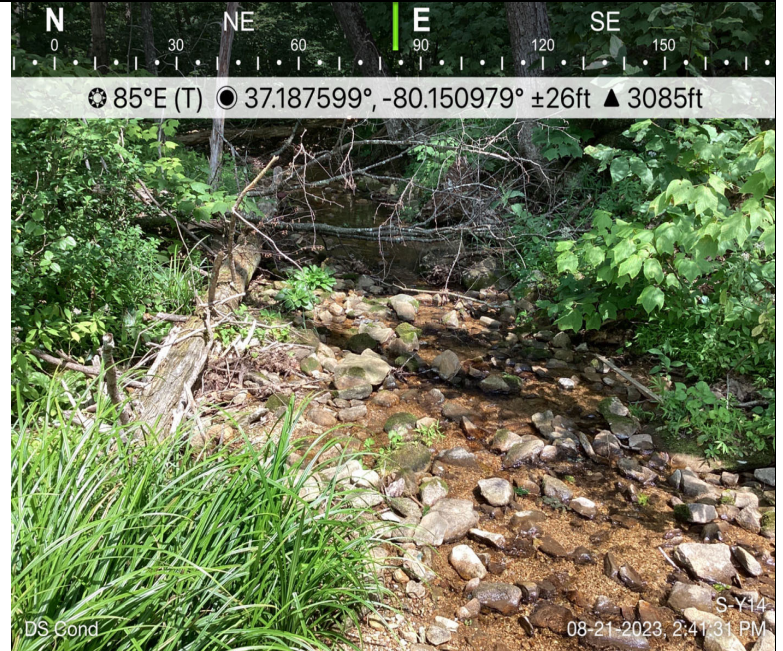
Photo Description: Conditions of the downstream area outside the ROW during pre-construction assessment.

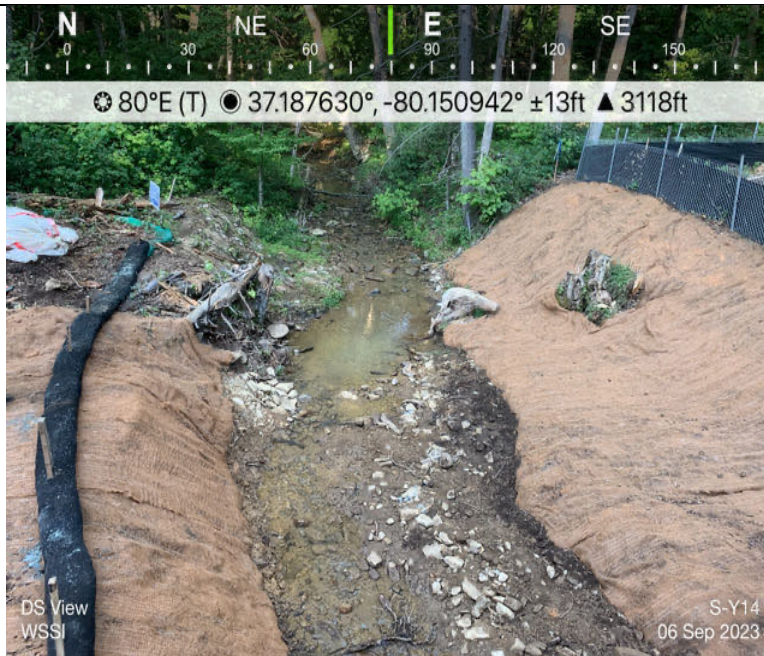
Photo Description: Downstream view of permitted impact area during post-construction assessment.

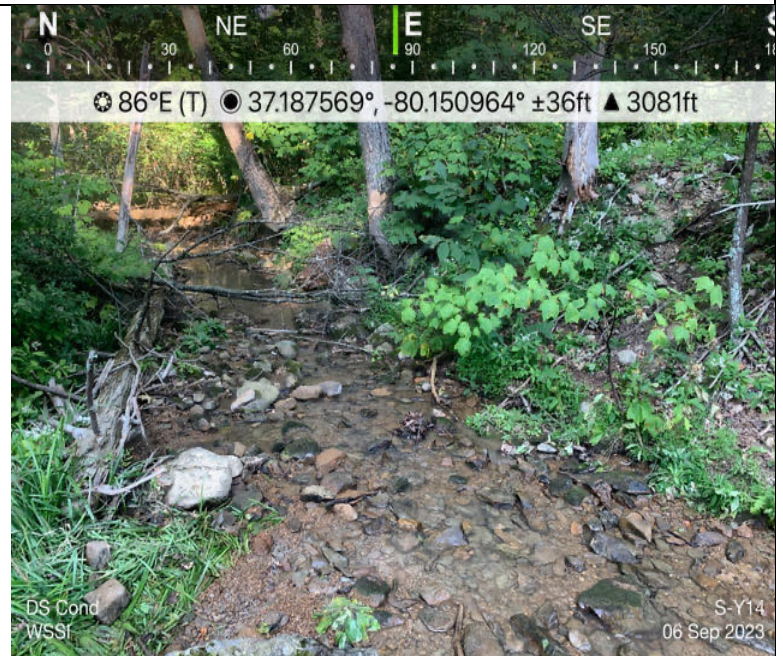
Photo Description: Conditions of the downstream area outside the ROW during post-construction assessment.

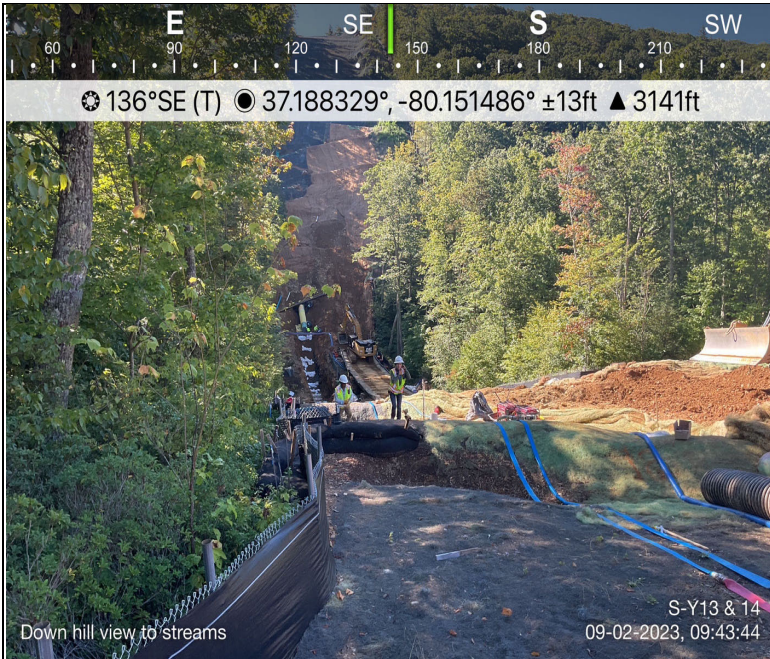
Photo Description: Overview of stream crossing area.

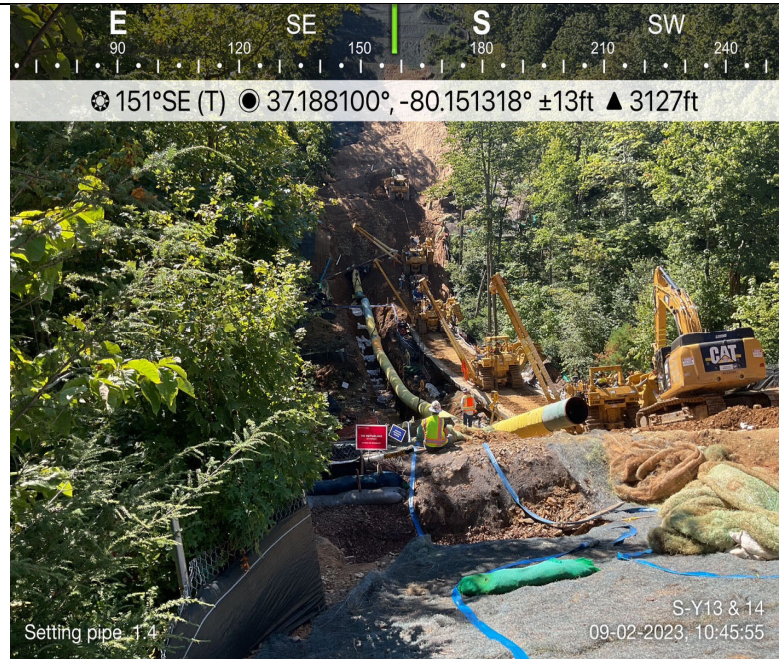
Photo Description: Pipe being set into trench.

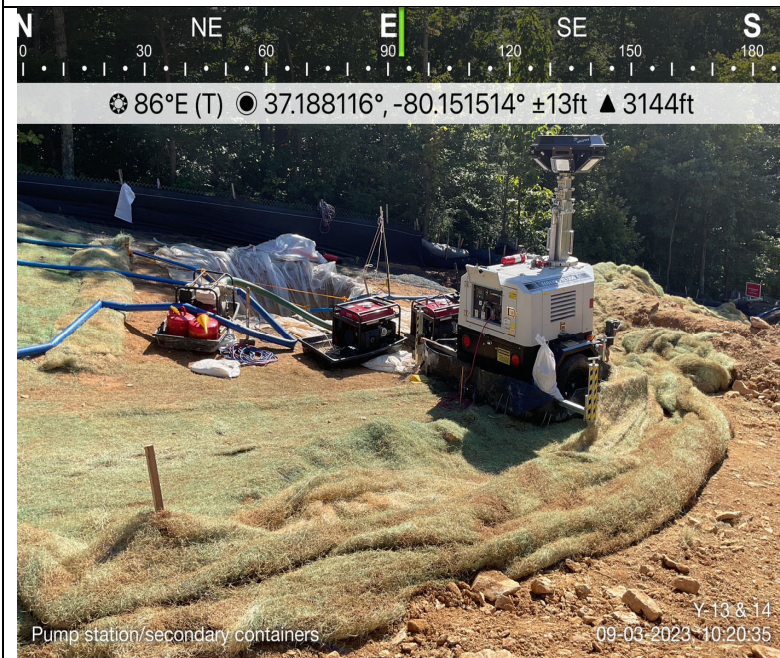
Photo Description: Dewatering pump station within secondary containment.

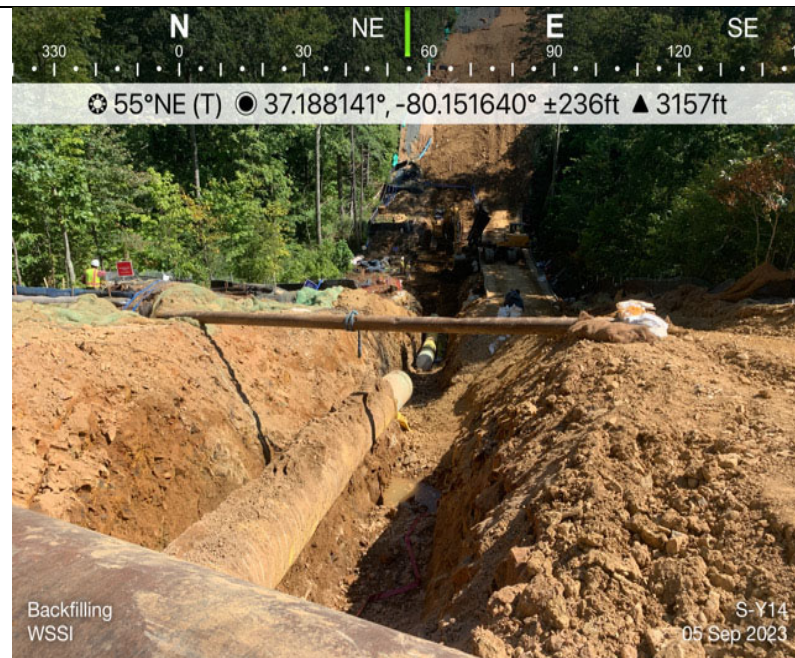
Photo Description: Backfilling trench.
