# STREAM BIOLOGICAL CONDITIONS ENVIRONMENTAL AUDITOR REPORT

Version 2.3

<b>Stream ID:</b> S-YZ4	<b>Crossing Start Date:</b> 09/06/2023	<b>Crossing Completion Date:</b> 09/08/2023
<b>Milepost:</b> 265.9	<b>Pre-Con Assessment Date:</b> 09/01/2023	<b>Post-Con Assessment Date:</b> 09/08/2023
<b>Station:</b> 14049 + 69	<b>Stream Classification:</b> Ephemeral (Perennial, Intermittent, Ephemeral)	<b>Bankfull Width (ft.):</b> 3
<b>County:</b> Franklin	<b>303(d) Impairment Listing:</b> Not Impaired	<b>Riffle:Pool Complexes Present?</b> No

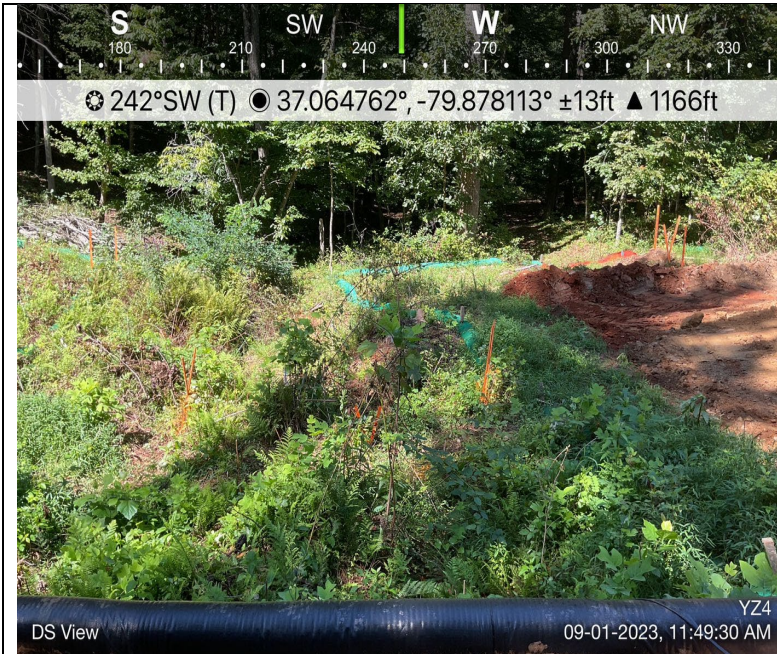
**Photo Description:** Downstream view of permitted impact area during pre-construction assessment.

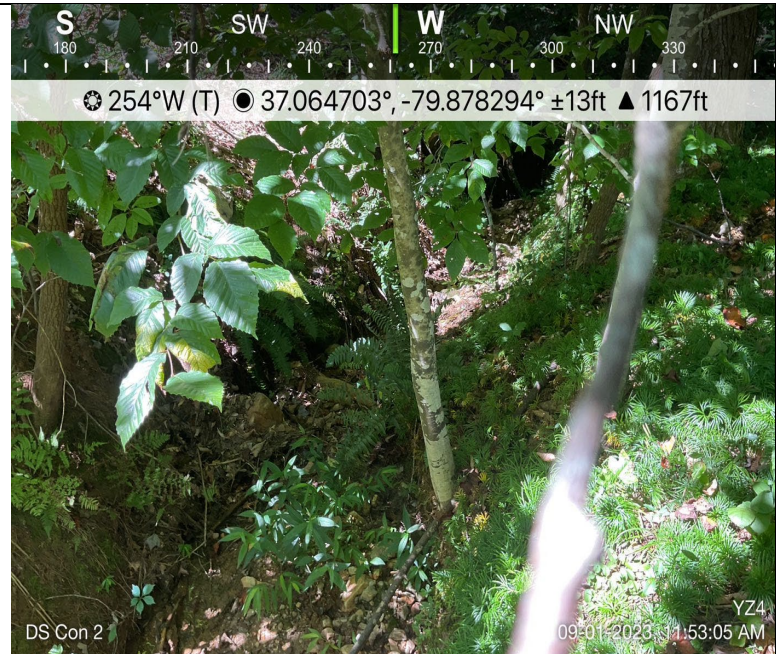
**Photo Description:** Conditions of the downstream area outside the ROW during pre-construction assessment.

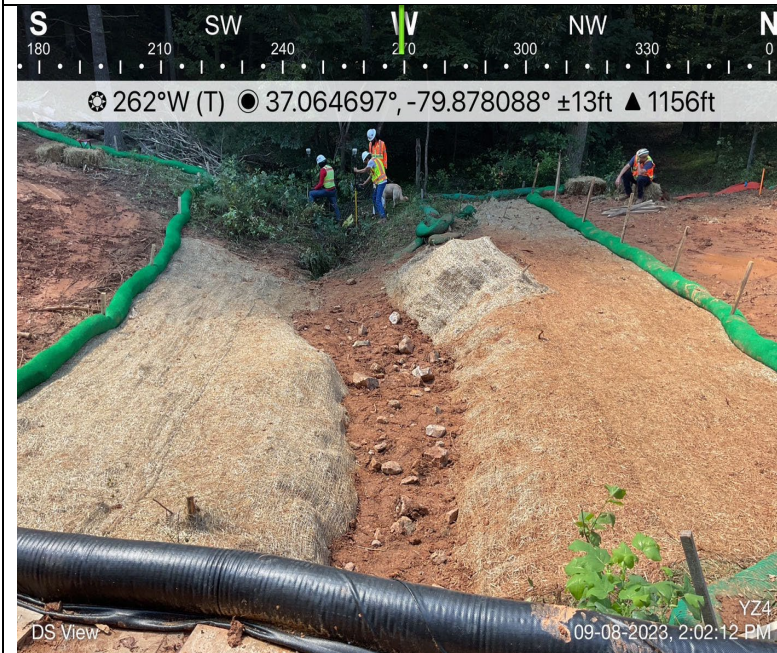
**Photo Description:** Downstream view of permitted impact area during post-construction assessment.

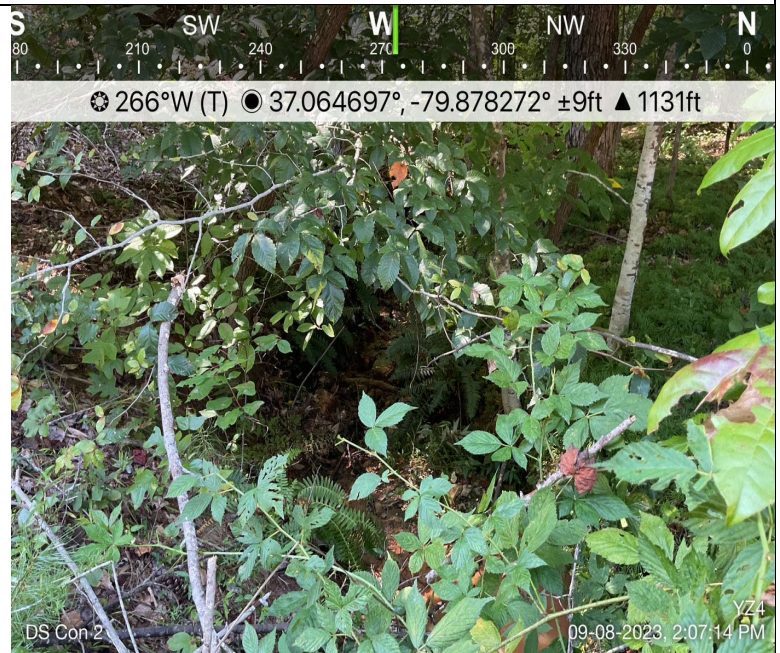
**Photo Description:** Conditions of the downstream area outside the ROW during post-construction assessment.

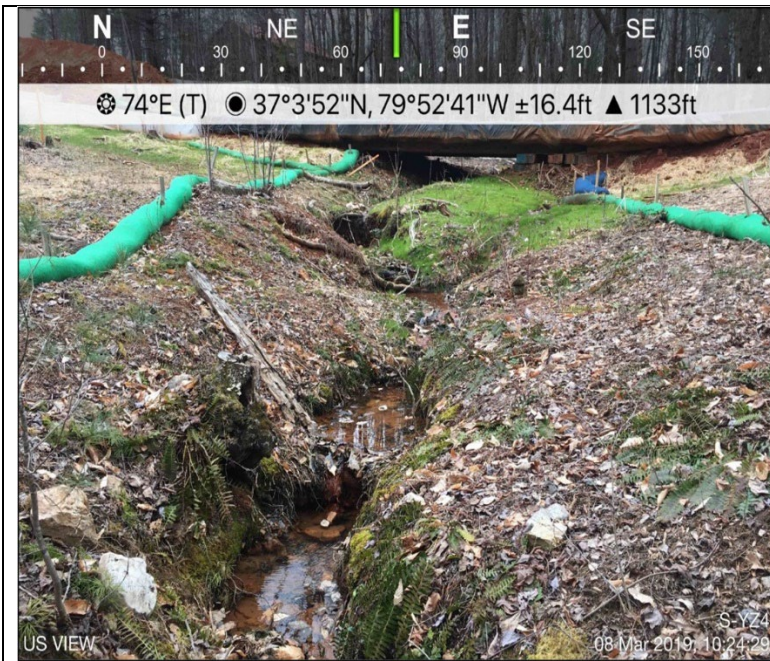
9-7-2023: Trench breakers were installed, the trench was backfilled, and right bank was restored. Restoration limitation was discovered in the pre-existing stream channel, that would be highly likely to cause the pipe to become exposed over time. While in the process of restoring the substrate and contours of stream S-YZ4, survey crews identified the previously existing 18" drop was directly over the center line of the installed pipe. The Environmental Inspector (EI) and Environmental Auditor (EA) reviewed the site and determined based on the site conditions the more stable configuration at the pipe centerline would be to grade in a transitional area (small riffle-pool), in favor of trying to build back a potentially unstable 18 inch "step-down" controlled by root structures as shown in the pre-existing conditions and photos. -D. Willson

**Photo Description:** 2019 photo looking upstream into the permitted impact area.

This modification is in accordance with the Mitigation Framework App. B Sec. 2.0.1. S-YZ4 is an ephemeral channel, and data does not indicate any pre-existing riffle:pool complexes for this resource. Please see additional photos section for documentation photos collected in 2019.

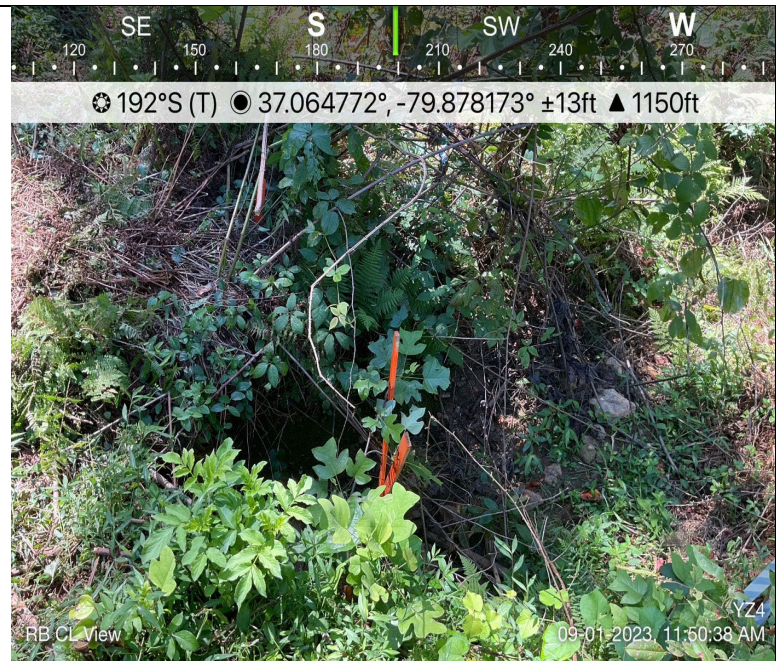
**Photo Description:** Right bank center line view of resource

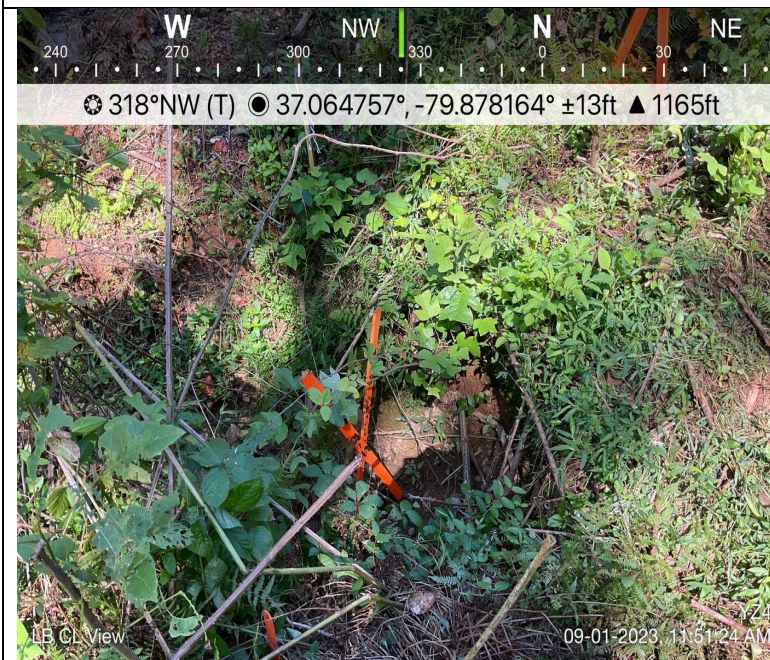
**Photo Description:** Left bank center line view of resource

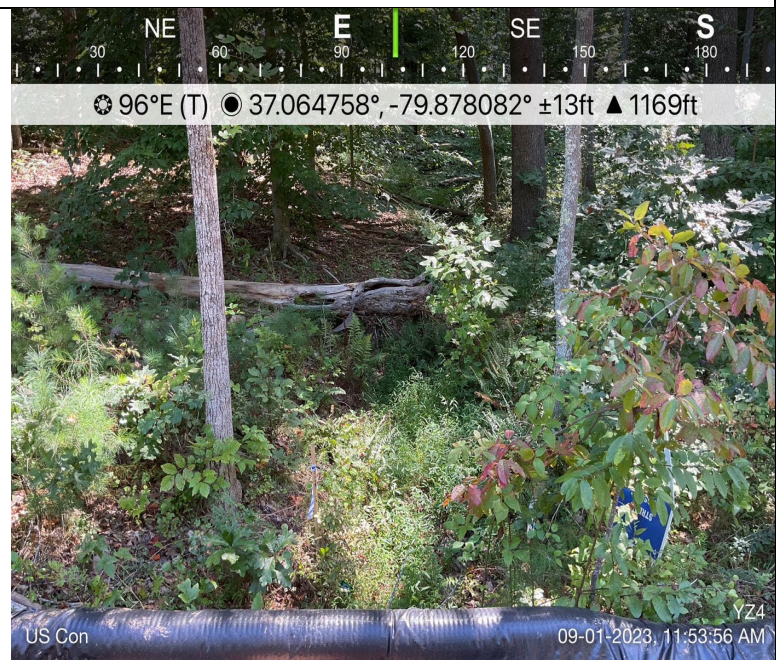
**Photo Description:** Upstream condition of unpermitted area

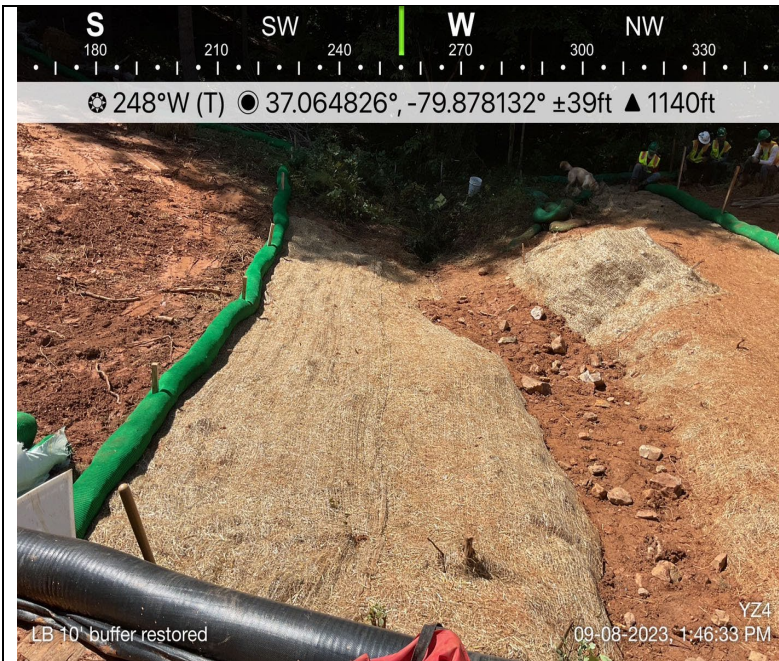
**Photo Description:** Restoration of left bank within FERC 10' buffer.

9-8-2023: Stream channel was restored to pre-existing conditions to the extent possible. Right bank was first restored to the 10' FERC buffer, then left bank was restored to full 50' buffer, then right bank 50' buffer restoration was completed. New erosion control measures were installed in addition to permanent & temporary seed with erosion control matting. Restoration was deemed complete by MVP EI. -D. Willson

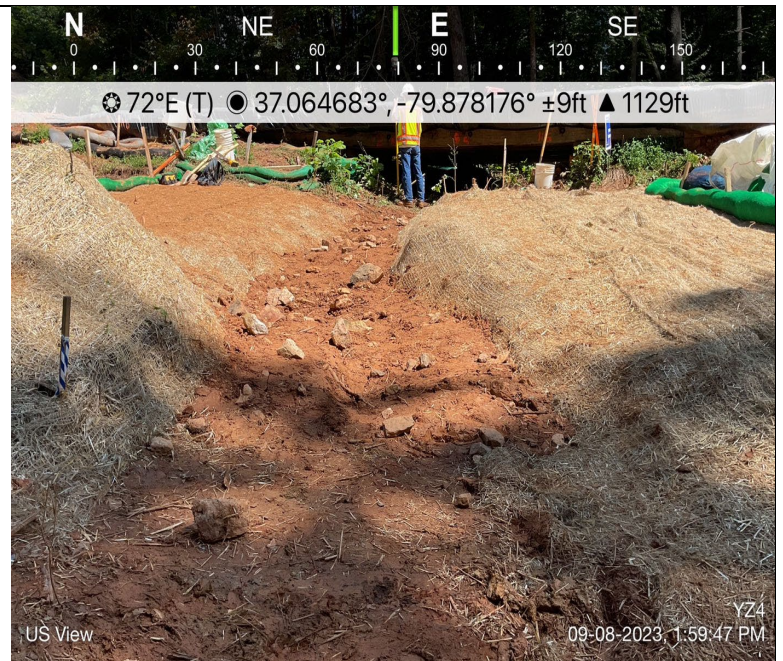
**Photo Description:** Upstream view of resource during restoration activities.

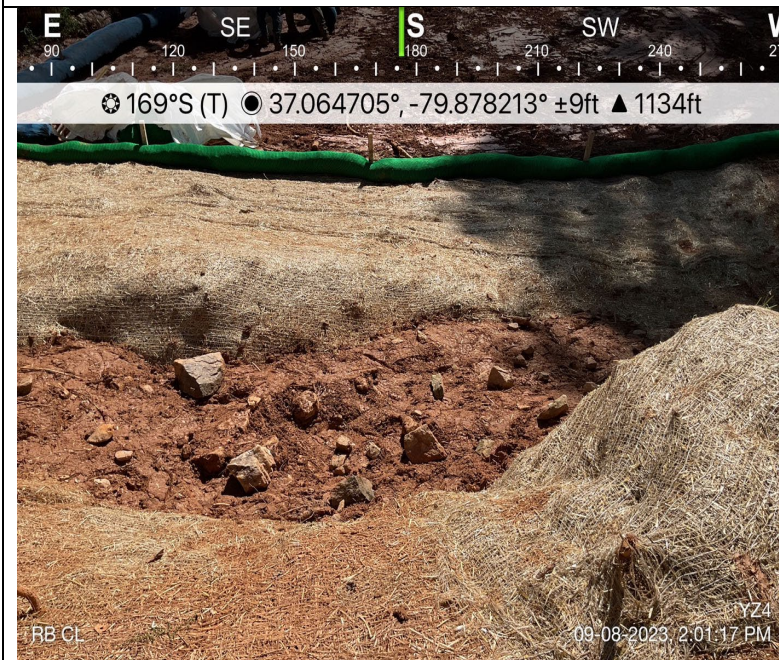
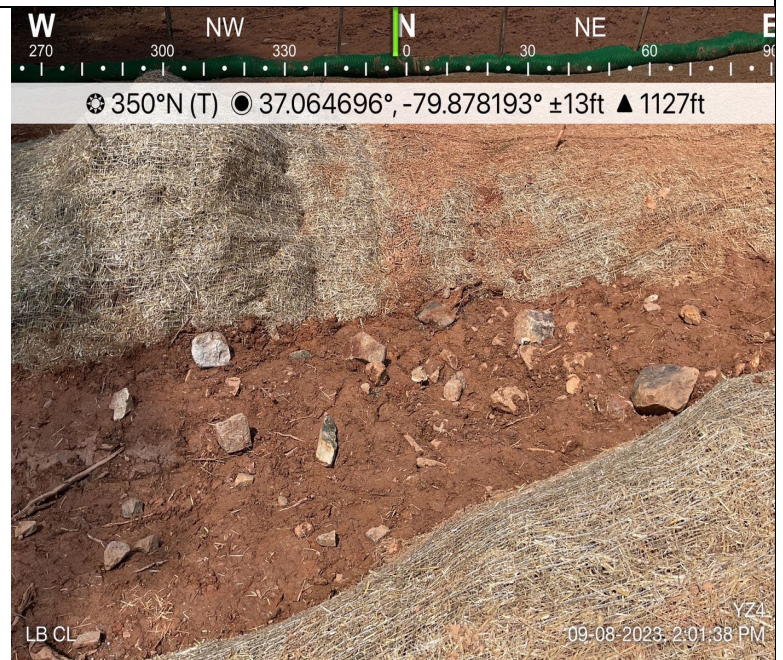
**Photo Description:** View of pipe centerline depicting modification area.
