Wetland Biological Conditions EA Report

Project Name	H-600 Pipeline Spread A	AFE	124300129	Spread	H-600 Pipeline Spread A
Contractor	Precision	Report #	39		
Environmental Auditor	Samantha Felix			Date/Time	9/2/2023 6:51 PM
Wetland ID	W-A1a	Crossing Start Date	8/22/2023	Crossing Completion Date	9/2/2023
Milepost	0.65	Pre-Con Assessment Date	8/26/2023	Post-Con Assessment Date	9/5/2023
Station	34+32	Cowardin Classification	PEM	Wetland Impact Area(acres)	0.0038
State	WV				
County	Wetzel

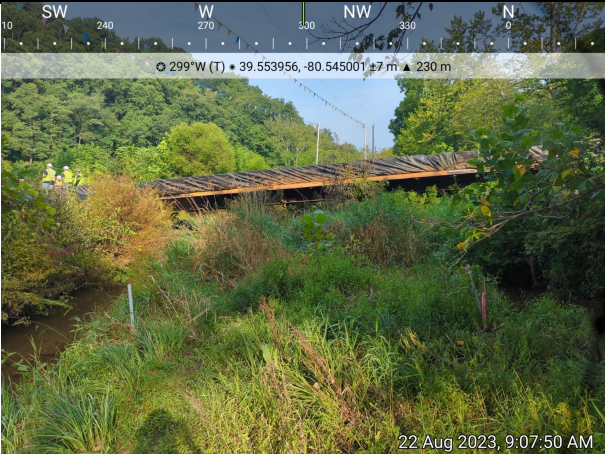
<p>NE E SE S 30 60 90 120 150 180 112°E (T) • 39.553937, -80.544973 ±7 m ▲ 229 m 22 Aug 2023, 9:08:00 AM</p>
<p>GPS Location See above.</p>	<p>GPS Location See above.</p>
<p>Description View of permitted resource impact area during pre-construction assessment.</p>	<p>Description At edge of LOD, view of unimpacted resource area conditions during pre-construction assessment.</p>

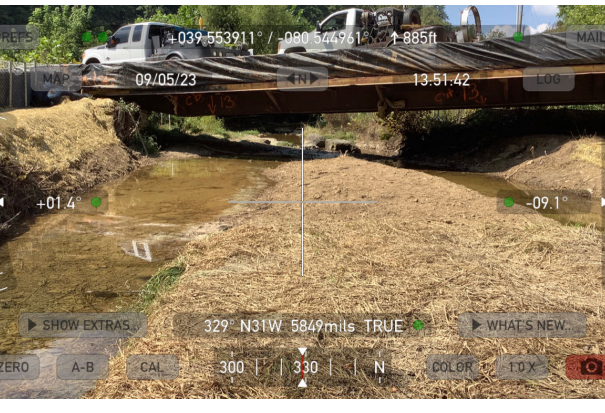
Conditions 18 and 19 were given a rating of 4 during post-construction assessment due to lack of vegetation in the disturbed permitted impact area following the completion of the crossing and restoration efforts. The adjacent S-A1a stream bank and stream bed substrates have been properly stabilized and the disturbed area has been seeded with the appropriate permanent seed mix in accordance with Appendix B: Restoration Work Plan of the Mountain Valley Pipeline Comprehensive Stream and Wetland Monitoring, Restoration and Mitigation Framework.

<p>Description View of permitted resource impact area during post-construction assessment.</p>	<p>Description At edge of LOD, view of unimpacted resource area conditions during post-construction assessment.</p>

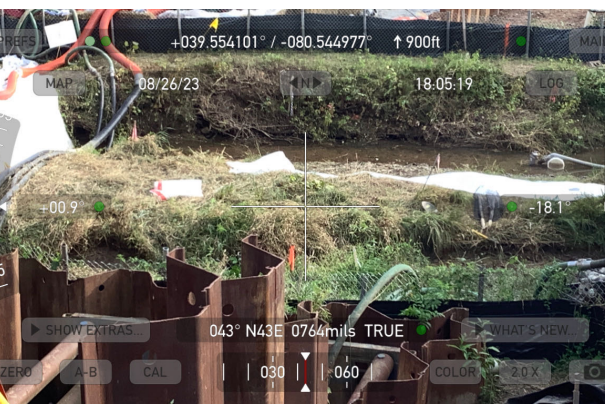
<p>PREPS +039.553853° / -080.544768° ↑ 893ft MAIL MAP 08/27/23 13.31.27 LOG +02.1° -08.6° SHOW EXTRAS 327° N33W 5813mils TRUE WHAT'S NEW... ZERO A-B CAL 300 330 N COLOR 2.0X 0.5</p>
<p>GPS Location See above.</p>	<p>GPS Location See above.</p>
<p>Description This photo shows the dam and pump installed for the wetland and stream crossing</p>	<p>Description This photo shows the contractor working on installing sheet piling.</p>

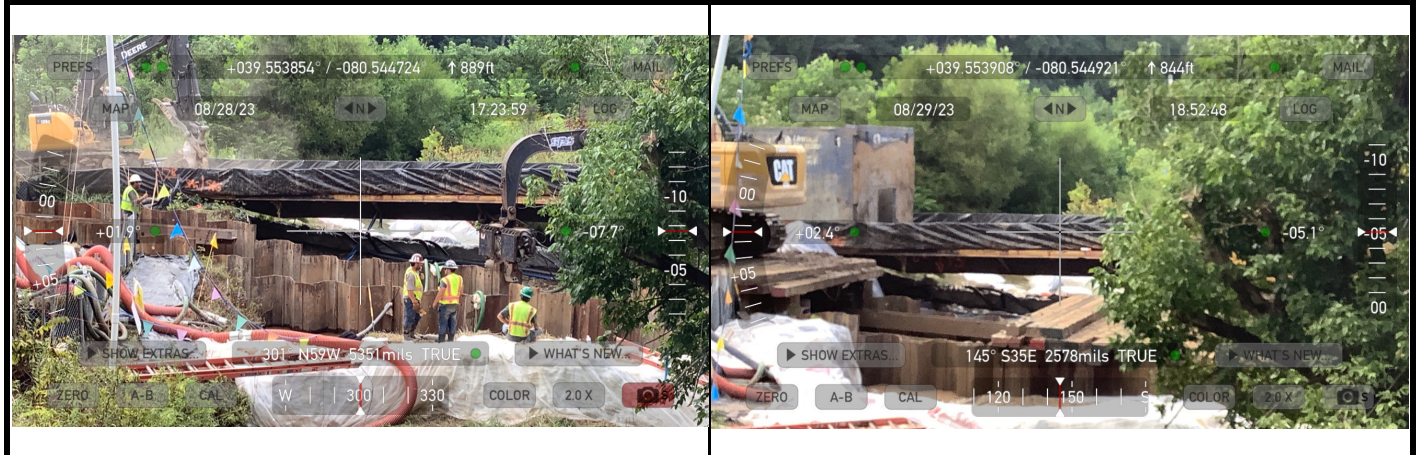
GPS Location See above.	GPS Location See above.
Description This photo shows the contractor continuing work on the sheet pile installation.	Description This photo shows the contractor continuing work on the sheet pile installation.

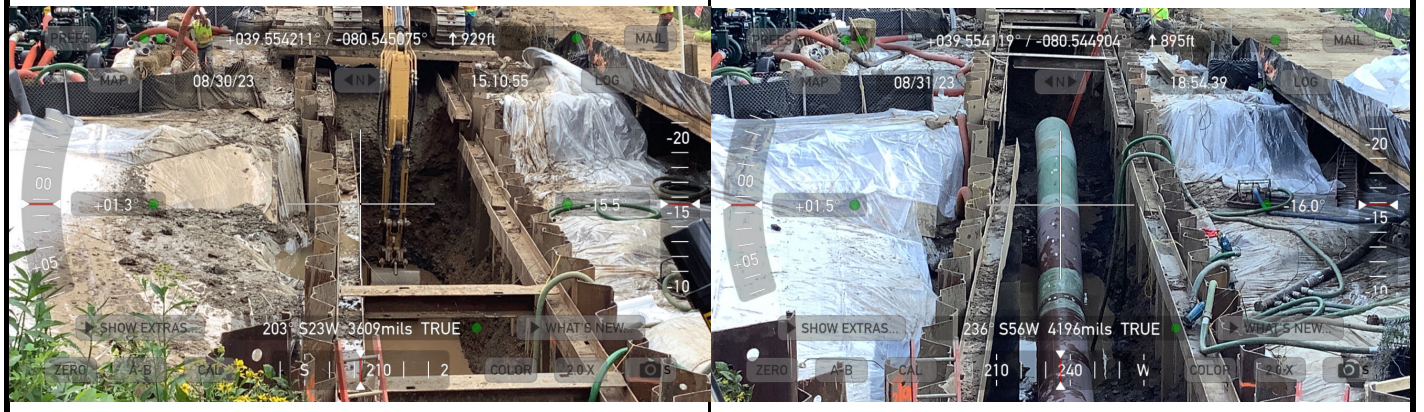
GPS Location See above.	GPS Location See above.
Description This photo shows the contractor working on excavating the trench	Description This photo shows the contractor working on installation of pipeline.

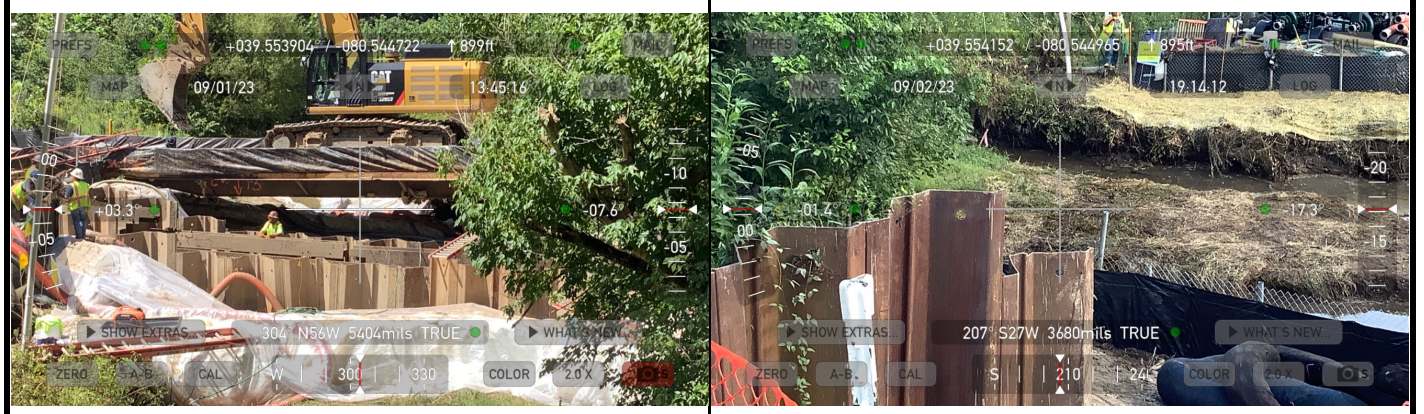
GPS Location See above.	GPS Location See above.
Description This photo shows the contractor working on backfilling the trench with soil.	Description This photo shows the completed crossing.
