Wetland Biological Conditions EA Report

Project Name	H-600 Pipeline Spread A	AFE	124300129	Spread	H-600 Pipeline Spread A
Contractor	Precision	Report #	37		
Environmental Auditor	Rachel Ellis			Date/Time	8/27/2023 8:24 AM
Wetland ID	W-B1a	Crossing Start Date	8/27/2023	Crossing Completion Date	9/2/2023
Milepost	18.81	Pre-Con Assessment Date	8/27/2023	Post-Con Assessment Date	9/5/2023
Station	993+36	Cowardin Classification	PEM	Wetland Impact Area(acs)	0.0119
State	WV				
County	Harrison

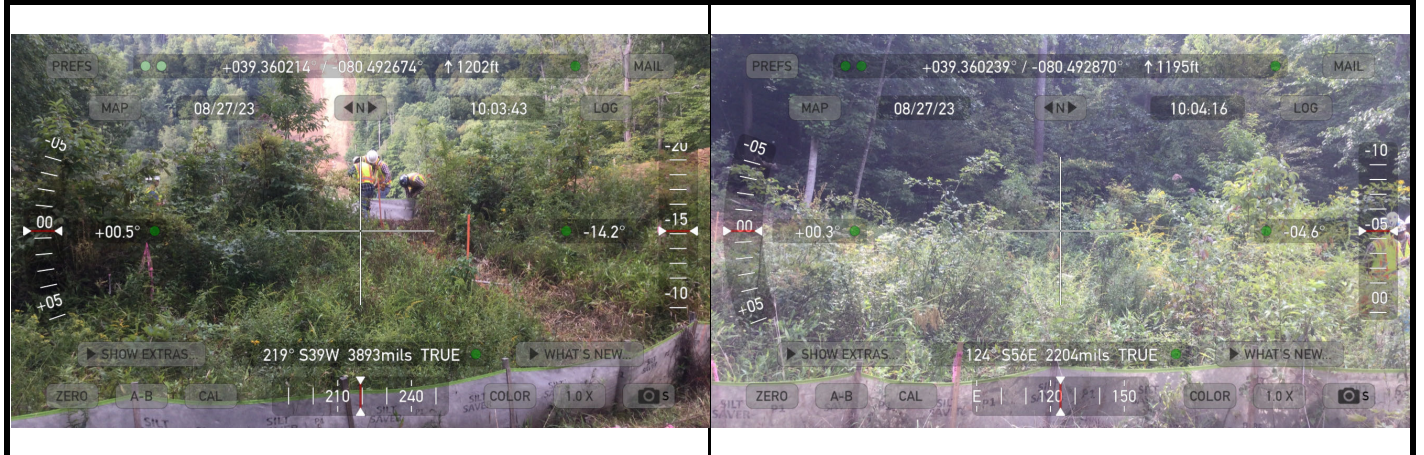
GPS Location Please see above.	GPS Location Please see above.
Description View of permitted resource impact area during pre-construction assessment.	Description At edge of LOD, view of unimpacted resource area conditions during pre-construction assessment.

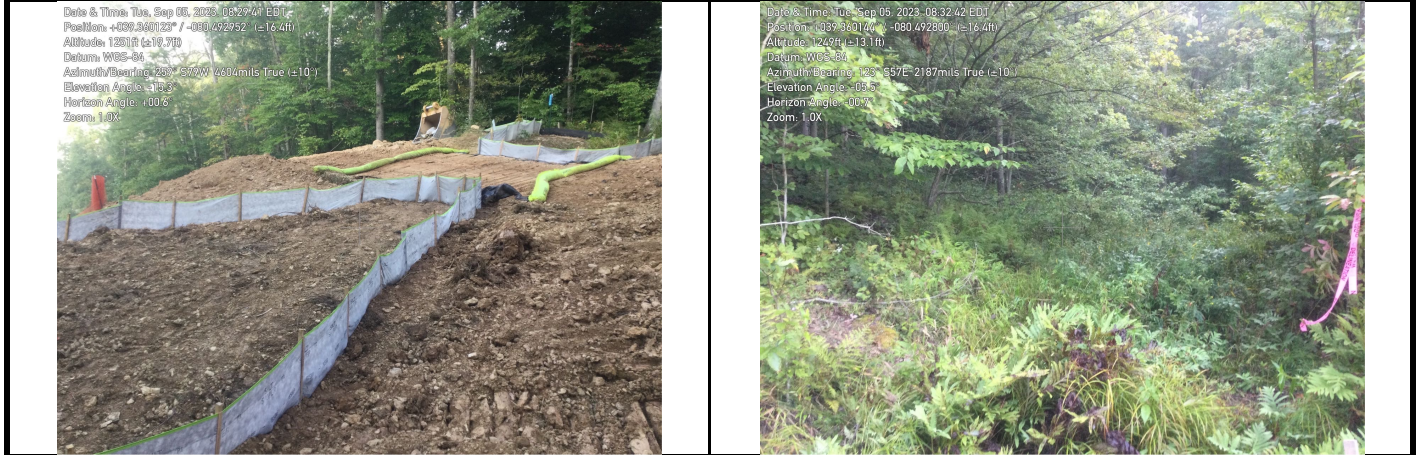
9/5/23 Post-construction Assessment
 The pipe was coated, trench breakers were finished being installed, and the wetland was backfilled with the native soil. During the post-construction assessment, conditions 18 and 19 were given a rating of 4. This rating was due to the permitted disturbance of wetland W-B1a and the lack of vegetation in the disturbed permitted impact area following completion of the crossing and restoration efforts. The W-B1A PEM wetland topsoils have been properly stabilized and the disturbed area has been seeded with the appropriate permanent seed mix in accordance with Appendix B: Restoration Work Plan of the Mountain Valley Pipeline Comprehensive Stream and Wetland Monitoring Restoration and Mitigation Framework.

GPS Location Please see above.	GPS Location Please see above.
Description View of permitted resource impact area during post-construction assessment.	Description At edge of LOD, view of unimpacted resource area conditions during post-construction assessment.

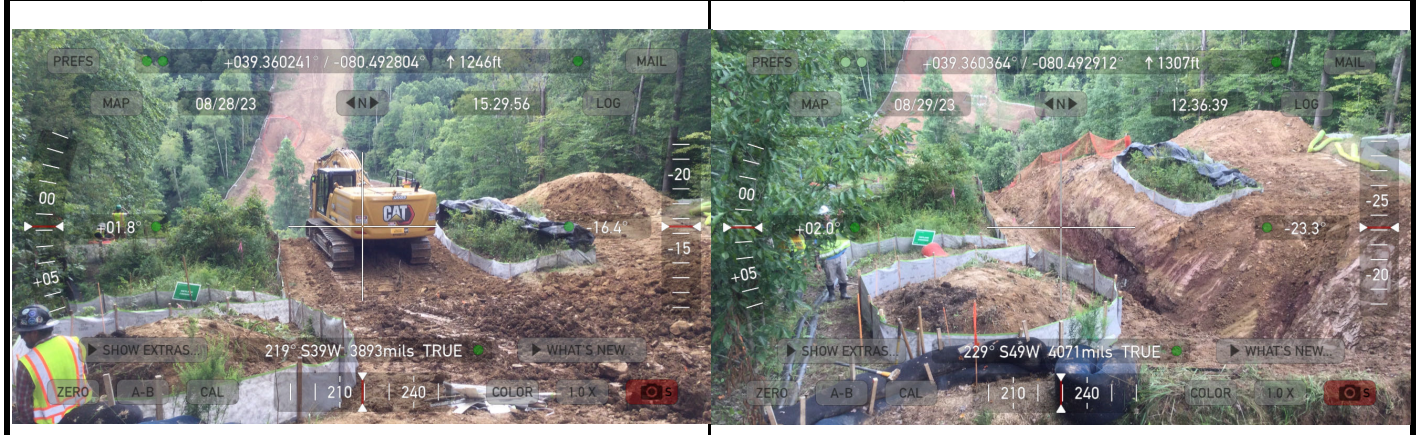
8/29/23
 Excavation through the wetland began following removal and segregation of topsoil, segregated soils were contained with silt fencing in case of weather. Mats were installed into the wetland.

GPS Location Please see above.	GPS Location Please see above.
Description Photo showing matting placed down and plastic wrap to prevent soil from falling into wetland.	Description Photo of construction on 8/29, work on excavation through wetland continued.

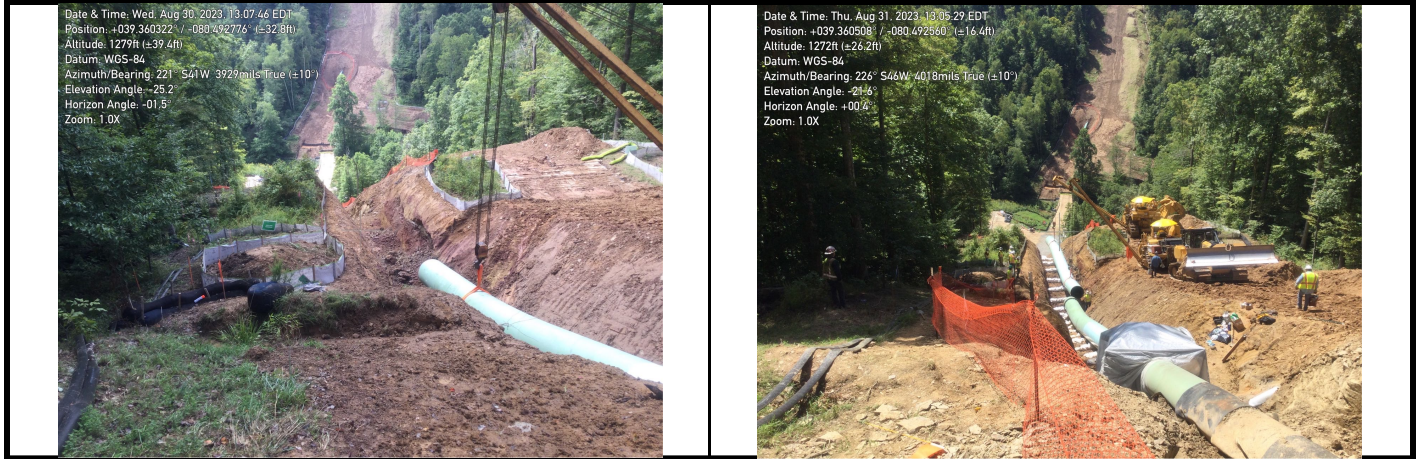
GPS Location	Please see above.	GPS Location	Please see above.
Description	Photo of construction on 8/30 showing pipe section in upland area adjacent to wetland installed	Description	Photo of construction on 8/31 showing wetland section of pipe was installed

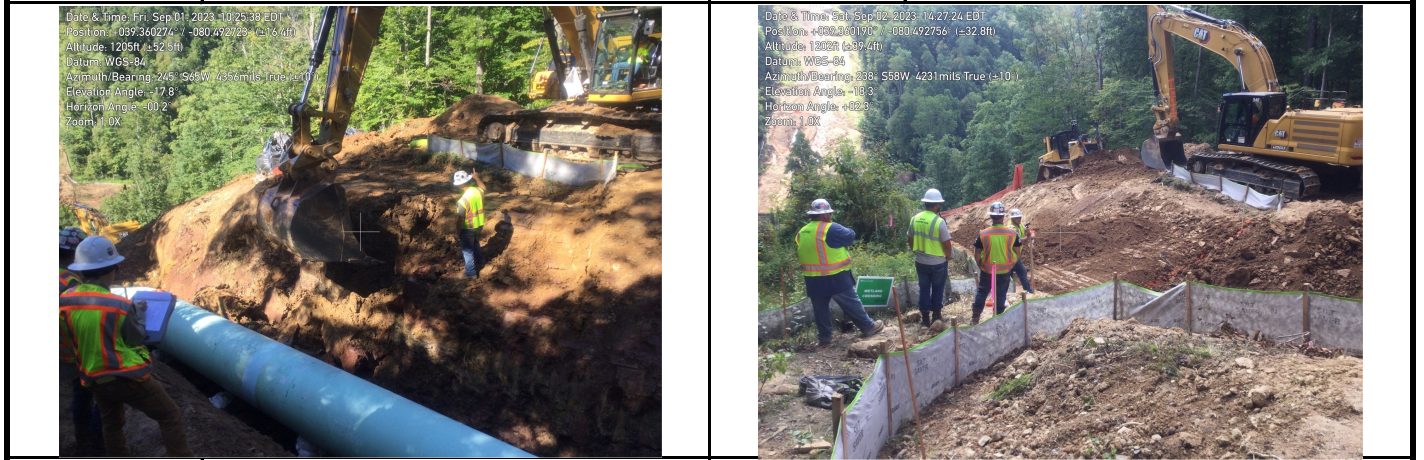
9/1/23
 There was an emergent trench collapse on the eastern side of the pipe within the wetland section. As a result, to maintain safe working conditions, several feet of additional wetland topsoil was segregated so that the trench wall could be sloped back. All impacts associated with the trench remained within the permitted temporary impact area.

GPS Location	Please see above.	GPS Location	Please see above.
Description	9/1 Photo showing partial trench collapse on eastern side of crossing resulted in more wetland vegetation removal due to safety concerns	Description	Photo showing subsoil being restored to crossing on 9/2
