# Wetland Biological Conditions EA Report

<b>Project Name</b>	H-600 Pipeline Spread C	<b>AFE</b>	124300131	<b>Spread</b>	H-600 Pipeline Spread C
<b>Contractor</b>	Precision	<b>Report #</b>	45		
<b>Environmental Auditor</b>	Todd Grant			<b>Date/Time</b>	9/6/2023 9:51 AM
<b>Wetland ID</b>	W-B39	<b>Crossing Start Date</b>	9/6/2023	<b>Crossing Completion Date</b>	9/10/2023
<b>Milepost</b>	96.71	<b>Pre-Con Assessment Date</b>	9/5/2023	<b>Post-Con Assessment Date</b>	9/10/2023
<b>Station</b>	5106+38	<b>Cowardin Classification</b>	PEM	<b>Wetland Impact Area(acres)</b>	0.0906
<b>State</b>	WV				
<b>County</b>	Webster

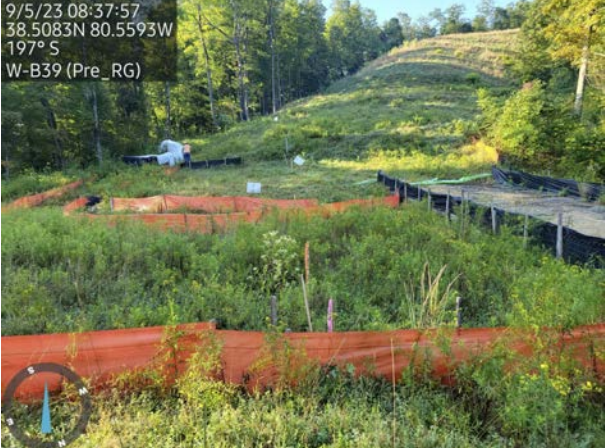
<p>9/5/23 08:37:57 38.5083N 80.5593W 197° S W-B39 (Pre_RG)</p>

<b>GPS Location</b>	In Photo	<b>GPS Location</b>	In Photo
<b>Description</b>	View of permitted resource impact area during pre-construction assessment. View down LOD from center line pre-construction.	<b>Description</b>	At edge of LOD, view of unimpacted resource area conditions during pre-construction assessment. Left side of the LOD edge of unimpacted resource pre-construction.
<p>09/10/2023 14:27:17 +38.508312,-80.559222 198° S W-B39 (Pos_TG)</p>

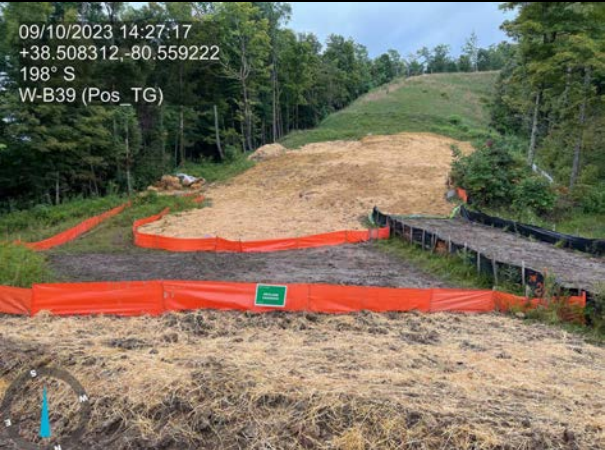
<b>GPS Location</b>	In Photo	<b>GPS Location</b>	In Photo
<b>Description</b>	View of permitted resource impact area during post-construction assessment. Viewing down LOD from center line post-construction.	<b>Description</b>	At edge of LOD, view of unimpacted resource area conditions during post-construction assessment. Left side of the LOD edge of unimpacted resource post-construction.

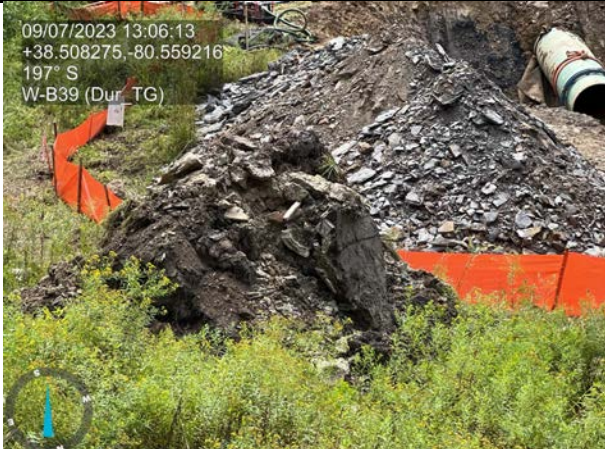
<p>09/07/2023 13:06:13 +38.508275,-80.559216 197° S W-B39 (Dur_TG)</p>

<b>GPS Location</b>	In Photo	<b>GPS Location</b>	In Photo
<b>Description</b>	View of wetland topsoil segregated inside wetland boundary.	<b>Description</b>	View of contractor lowering pipe into ditch and preparing to begin welding.

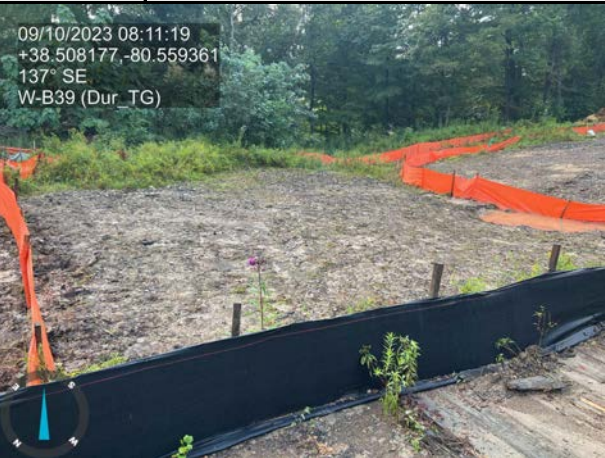
9/10/2023- The previous day's rain total was 2.8". On arrival it was observed that the ditch had settled on the GAS wetland boundary. The ECD's that were installed as the rain event started appeared in good condition and functioning. After consulting with the contractor and Environmental Inspector, it was decided that the topsoil in the subsided area of the ditch should be removed and additional ditch spoil would need to be added to bring the low area up to original grade. The contractor removed the topsoil from the low area and segregated it inside the wetland. Once the area was filled with additional ditch spoil, the wetland topsoil was replaced. The contractor made all efforts to recontour the area to original condition without compacting the soil. Due to the wet conditions, there are visible marks in the wetland from equipment that could not be entirely removed. Conditions 18 and 19 were given a rating of 4 due to lack of vegetation in the disturbed permitted impact area following the crossing and restoration efforts. The W-B39 PEM topsoils have been seeded with the appropriate permanent seed mix in accordance with Appendix B: Restoration Work Plan of the Mountain Valley Pipeline Comprehensive Stream and Wetland Monitoring, Restoration and Mitigation Framework. Buffer zones to wetland W-B39 were seeded and stabilized. T. Grant

<b>GPS Location</b>	In Photo	<b>GPS Location</b>	In Photo
<b>Description</b>	View of wetland with ditch subsidence on GAS following 2.8" rain event.	<b>Description</b>	View of contractor beginning repair of ditch subsidence following 2.8" rain event.
