Wetland Biological Conditions EA Report

Project Name	H-600 Pipeline Spread D	AFE	124300132	Spread	H-600 Pipeline Spread D
Contractor	Precision	Report #	36		
Environmental Auditor	Josh Guy			Date/Time	8/22/2023 12:07 PM
Wetland ID	W-E18-PSS	Crossing Start Date	8/22/2023	Crossing Completion Date	9/1/2023
Milepost	109.87	Pre-Con Assessment Date	8/22/2023	Post-Con Assessment Date	9/1/2023
Station	5800+91	Cowardin Classification	PSS	Wetland Impact Area(acs)	0.0538
State	WV				
County	Webster

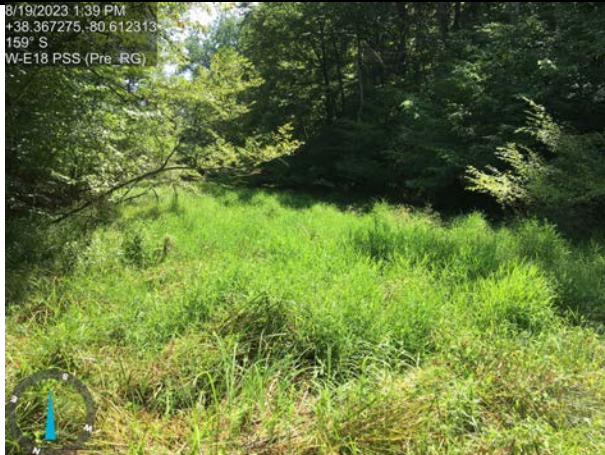
GPS Location See above in photo		GPS Location See above in photo			
Description View of permitted resource impact area during pre-construction assessment. At GAS resource boundary. Viewing pre-construction current conditions.		Description At edge of LOD, view of unimpacted resource area conditions during pre-construction assessment. At edge of LOD, viewing unimpacted resource area pre-construction.			
<p>09/01/2023 15:28:38 +38.367207 -80.612293 172° S W-E18-PSS-(Post_JGf)</p>  		<p>09/01/2023 16:57:04 +38.367203 -80.612187 153° SE WL-E18 PSS-(Post_JGf)</p>

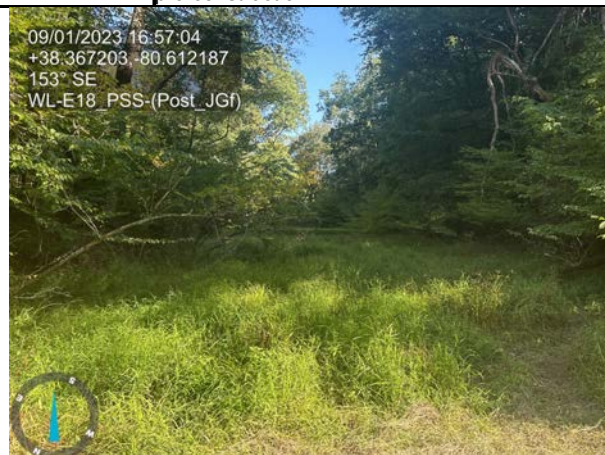
GPS Location See above in photo		GPS Location See above in photo			
Description View of permitted resource impact area during post-construction assessment. At GAS resource boundary. Viewing topsoil restoration completion efforts.		Description At edge of LOD, view of unimpacted resource area conditions during post-construction assessment. At edge of LOD, viewing current conditions of unimpacted resource post construction.

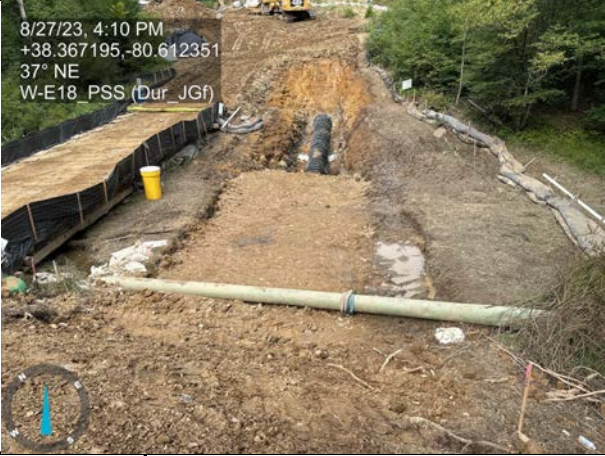
GPS Location	See above in photo	GPS Location	See above in photo
Description	View from GAS upland area of resource. View of backfilled resource before restoring topsoil.	Description	View from CIS W-E18-PSS boundary in upland area. View of trench breaker installation at CIS resource boundary 5800+84.

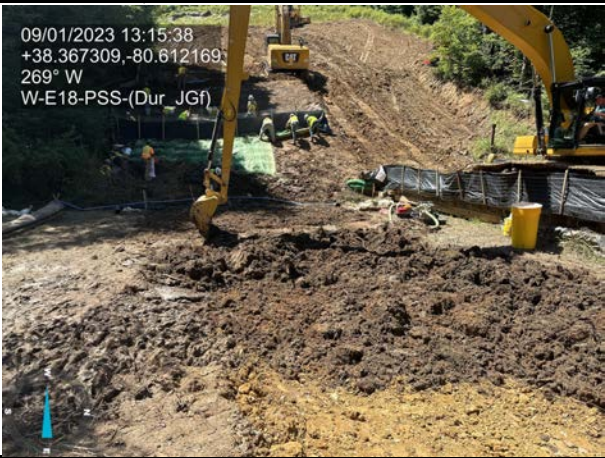
GPS Location	See above in photo	GPS Location	See above in photo
Description	View from CIS of resource boundary. View of contractor restoring topsoil to resource.	Description	View from GAS W-E18-PSS boundary in upland area. View of trench breaker installation at GAS resource boundary 5801+51.
Insert image here		Insert image here	
GPS Location		GPS Location	
Description		Description
